the **play inspection** company

Annual Inspection

Adisham Parish Council

Adisham Recreation Ground

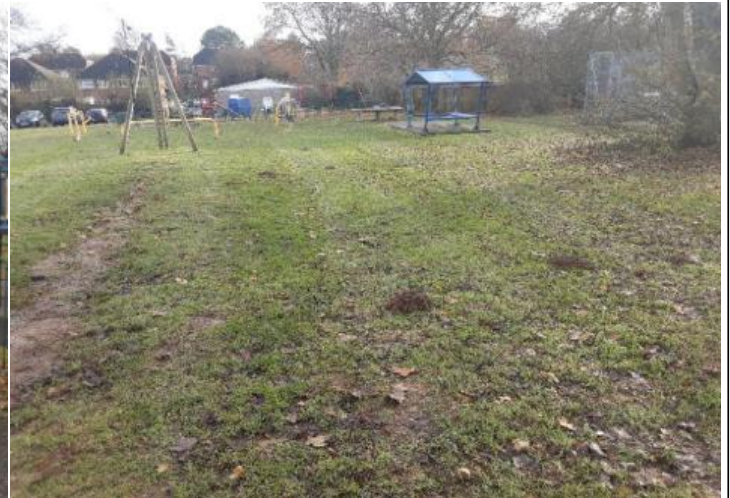
Item: Ancillary Items - Site General
Manufacturer: Owner/Operator

Finding: There are a number of molehills within the area and these may present unforeseen hazards for users

Action: Remove moles by appropriate means, reinstate surfaces to level and maintain the area

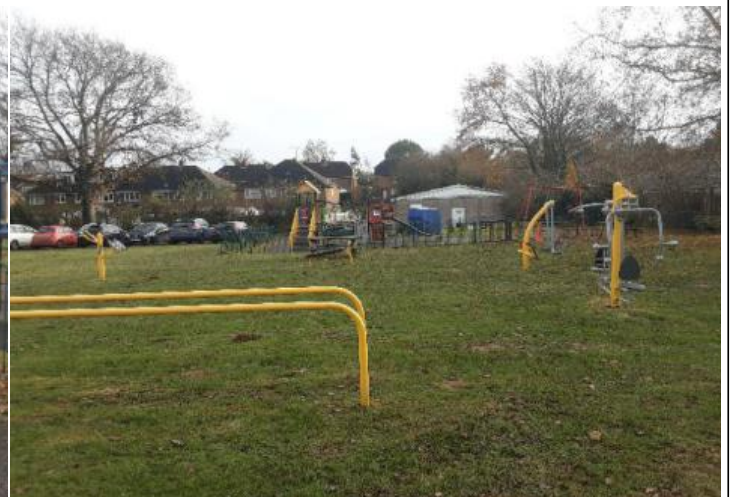
Item: Ancillary Items - Site General
Manufacturer: Owner/Operator

Finding: It is recommended that Adult Outdoor Fitness equipment is installed a minimum of 25m away from a childrens playground or separated and screened to discourage access by younger children

Action: Monitor use and review risk assessment regularly

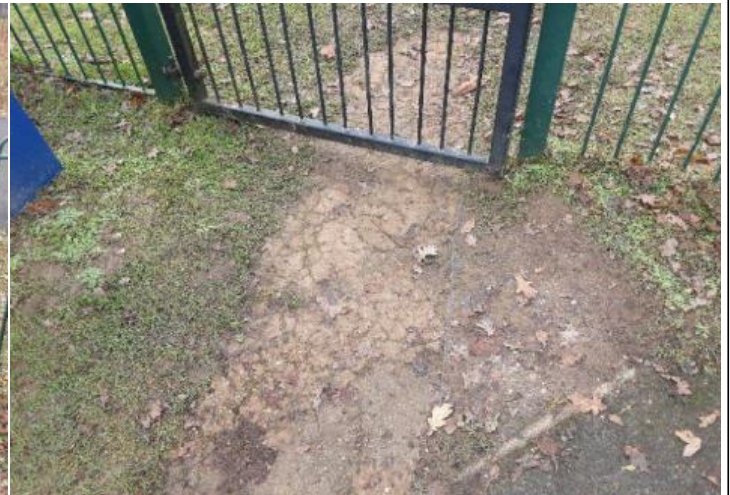
Item: Gates - Gate
Manufacturer: Not Identified

Finding: There is moderate damage to the surface
Action: Repair the damaged areas of surfacing

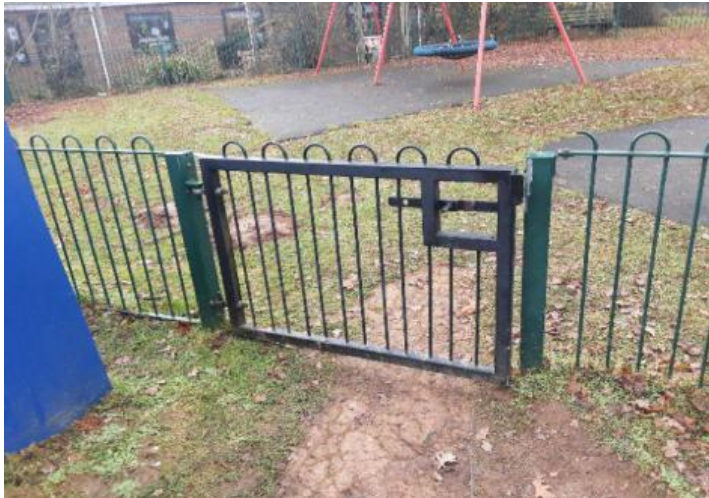
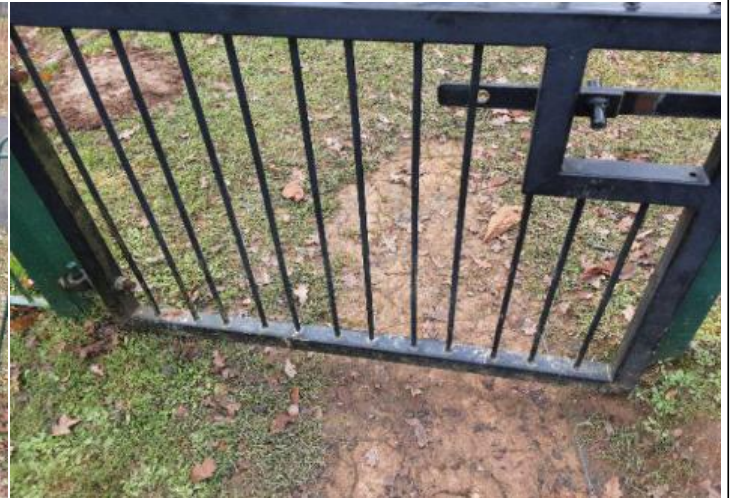
Item: Gates - Gate
Manufacturer: Not Identified

Finding: Cable ties have been used on the item and there are sharp projecting ends

Action: Remove if not required or replace with a more appropriate alternative fixing method if used as a fixing

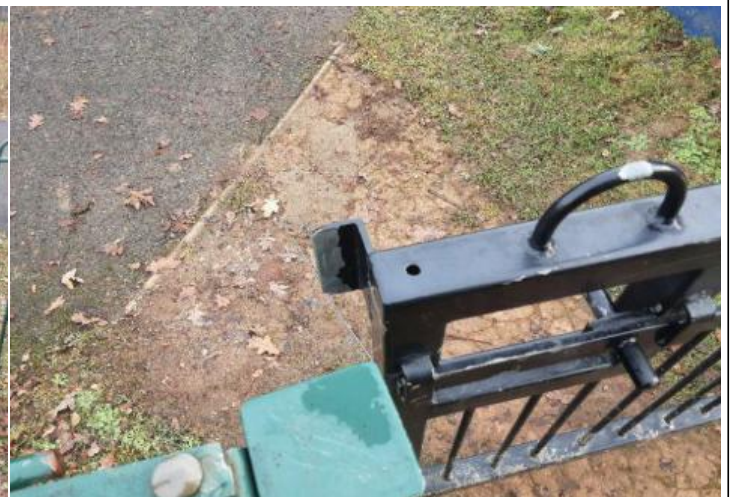
Item: Gates - Gate
Manufacturer: Not Identified

Finding: The rubber buffer is missing from the latch plate

Action: Replace rubber buffer

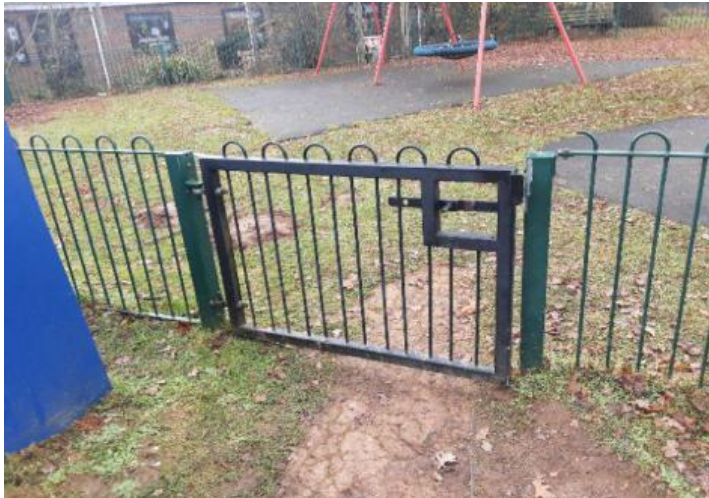
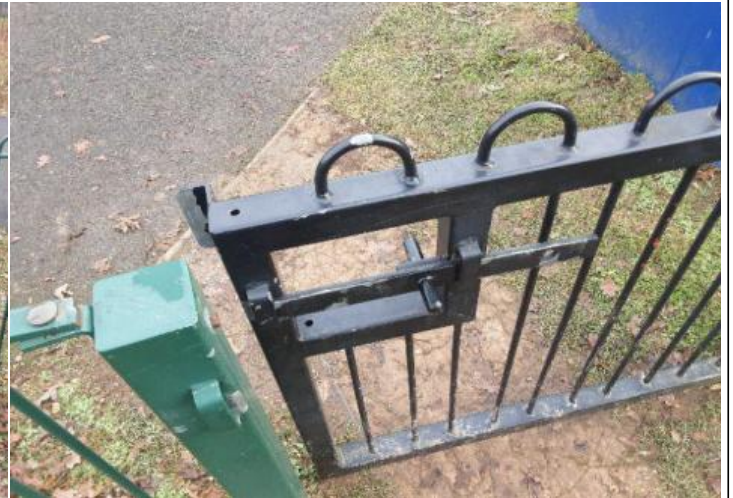
Item: Gates - Gate
Manufacturer: Not Identified

Finding: The gate rebounds when opened quickly and could strike the next user entering the area
Action: Monitor use and adjust/replace as required

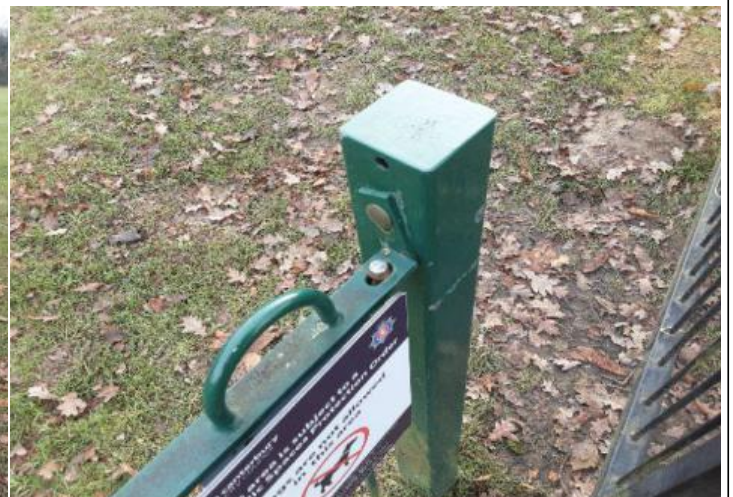
Item: Fences - Fence - Bow Top
Manufacturer: Not Identified

Finding: A number of fixings have worked loose around the fencing
Action: Secure all loose fixings

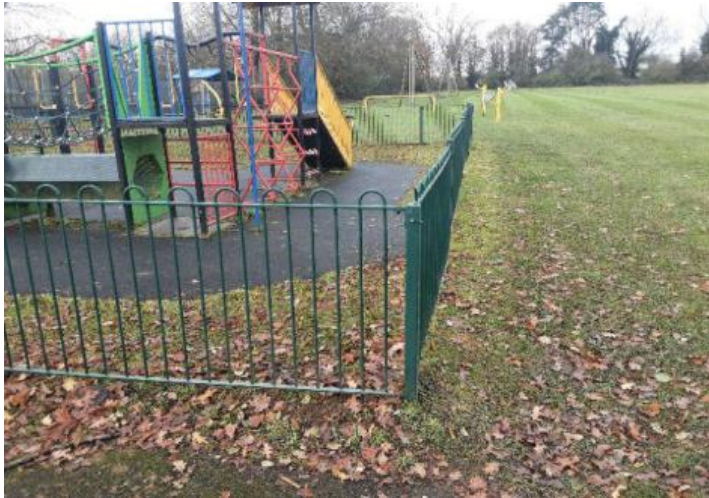
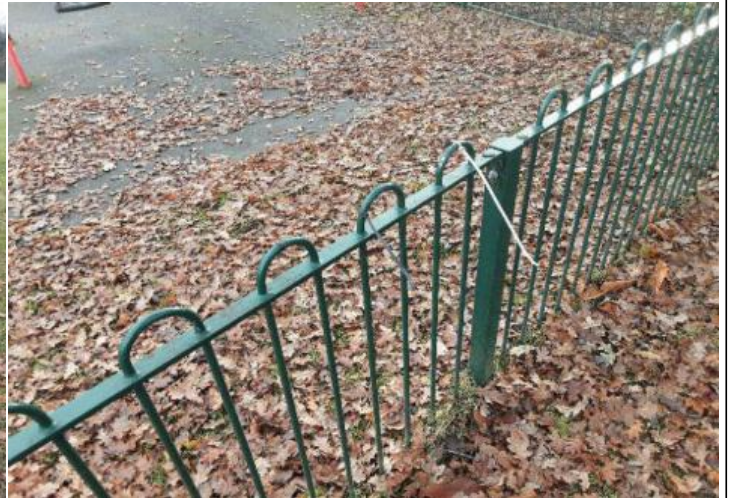
Item: Fences - Fence - Bow Top
Manufacturer: Not Identified

Finding: Cable ties have been used on the item and there are sharp projecting ends

Action: Remove if not required or replace with a more appropriate alternative fixing method if used as a fixing

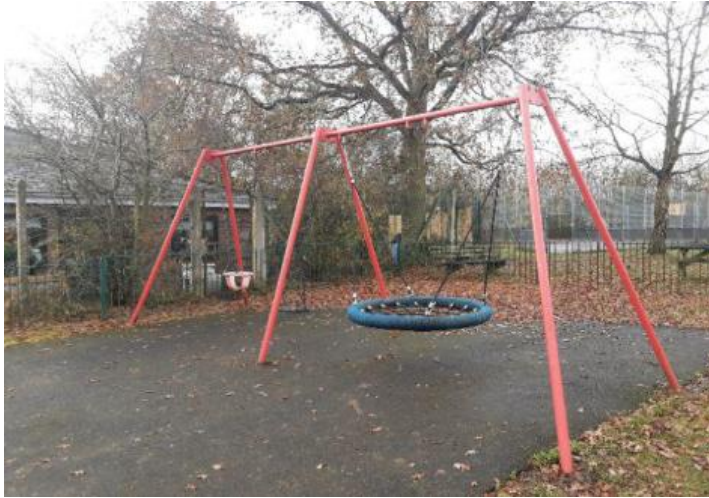
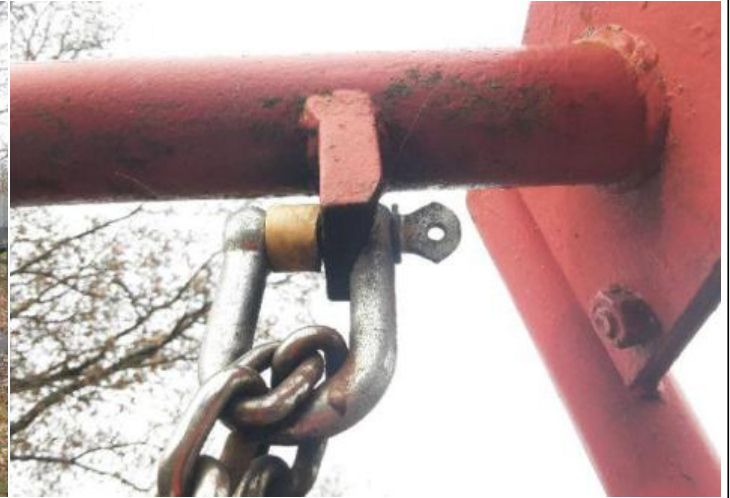
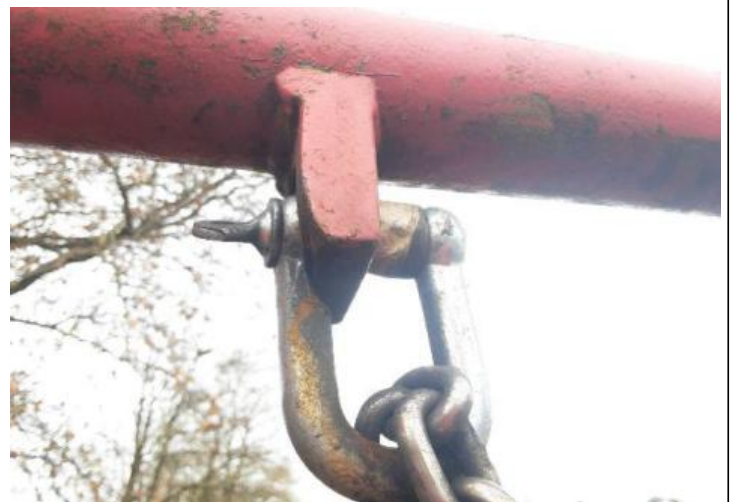
Item: Swings - 2 Bay Swing
Manufacturer: Not Identified

Finding: The crossbar lugs are worn in excess of 90% which has worn the bushes and shackles on the basket seat suspension, client informed

Action: Remove the basket seat and replace the crossbar

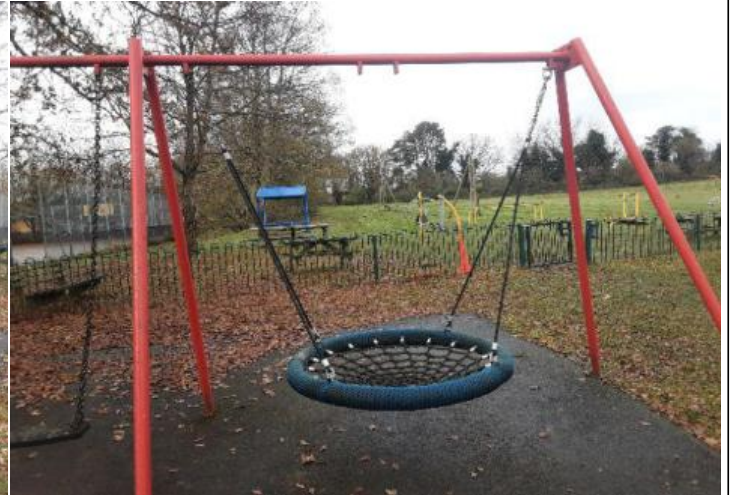
Item: Swings - 2 Bay Swing
Manufacturer: Not Identified

Finding: The basket swing has been installed into incorrect frame design and is wearing the connecting points excessively

Action: Remove the basket seat and replace with compatible seats once all required repairs are completed

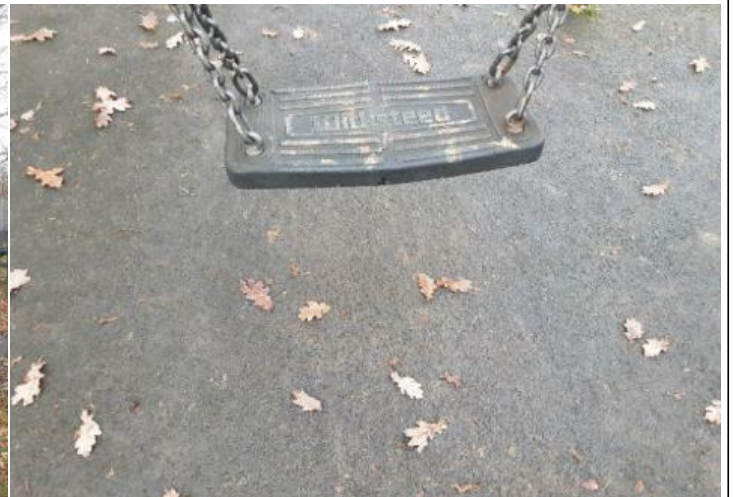
Item: Swings - 2 Bay Swing
Manufacturer: Not Identified

Finding: The seat clearance from finished surface level to the underside of the seat is too low and does not meet the requirements of BS EN 1176 Part 2 (350mm minimum clearance required)

Action: Adjust seat height/s (400mm-500mm is recommended)

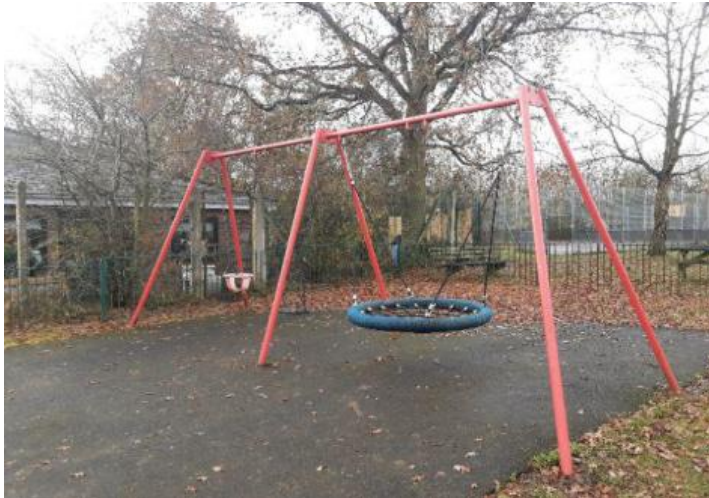
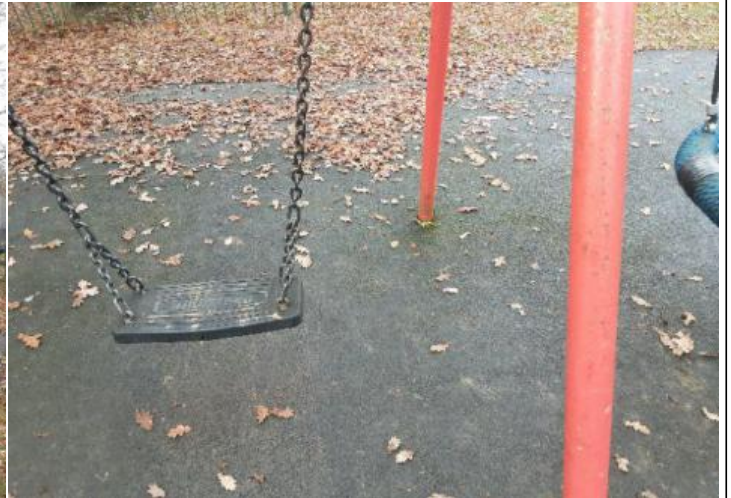
Finding: The seats are too close to the frame as defined in BS EN 1176 Part 2; this is a low risk failure and no remedial action is required

Action: Monitor - No remedial work recommended

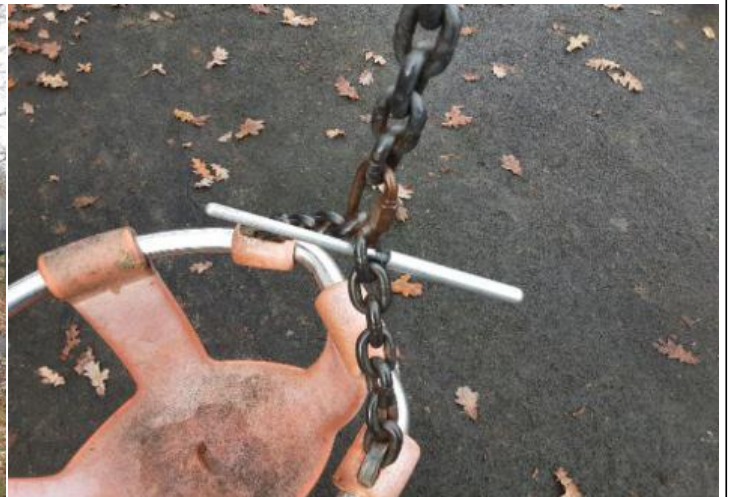
Finding: The chain openings are in excess of the 8.6mm as recommended by BS EN 1176

Action: Monitor - No remedial work recommended

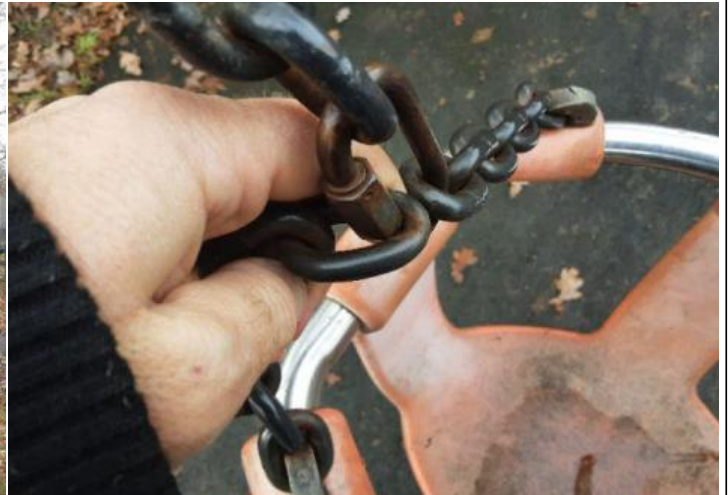
Finding: There is some notable evidence of chain wear

Action: Monitor for any further deterioration and replace when 40% worn

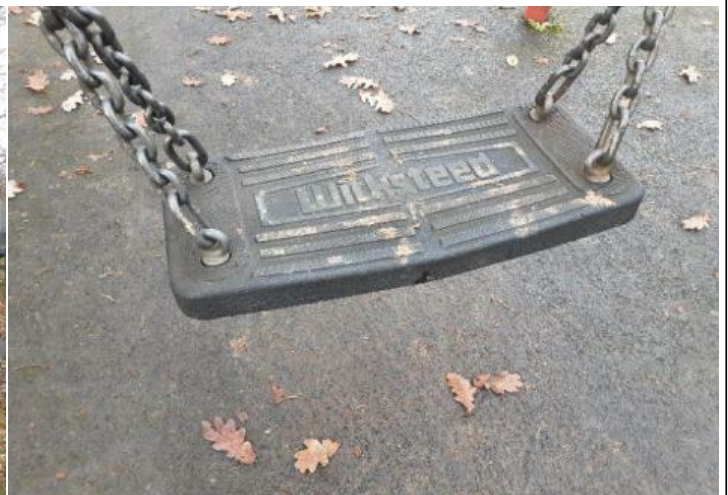
Finding: The seat has minor damage or wear

Action: Monitor for any further deterioration and replace as required

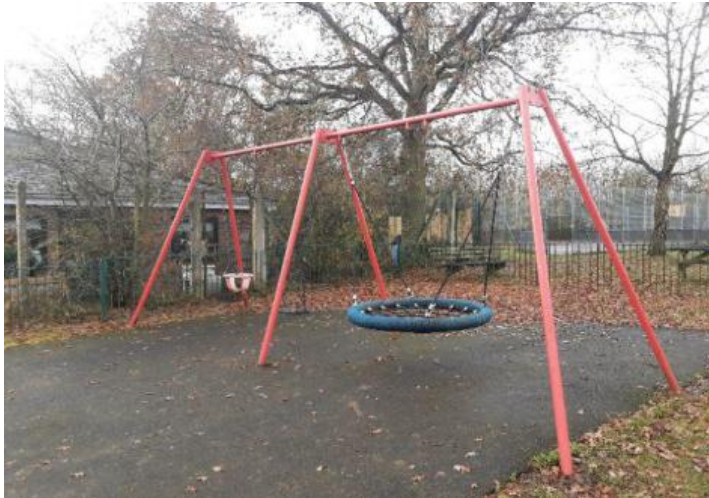
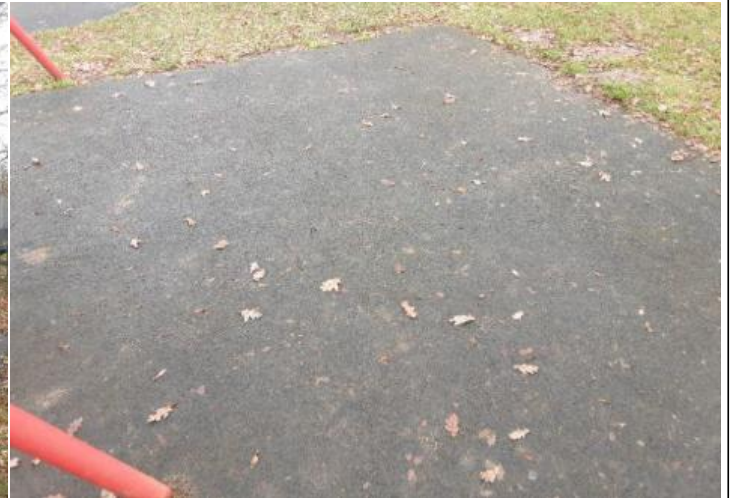
Finding: The safety surface around the area is beginning to wear

Action: Monitor for any further deterioration and repair as required

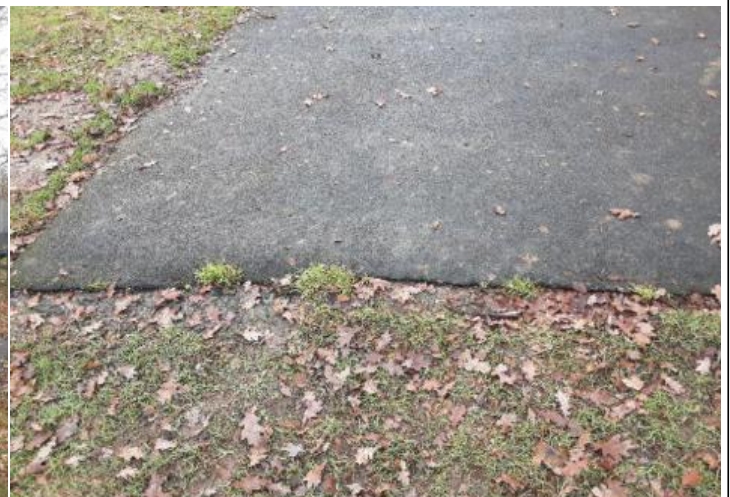
Finding: The surface is lifting at the edges and creating trip points

Action: Repair perimeter of surfacing to remove trip points

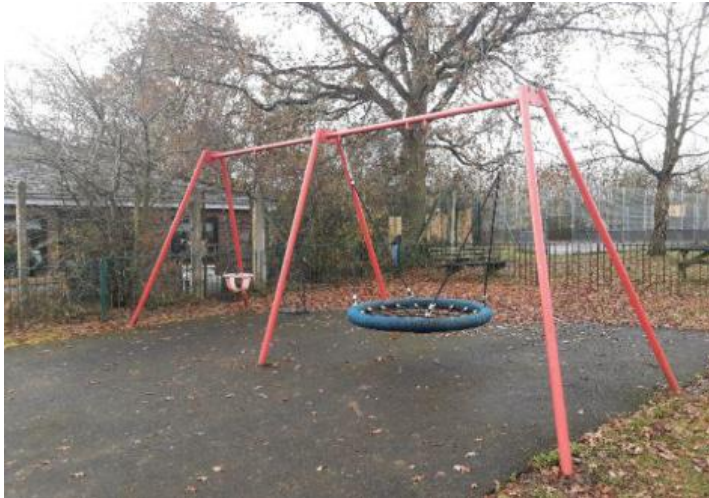
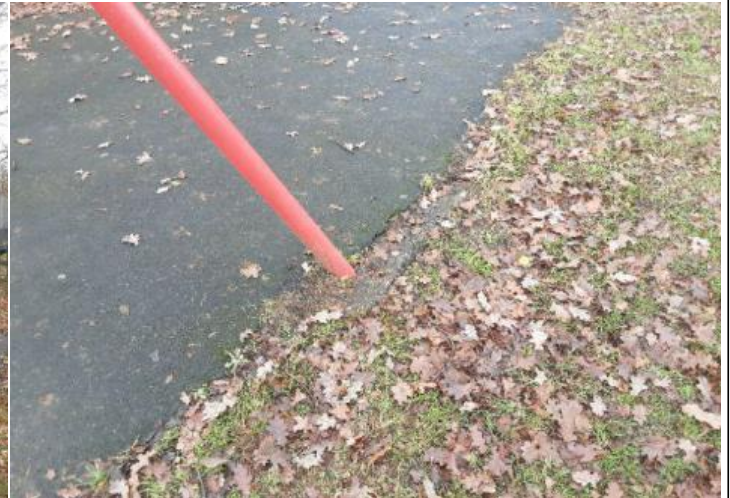
Finding: The surface has eroded and the foundations are exposed

Action: Reinststate surrounding surfaces to cover the foundations

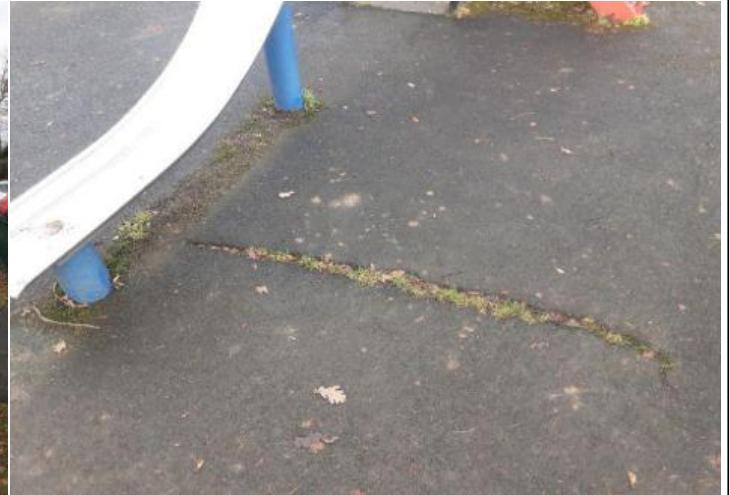
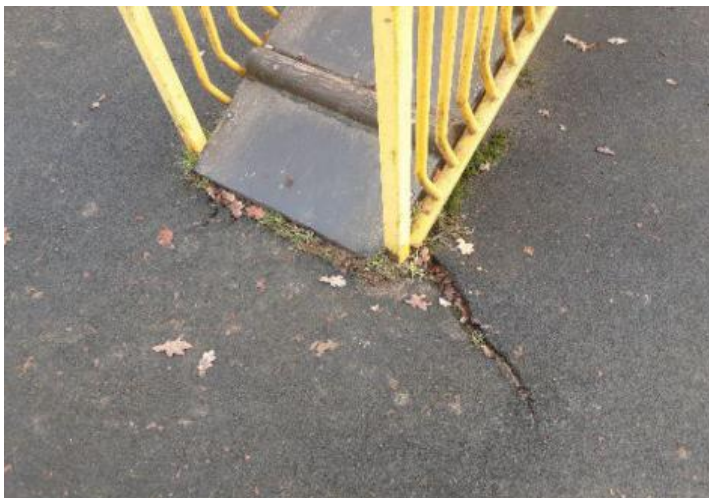
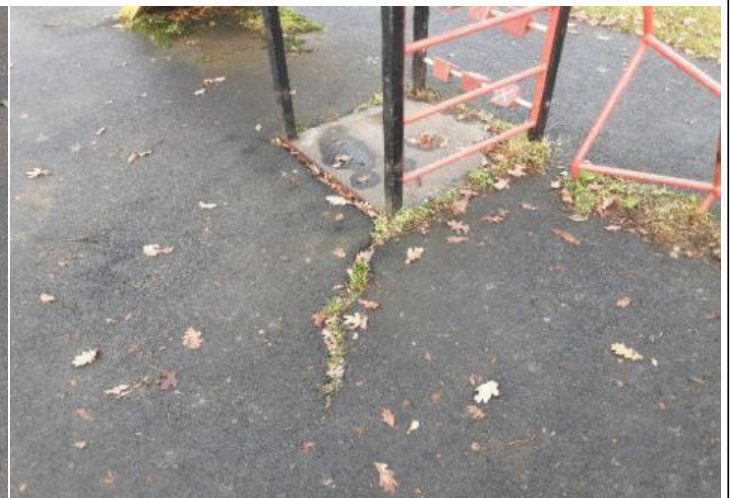
Finding: There is moderate damage to the surface

Action: Repair the damaged areas of surfacing

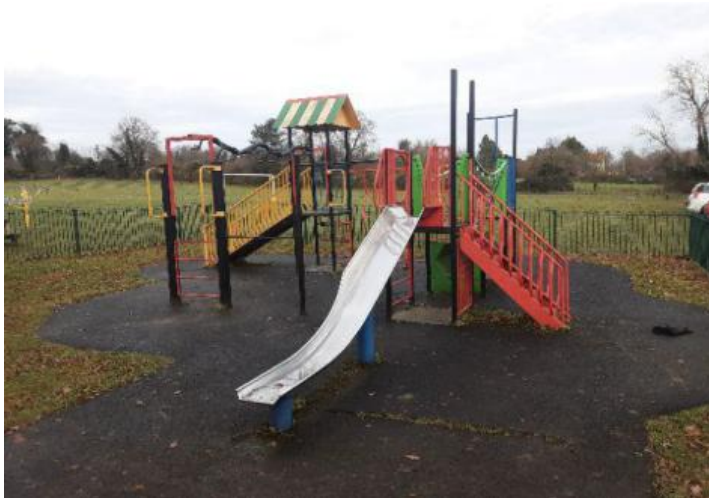
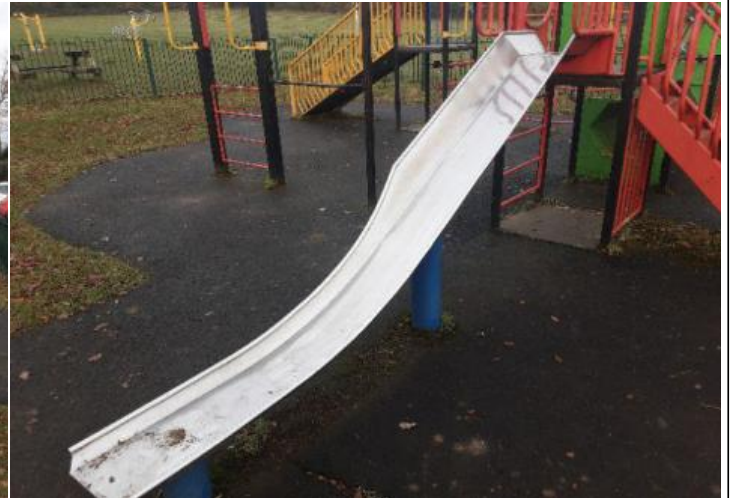
Finding: There are a number of dents in the slide surface

Action: Monitor for any further deterioration and repair as required

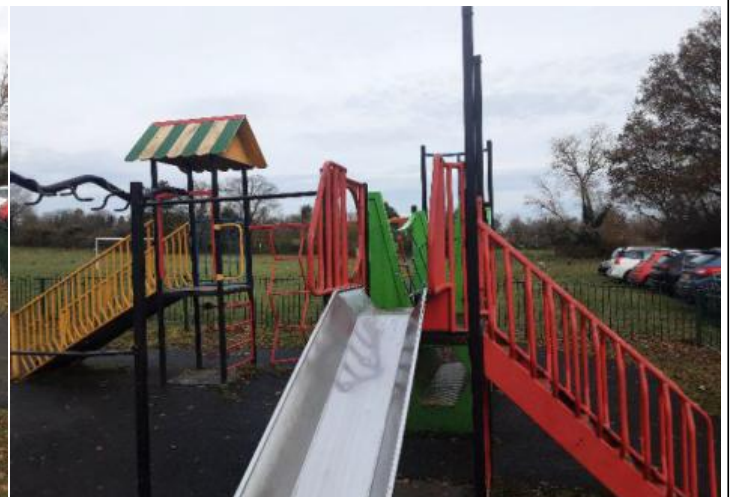
Finding: This item has no slide bar fitted as required by BS EN 1176 Part 3

Action: Monitor - No remedial work recommended

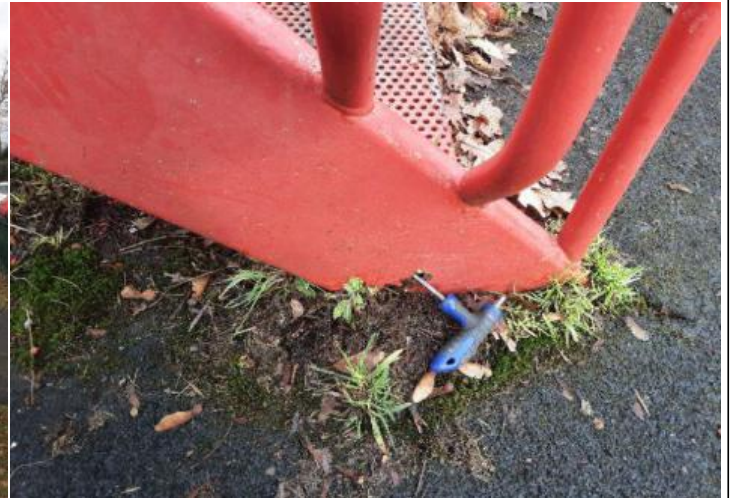
Finding: Parts of the steel on this item have corroded excessively and the metal has perforated in places

Action: Ensure all affected areas are treated and repaired

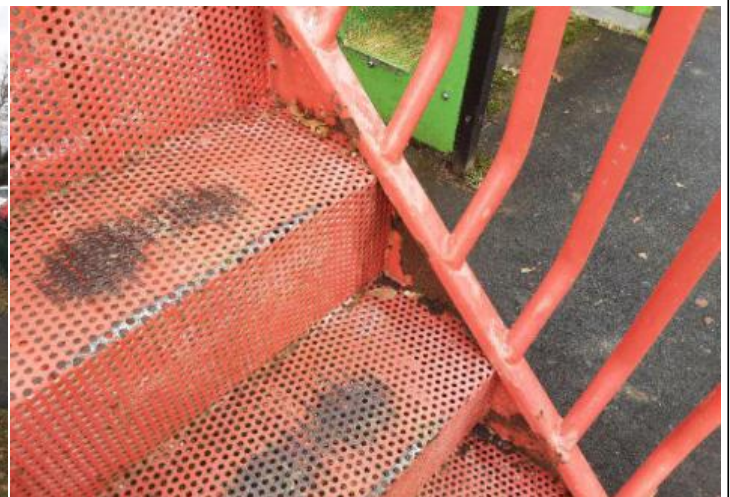
Finding: The paintwork on this item has been damaged or worn exposing the metal underneath which is rusting / corroding

Action: Treat affected areas and repaint

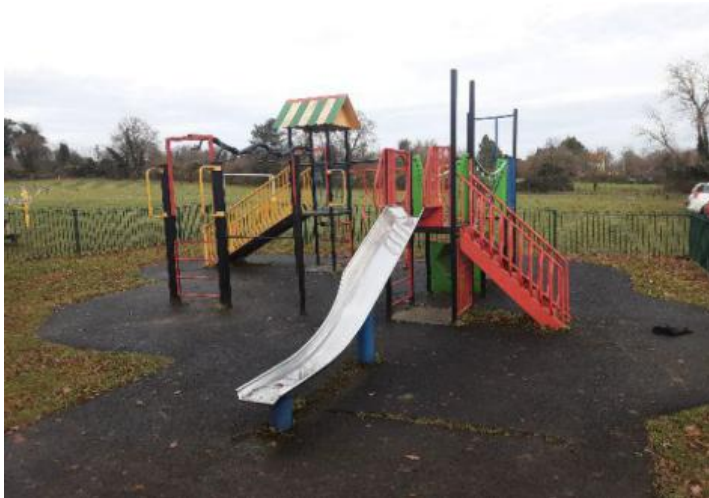
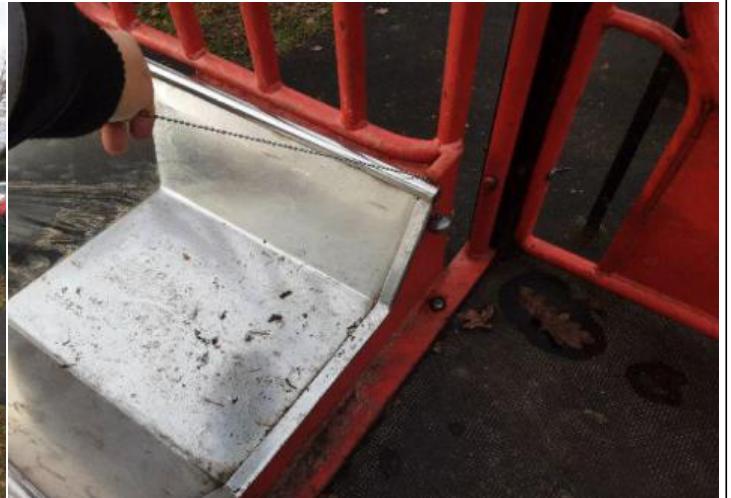
Finding: There is / are toggle entrapment/s present in contravention of the recommendations set out in BS EN 1176 Part 3

Action: Monitor - no remedial work recommended

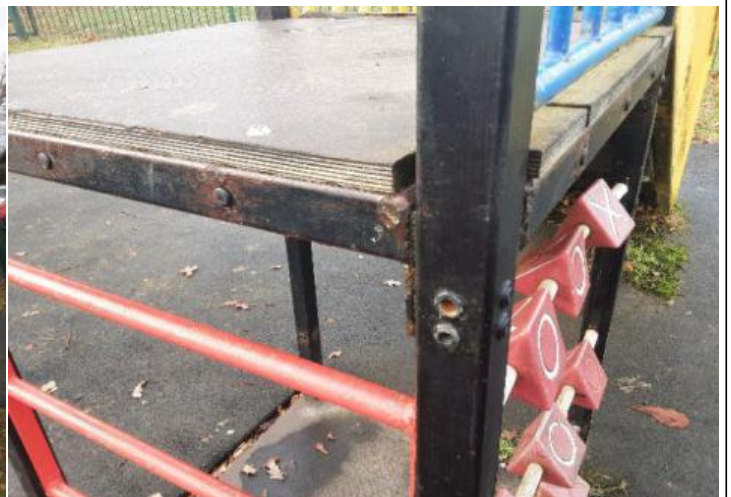
Finding: There is/are inserts missing

Action: Replace missing inserts

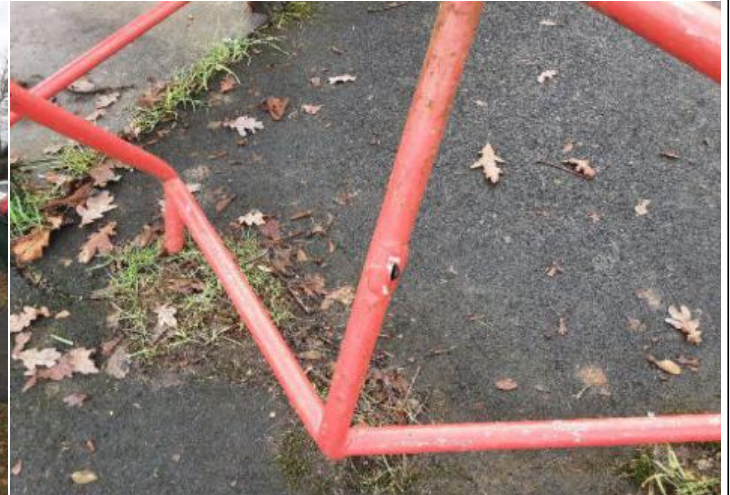
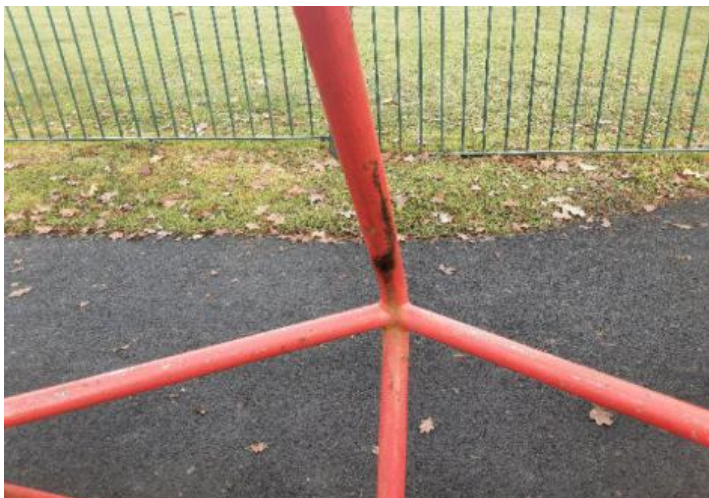
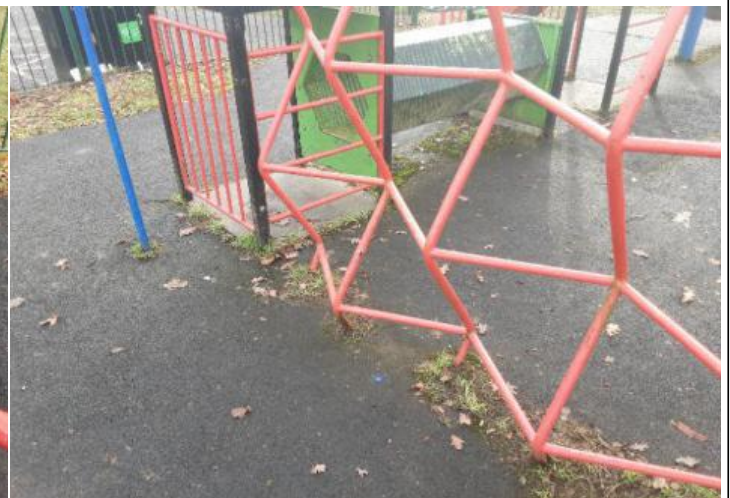
Finding: The tube(s) on this item have corroded from the inside and split the steel

Action: Replace all affected parts

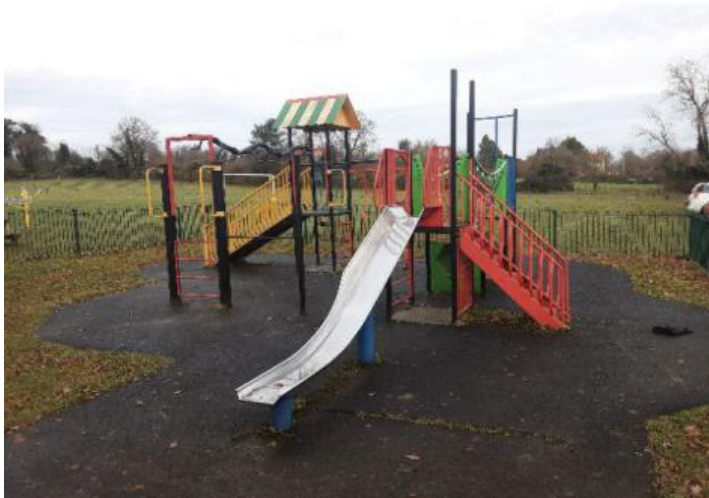
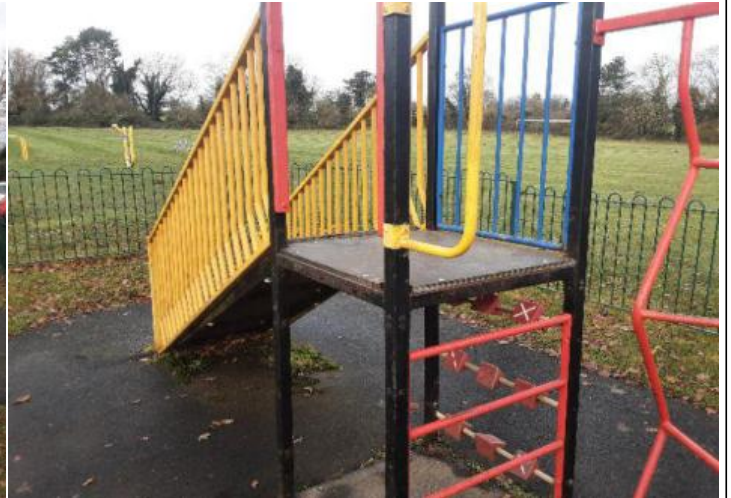
Finding: The unit is easily accessible and has an opening in the barrier to steep play elements in excess of 500mm in contravention of BS EN 1176 Part 1
Action: Monitor - No remedial work recommended

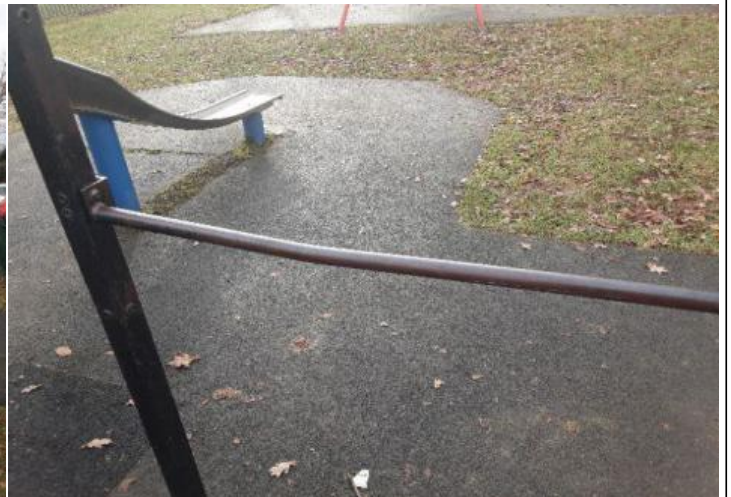
Finding: There is some damage to the item

Action: Monitor for any further deterioration and repair as required

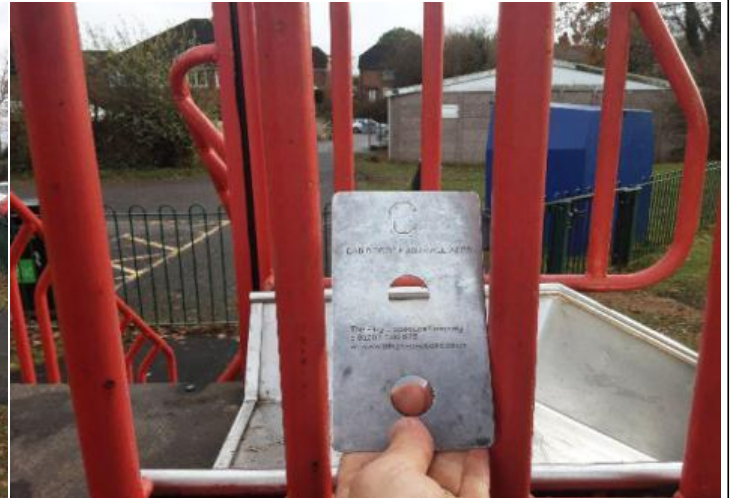
Finding: The item fails to meet the requirements of BS EN 1176 Part 1 4.2.7.2 head and neck entrapment in the barriers and/or steps

Action: Monitor - No remedial work recommended

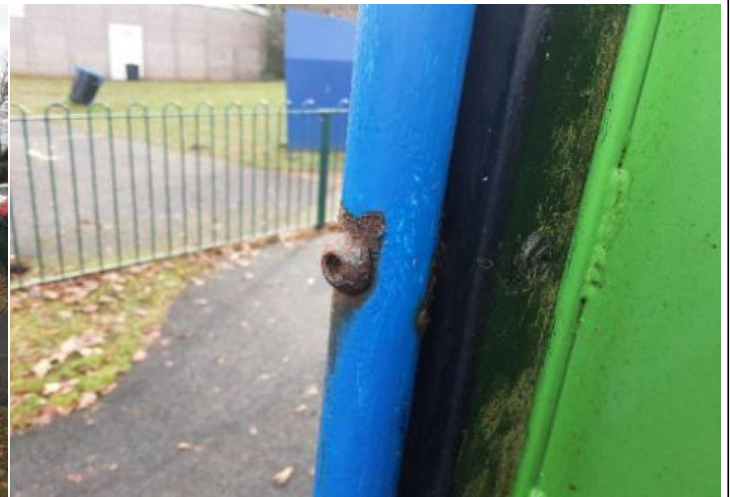
Finding: The fixings have corroded excessively

Action: Replace all corroded fixings

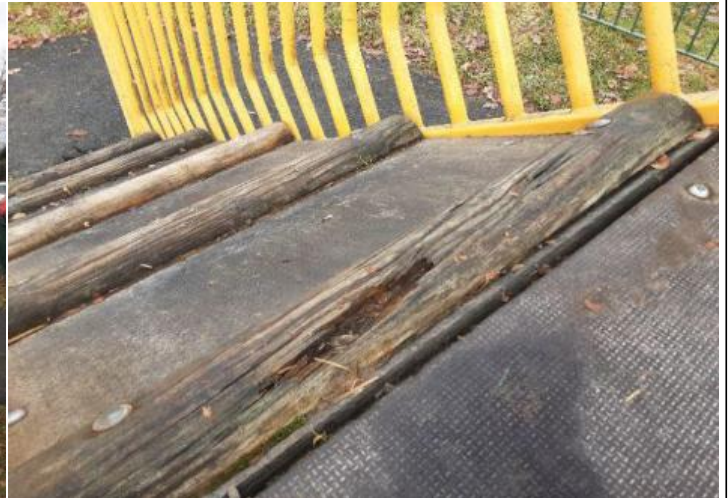
Finding: There are areas or parts of the timber on the ramp treads that have rotted
Action: Replace all affected timbers

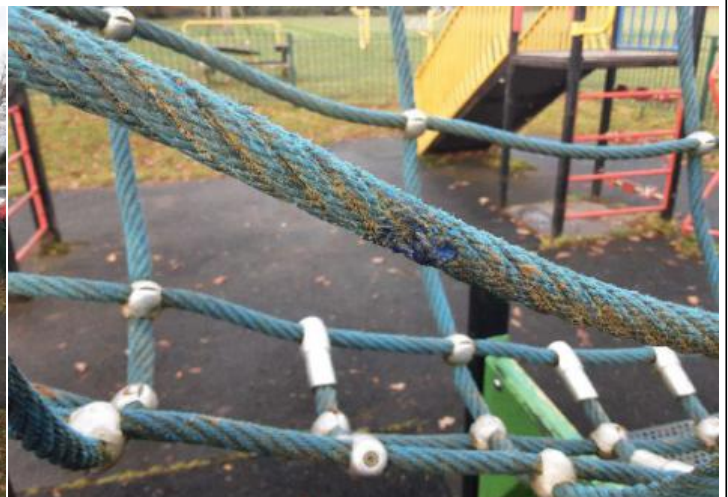
Finding: There is some evidence of fire damage to the item
Action: Monitor for any further deterioration and repair as required

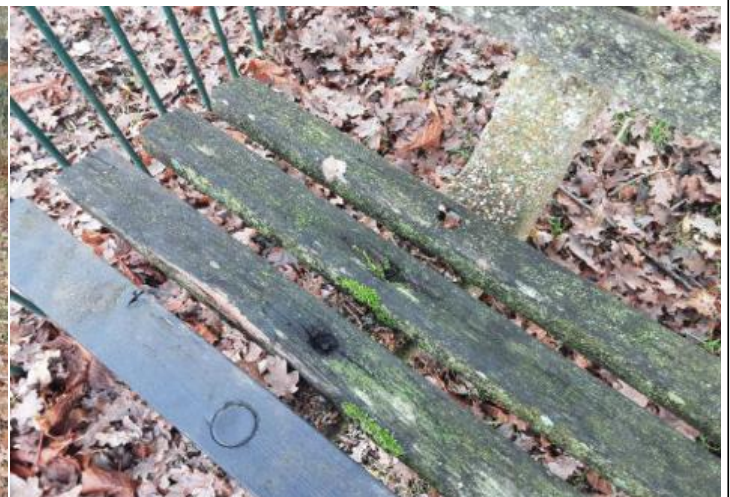
Finding: There is some evidence of rot in the timber

Action: Monitor for any further deterioration and replace as required

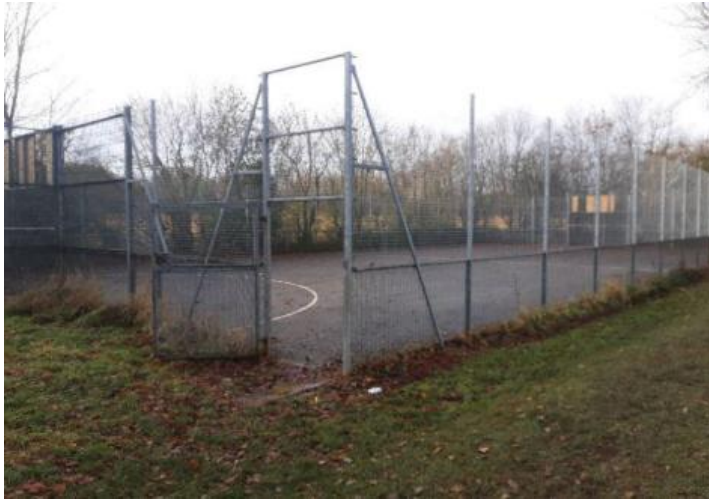
Finding: A clearly visible facility sign should be provided in a prominent position with the wording as detailed BS EN 15312- the equipment is not intended for children less than 3 years old- the warning - Do not climb on the framework or nets- the warning - Do not hang on the ring (if provided)- the warning - Do not wear rings or other jewellery- name and telephone number of the administrator- number to call in case of accident

Action: Provide signage to BS EN 15312

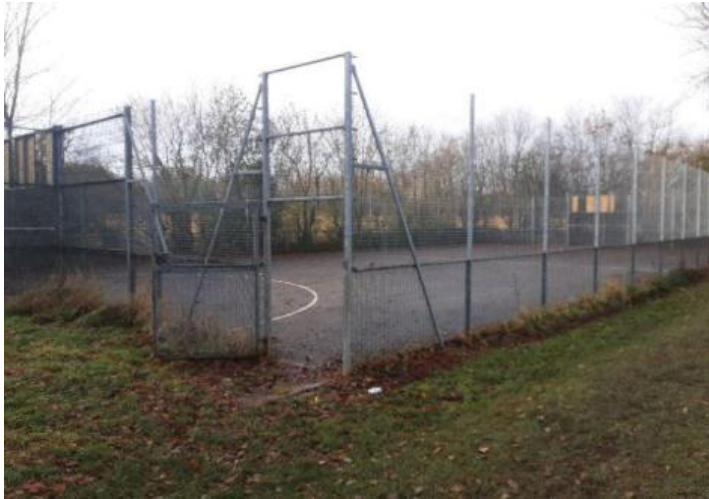
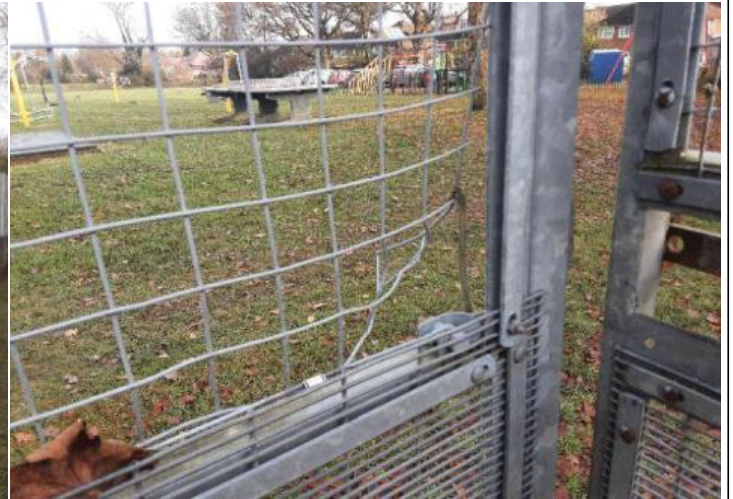
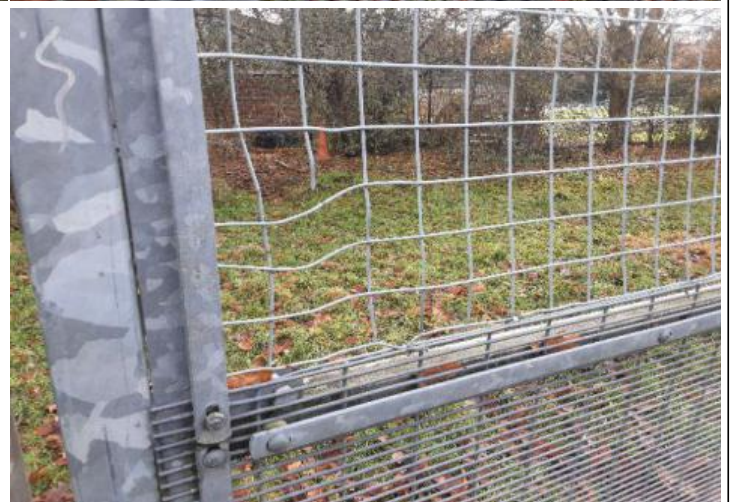
Finding: The fence is severely damaged in places

Action: Repair or replace all affected sections

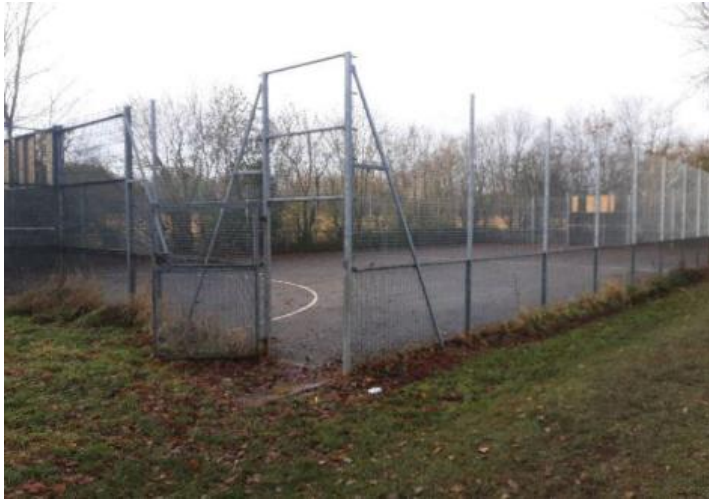
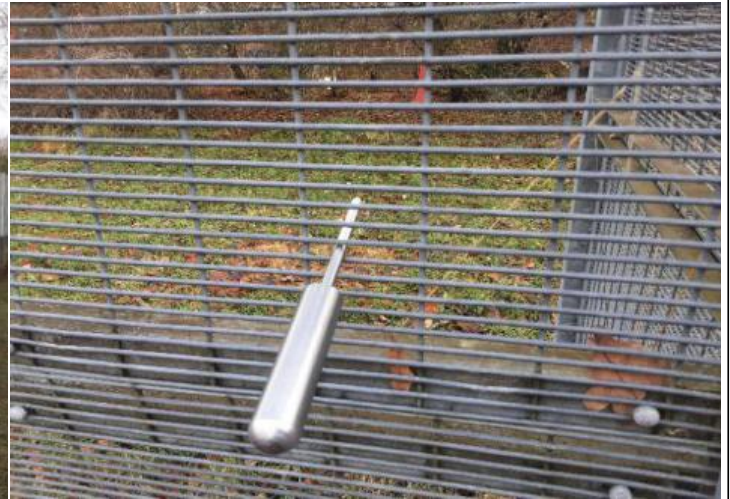
Finding: There is/are finger entrapments in the panels and the item fails to meet the requirements of BS EN 15312 Clause 4.4.2.2 Entrapment of fingers

Action: Monitor - No remedial work recommended

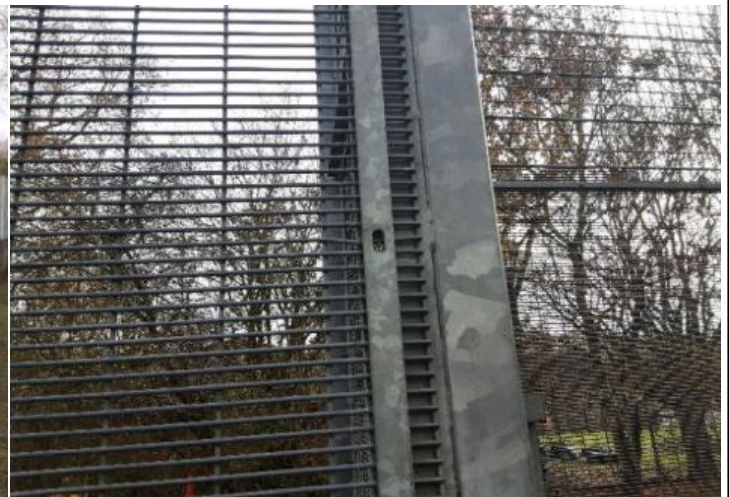
Finding: There is or are fixings missing on the item

Action: Replace all missing fixings

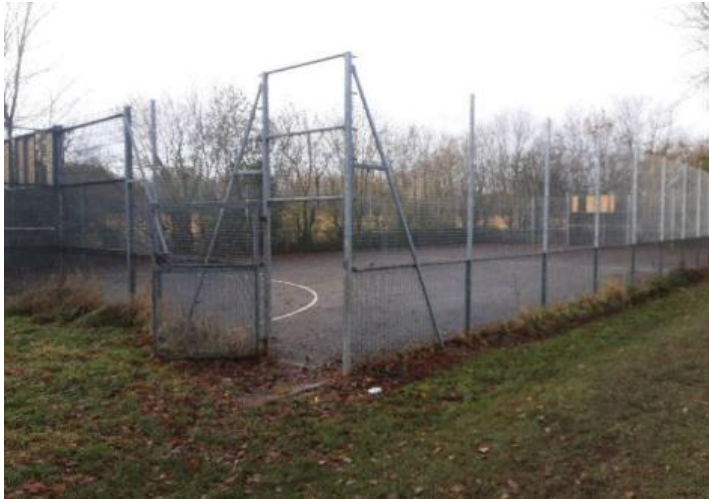
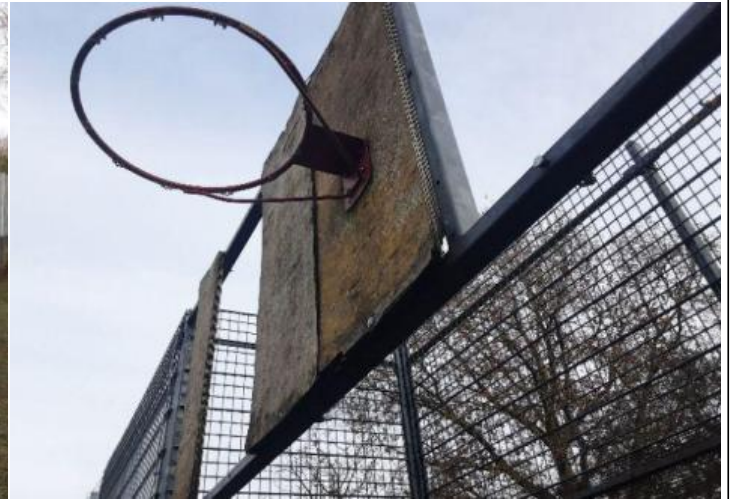
Finding: There are areas or parts of the timber on the structure that have rotted

Action: Replace all affected timbers

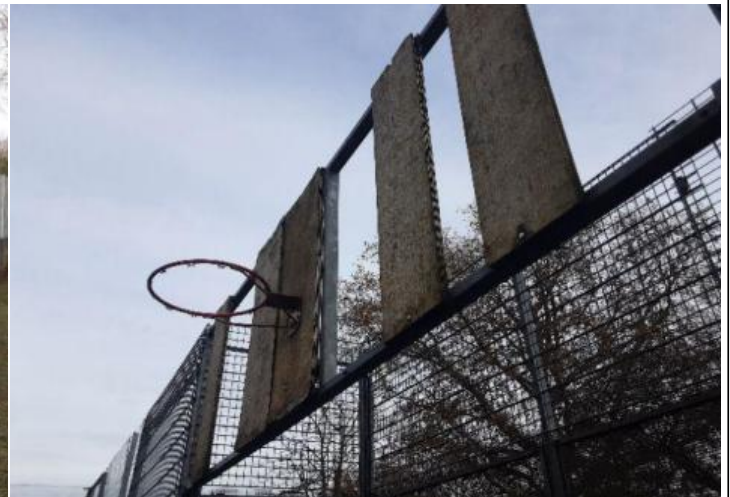
Finding: The free space between the backboard and the framework is less than 600mm and fails the requirements of BS EN15312:2007 +A1 2010

Action: Monitor - No remedial work recommended

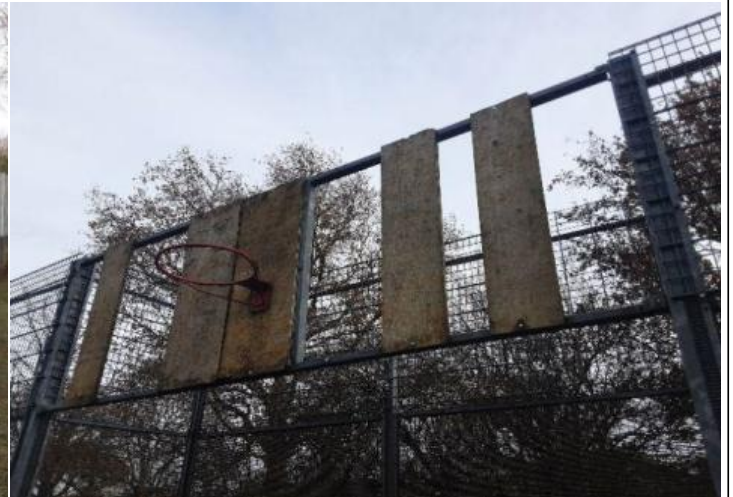
Item: Multi Use Games Area - Multi Use Games Area (MUGA) **Risk Level:** L - Low Risk
Manufacturer: Not Identified **Surface:** Bitmac

Finding: A number of panels are missing above the goal **Action:** Replace
