the **play inspection** company

Annual Inspection

Adisham Parish Council

Adisham Recreation Ground

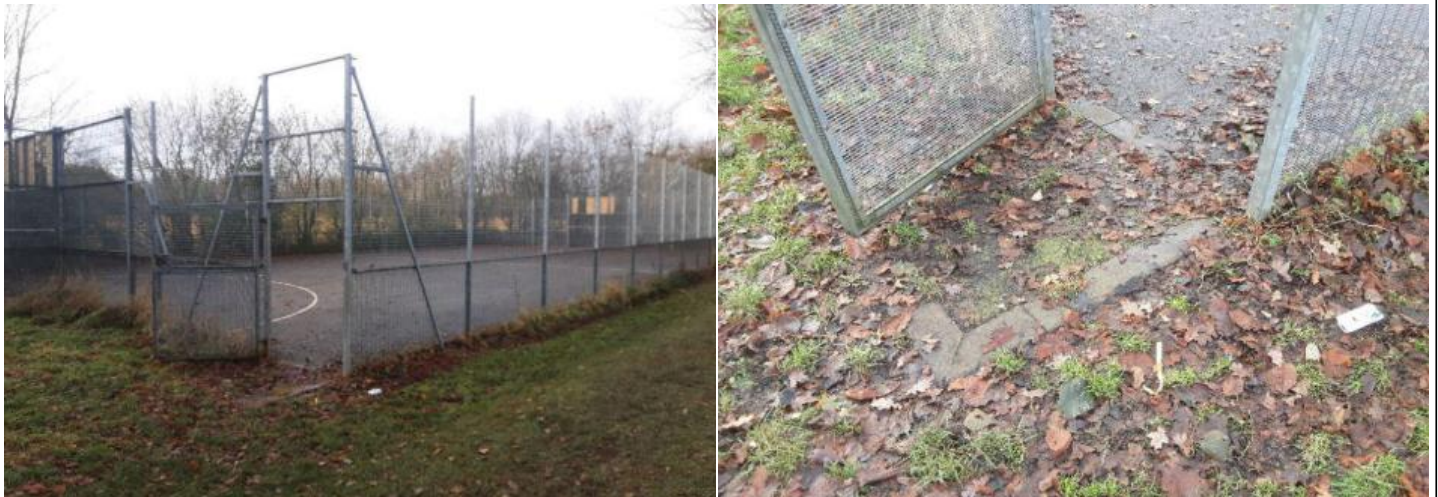
Item: Multi Use Games Area - Multi Use Games Area (MUGA)
Manufacturer: Not Identified
Risk Level: L - Low Risk
Surface: Bitmac

Finding: There are trip hazards at the edges of the surface

Action: Reinstate surrounding surface levels to remove the trip points

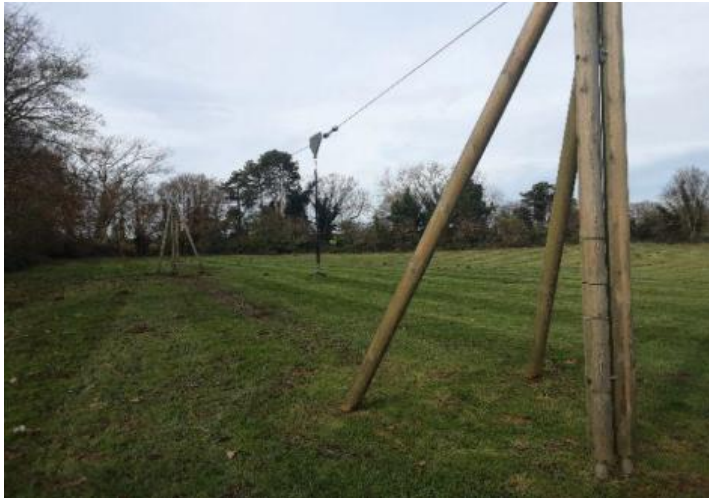
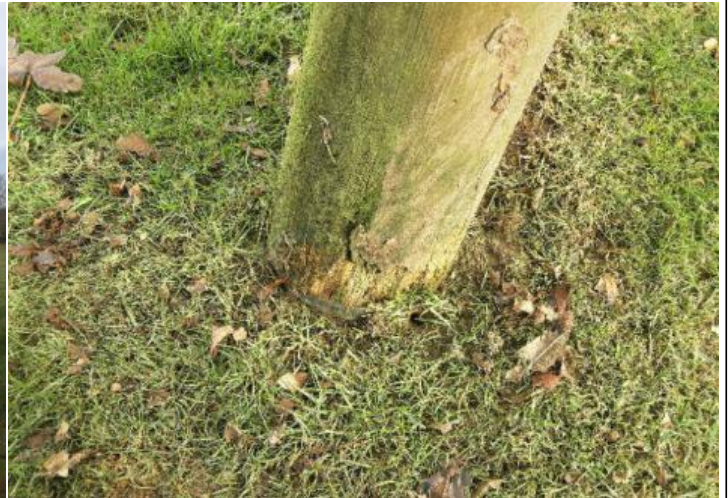
Finding: There is some strimmer / machinery damage apparent on the posts, this can penetrate the preservative applied to the timber and accelerate the rotting process

Action: Monitor for any deterioration (rot) and replace as required

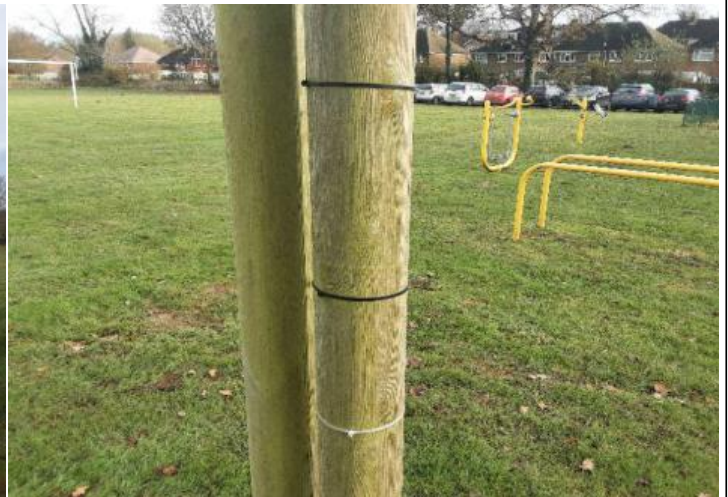
Finding: Cable ties have been used on the item and there are sharp projecting ends

Action: Remove if not required or replace with a more appropriate alternative fixing method if used as a fixing

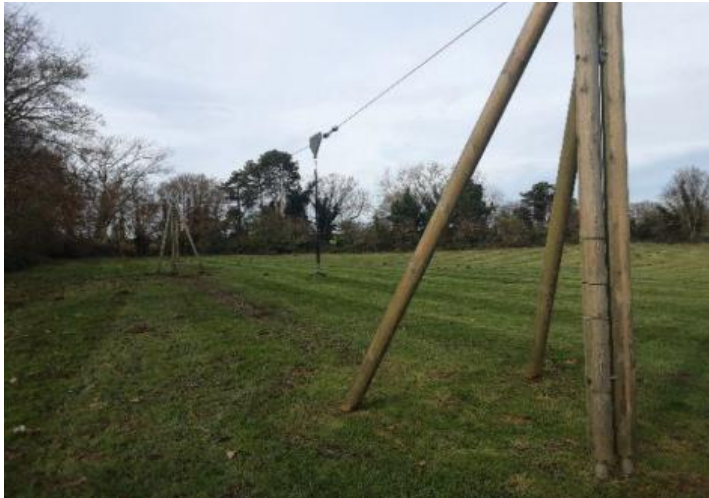
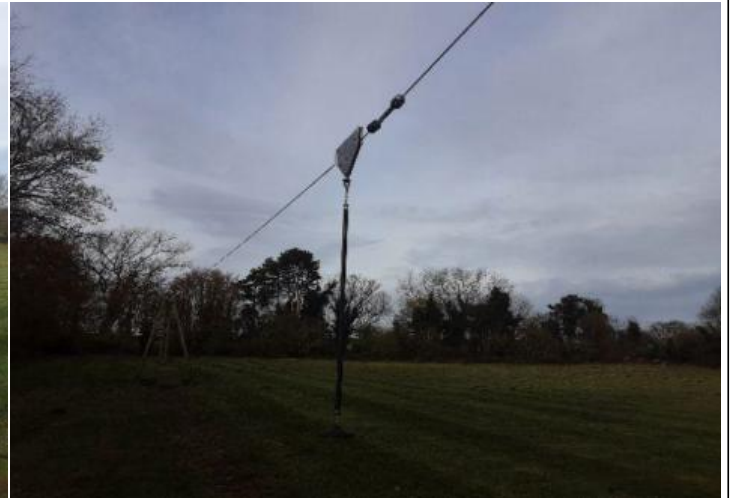
Item:	Other - Cable Runway	Risk Level:	N - Risk Assessment not Undertaken
Manufacturer:	Playdale Playgrounds Ltd	Surface:	Grass Matrix Tiles

Finding: We have completed a visual inspection of the suspension links, cable and fixing points from ground level, however it is not possible to fully inspect these areas without either hiring equipment to gain access or removing the cable and suspension and inspecting at ground level. We recommend that the main cable and fixing security is thoroughly inspected at least in accordance with the manufacturers recommendations to check for wear, damage, security or internal rusting; this will help to ensure the continued safe use of the equipment

Action: Inspect in accordance with the manufacturers recommendations

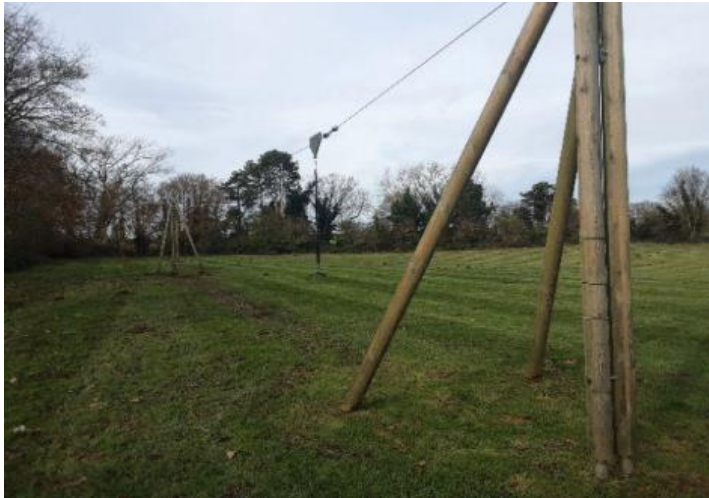
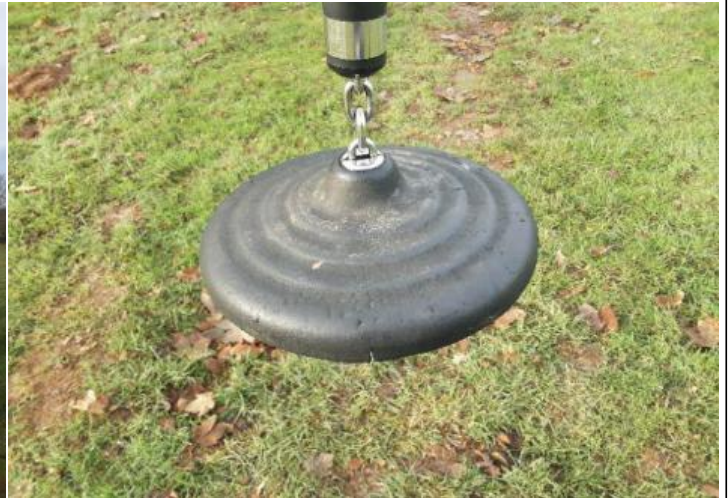
Finding: The cableway seat has been damaged

Action: Monitor for any further deterioration and replace as required

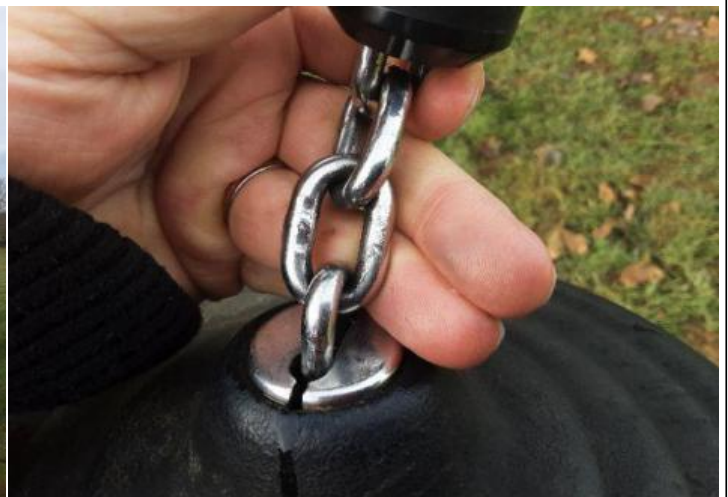
Finding: There is some notable evidence of chain wear

Action: Monitor for any further deterioration and replace when 40% worn

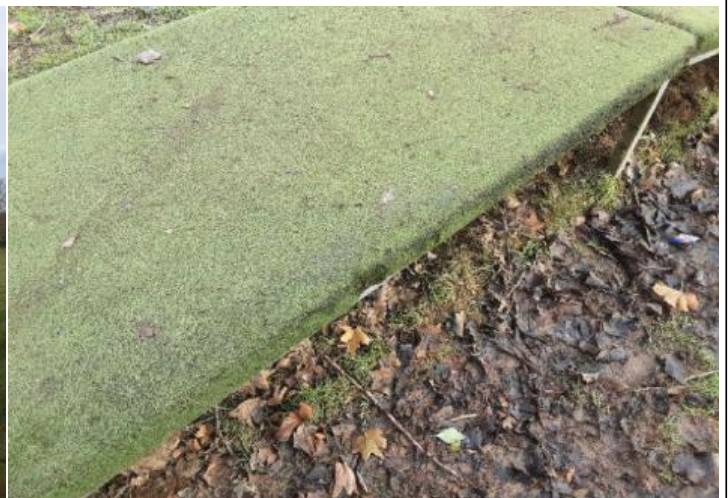
Finding: There is some evidence of fire damage to the item

Action: Monitor for any further deterioration and repair as required

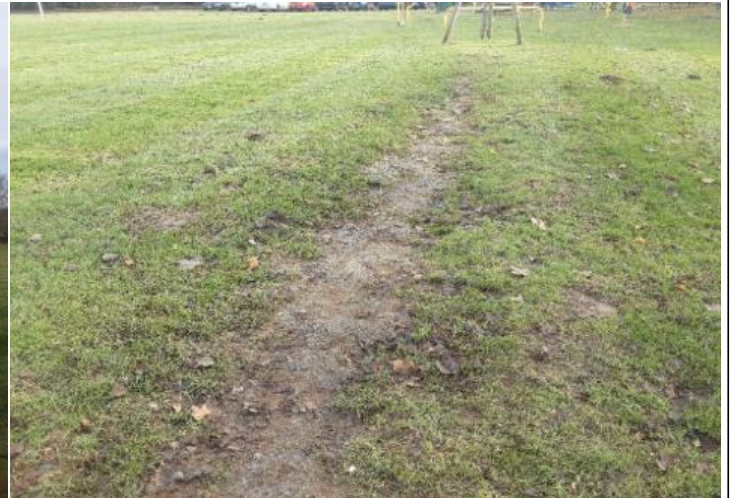
Finding: The surface is uneven creating potential trip hazards

Action: Repair all affected areas
