the **play inspection** company

Annual Inspection

Adisham Parish Council

Adisham Recreation Ground

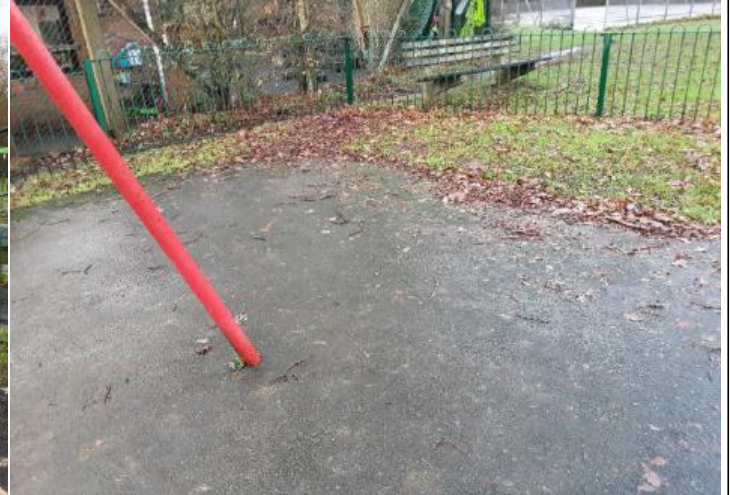
Finding: There is algae, silt or moss growth on the surface resulting in slippery conditions
Action: Clean and treat appropriately

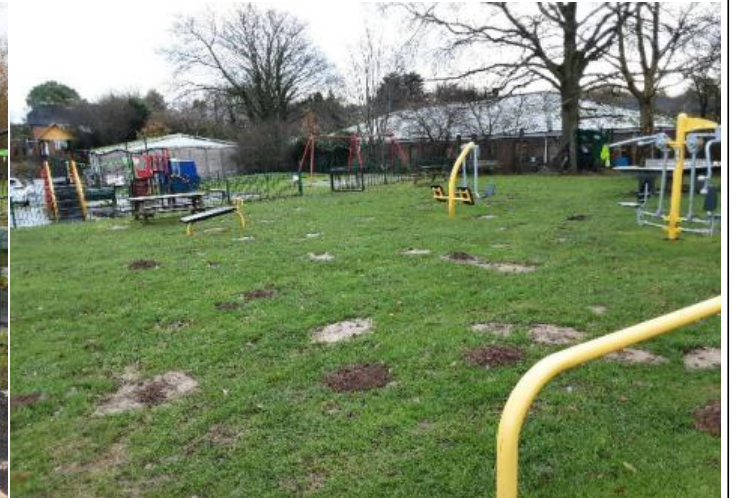
Finding: It is recommended that Adult Outdoor Fitness equipment is installed a minimum of 25m away from a childrens playground or separated and screened to discourage access by younger children

Action: Monitor use and review risk assessment regularly

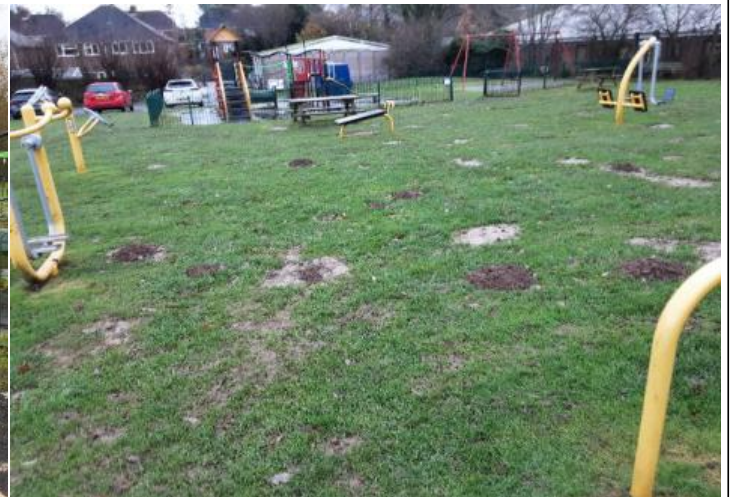
Finding: There are a number of molehills within the area and these may present unforeseen hazards for users

Action: Remove moles by appropriate means, reinstate surfaces to level and maintain the area

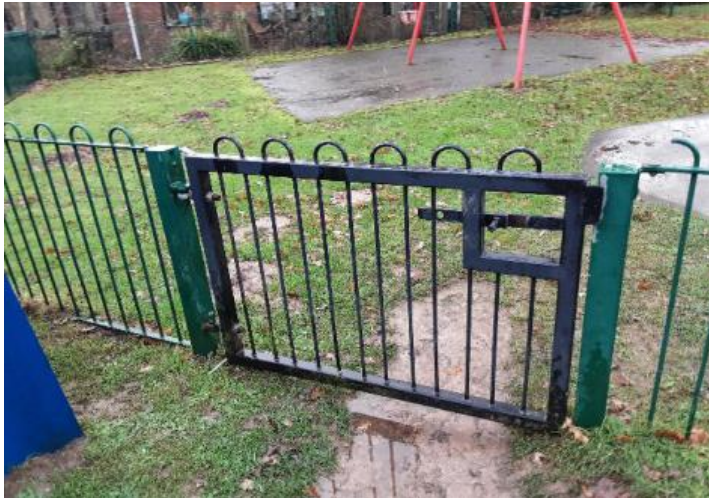
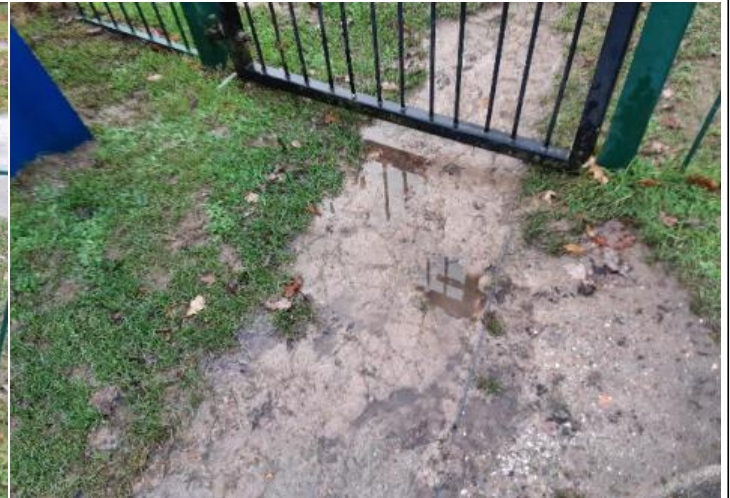
Finding: The area under the gate has eroded leaving uneven areas, or the concrete foundations exposed, resulting in trip hazards at the entrance/exit to the playground

Action: Reinstate to level with surrounding surfaces

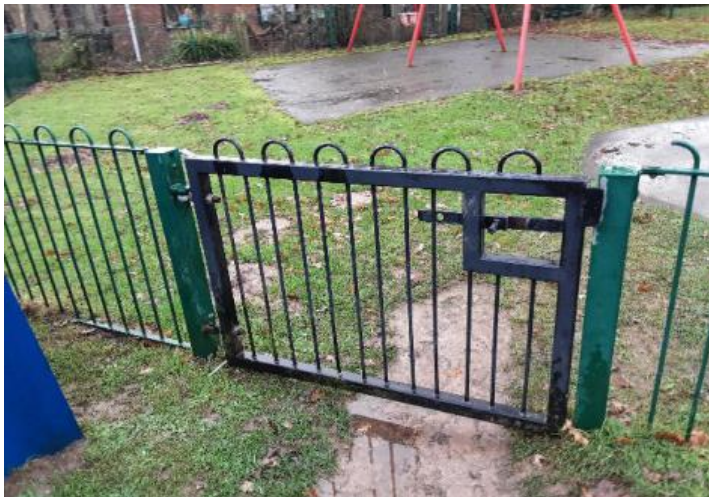
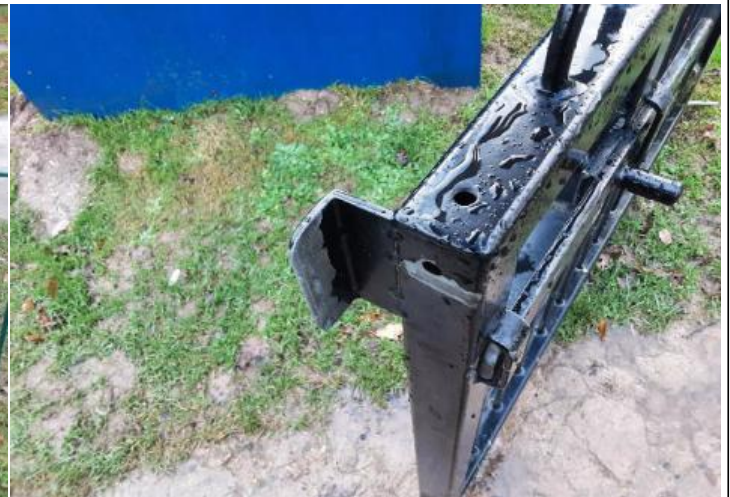
Finding: The rubber buffer is missing from the latch plate

Action: Replace rubber buffer

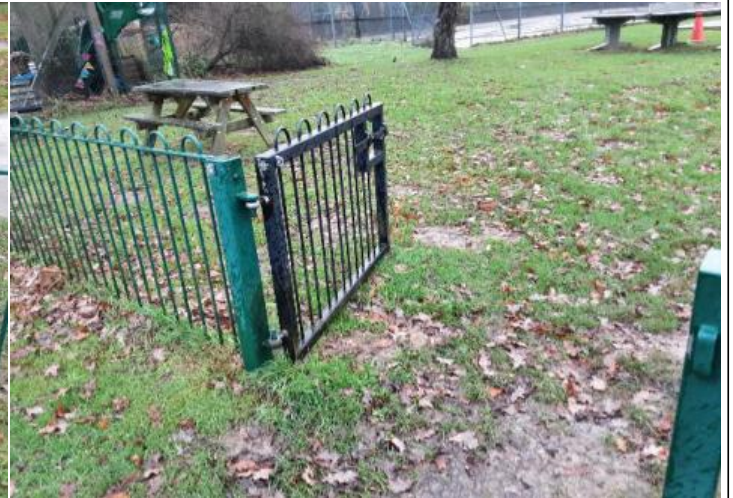
Finding: The self closing mechanism is missing from one of the gates
Action: Replace

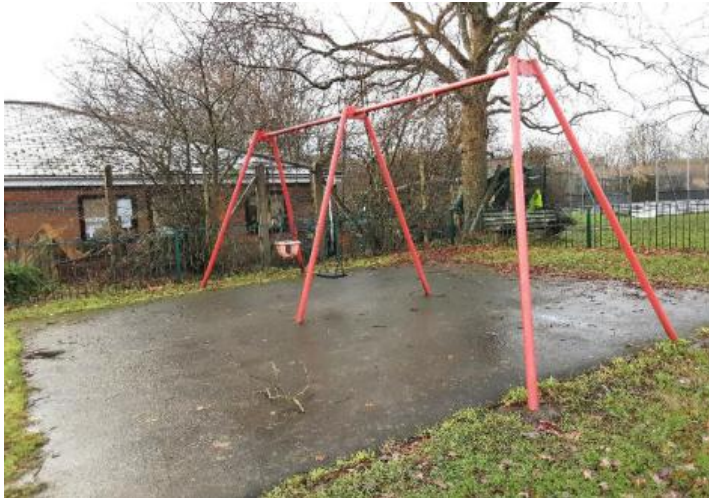
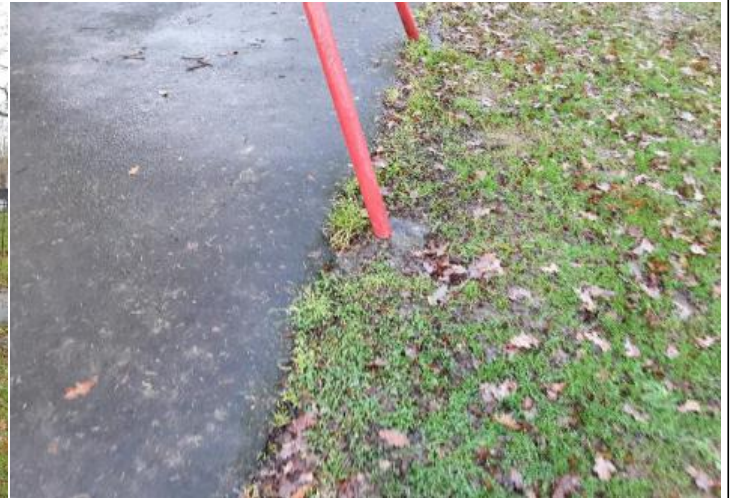
Finding: The surface has eroded and the foundations are exposed

Action: Reinstate surrounding surfaces to cover the foundations

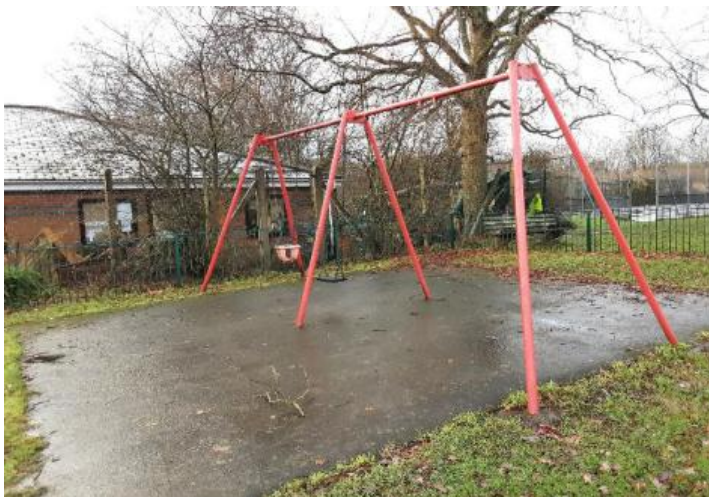
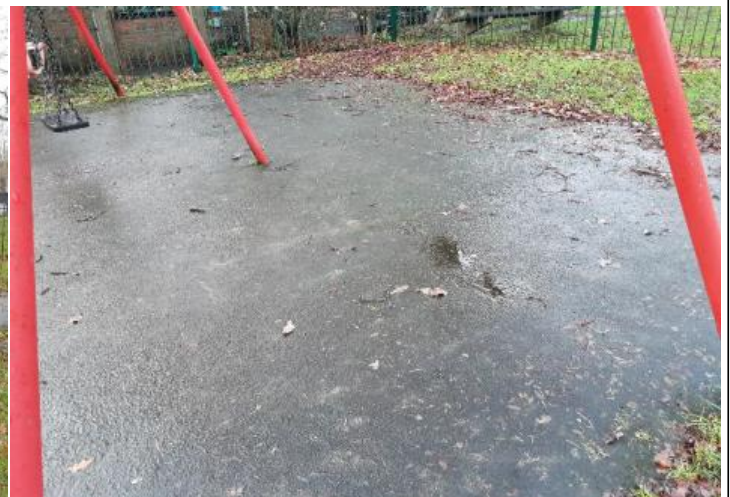
Finding: The safety surface around the area is beginning to wear

Action: Monitor for any further deterioration and repair as required

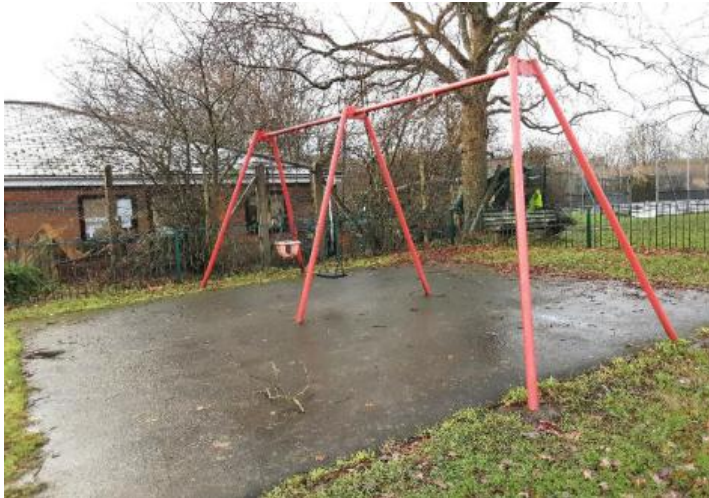
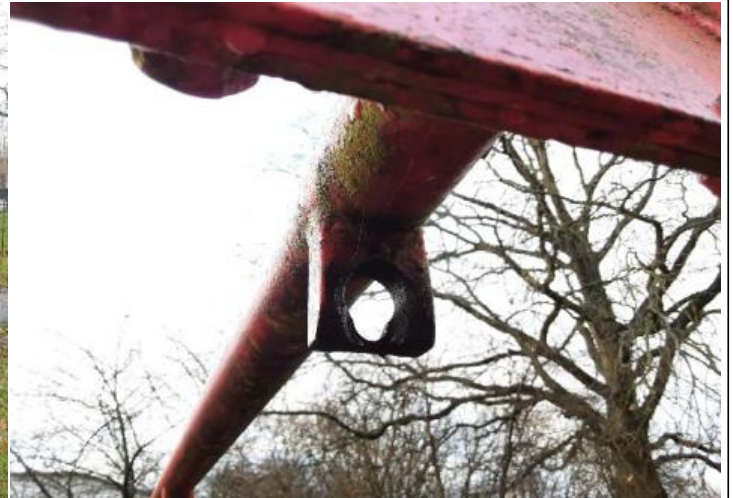
Finding: The connecting lugs are worn

Action: Replace lugs or all affected components before replacing any swing suspensions, NOTE - risk assessment based on the swing suspension not being present.

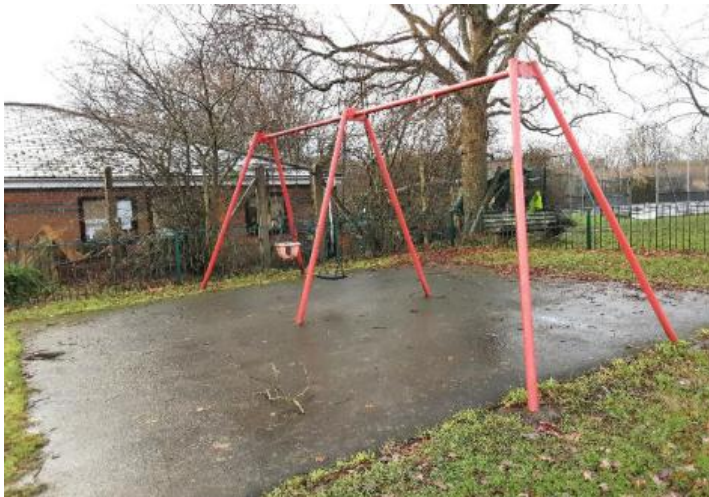
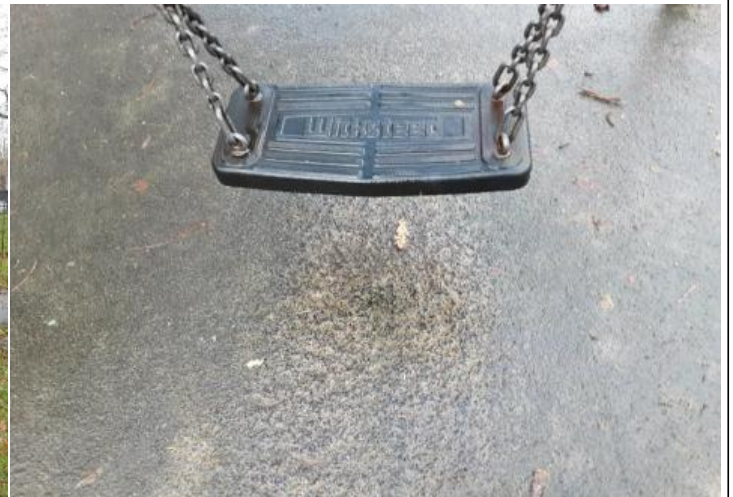
Finding: The seat clearance from finished surface level to the underside of the seat is too low and does not meet the requirements of BS EN 1176 Part 2 (350mm minimum clearance required)

Action: Adjust seat height/s (400mm-500mm is recommended)

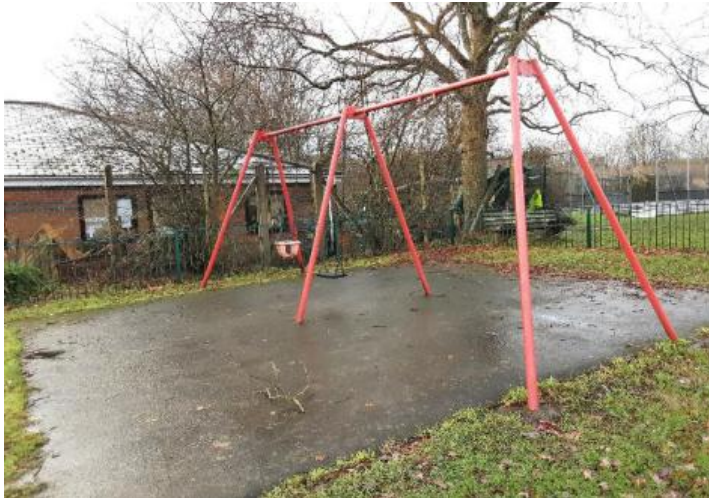
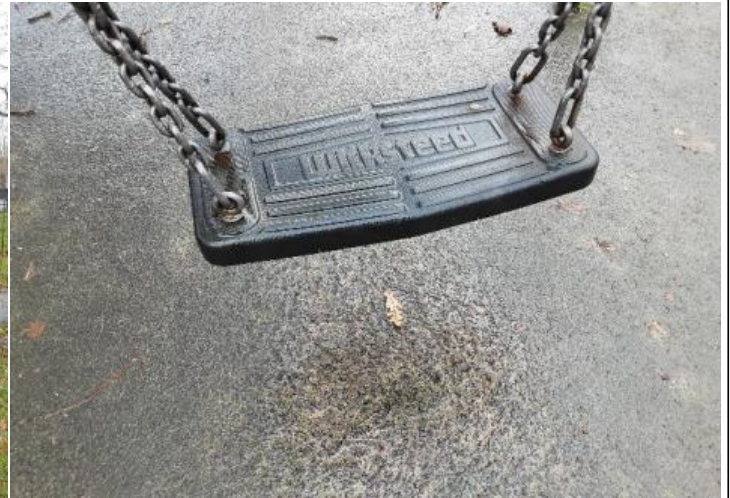
Finding: The seat has minor damage or wear

Action: Monitor for any further deterioration and replace as required

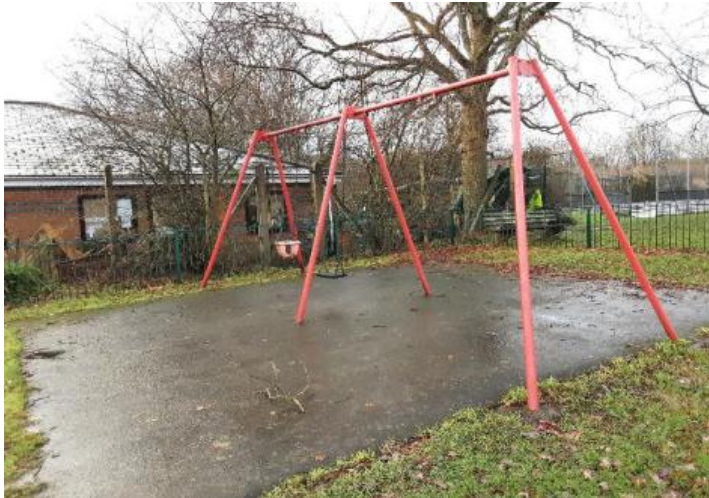
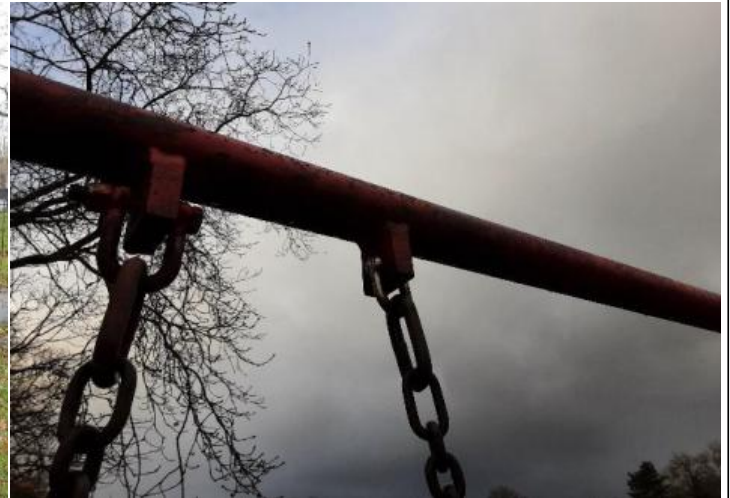
Finding: The bush / bushes is / are showing signs of wear

Action: Monitor for any further deterioration and replace as required

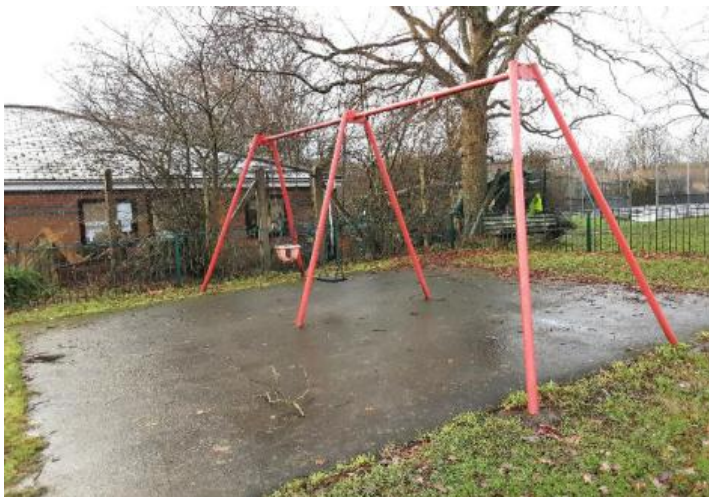
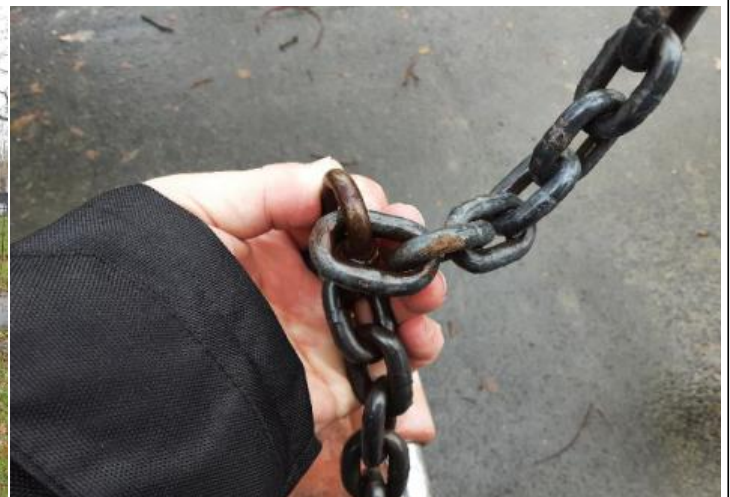
Finding: There is some notable evidence of chain wear

Action: Monitor for any further deterioration and replace when 40% worn

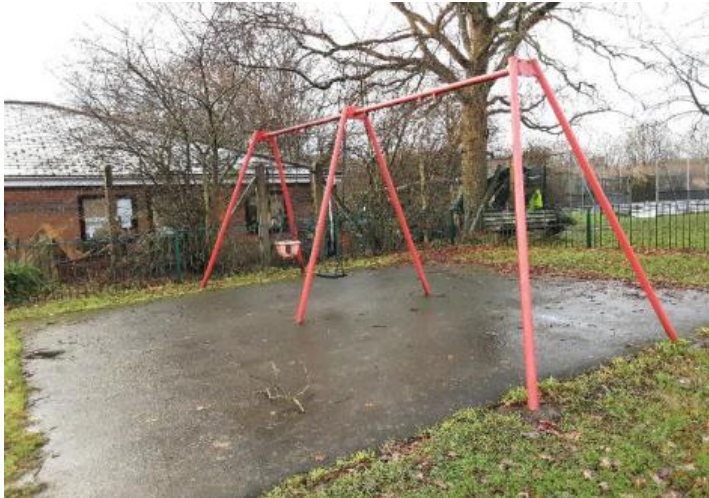
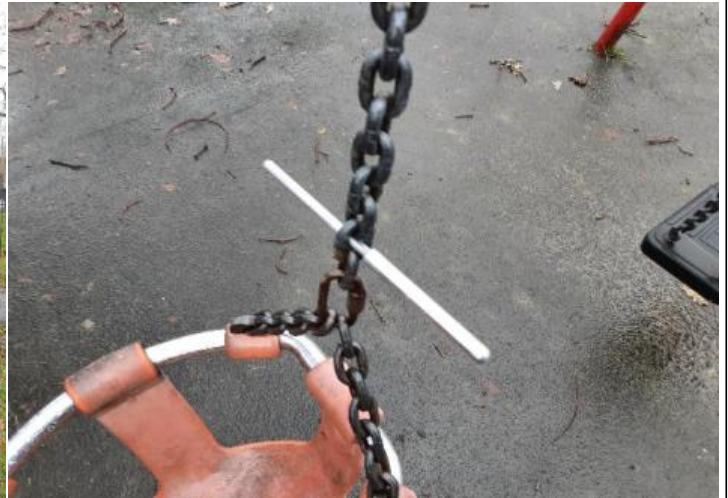
Finding: The chain openings are in excess of the 8.6mm as recommended by BS EN 1176
Action: Monitor - No action given the risk assessment

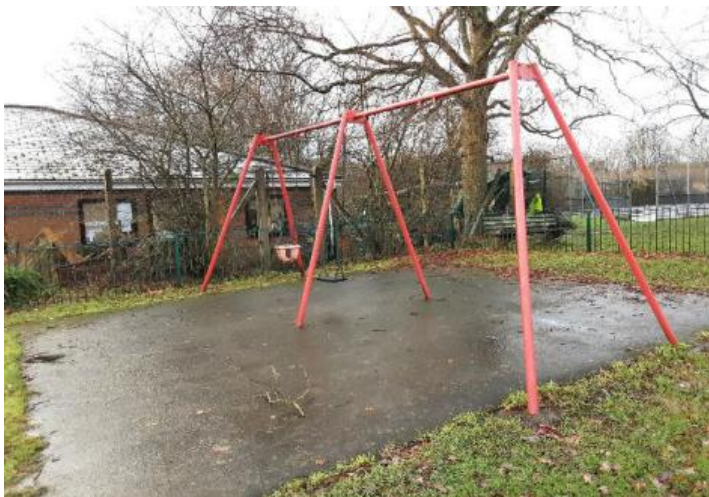
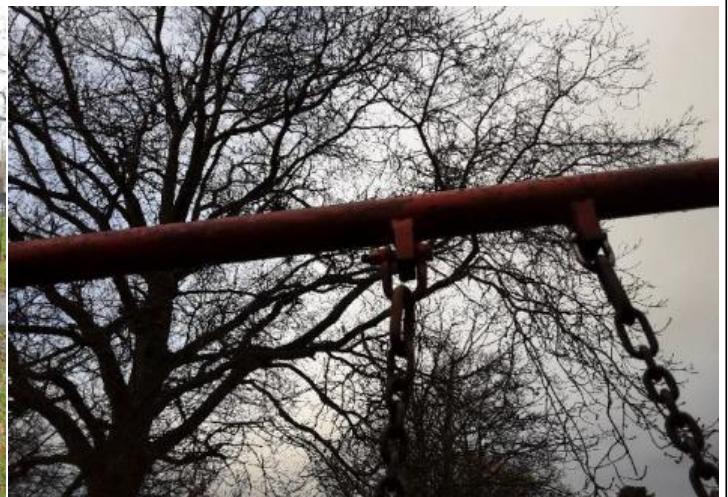
Finding: There is some wear to the shackles.
Action: Monitor for any further deterioration and replace when 40% worn

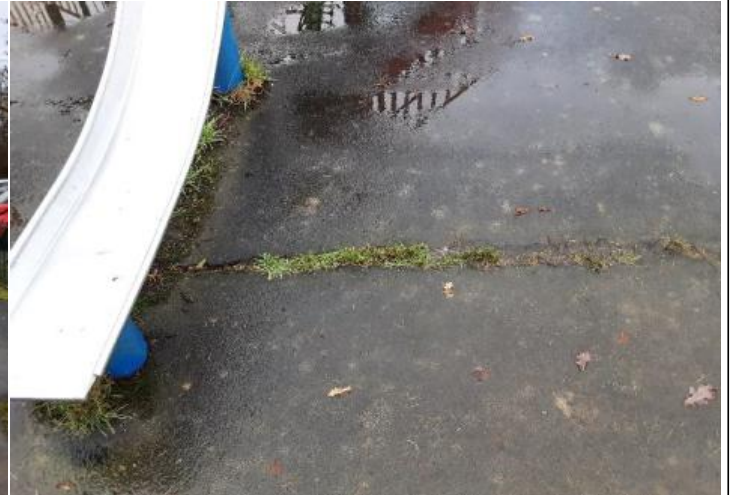
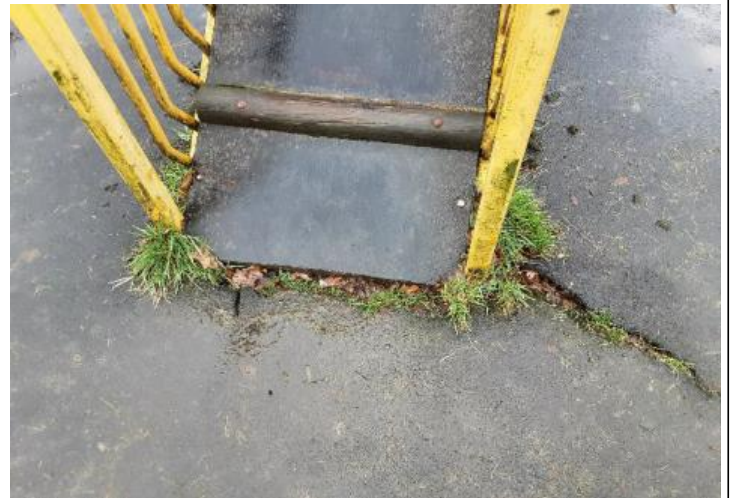
Finding: There is moderate damage to the surface

Action: Repair the damaged areas of surfacing

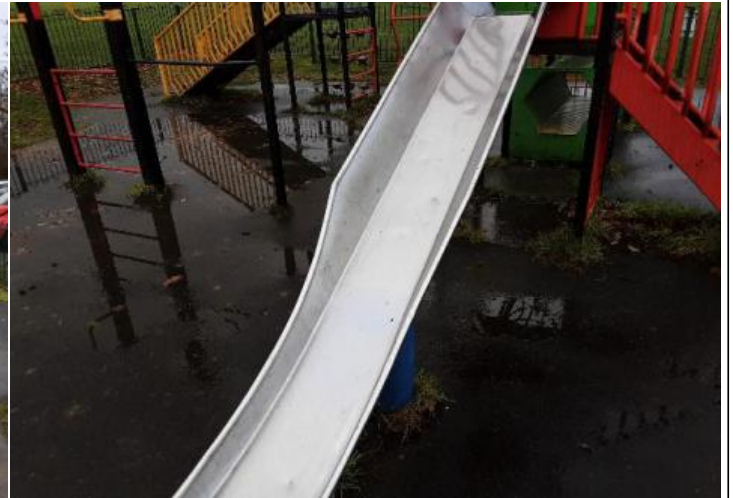
Finding: There are a number of dents in the slide surface

Action: Monitor for any further deterioration and repair as required

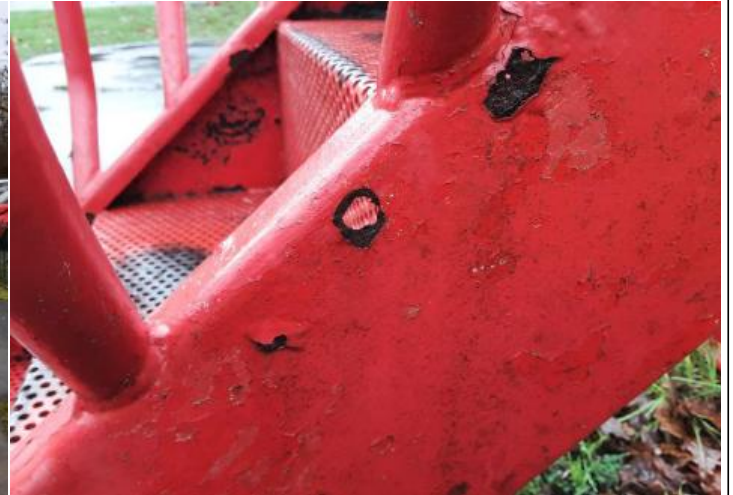
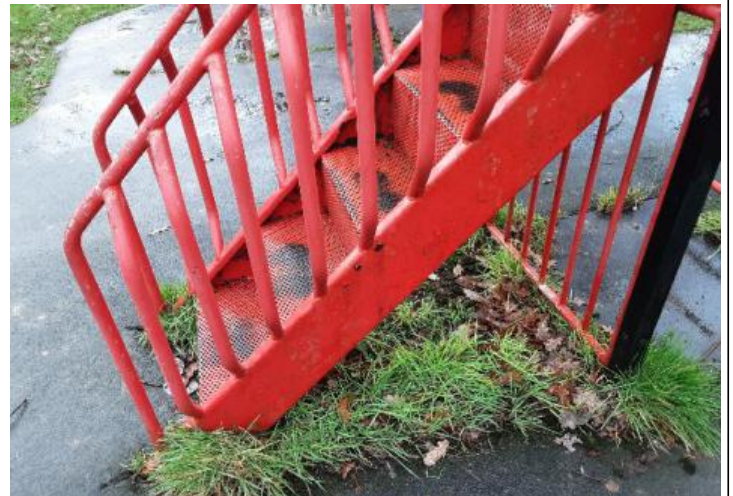
Finding: Parts of the steel on this item have corroded excessively and the metal has perforated in places

Action: Ensure all affected areas are treated and repaired

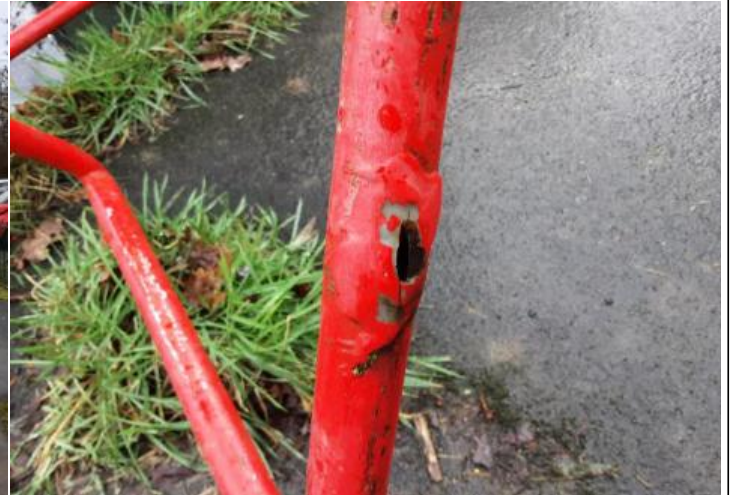
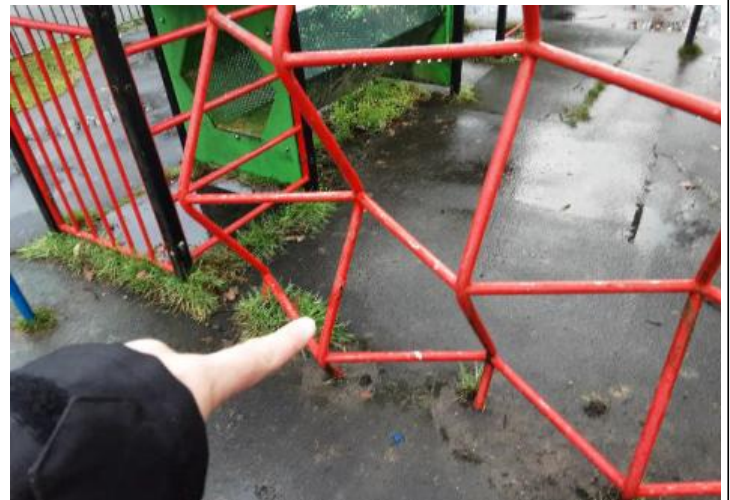
Finding: Parts of the steel on this item have corroded excessively and the metal has perforated in places

Action: Ensure all affected areas are treated and repaired

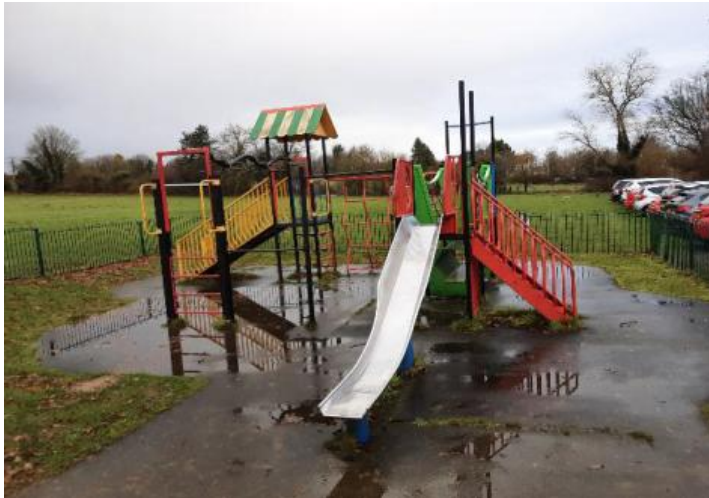
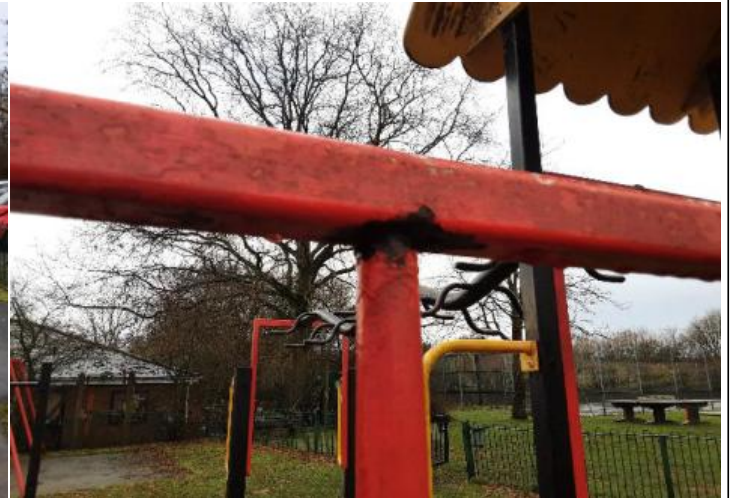
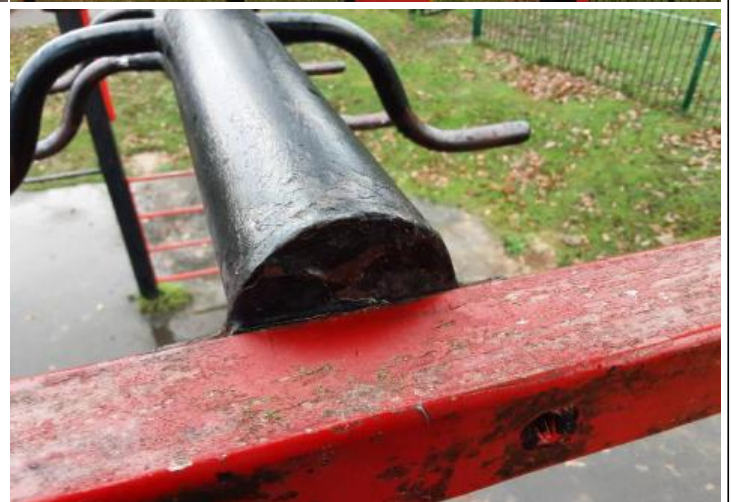
Finding: The paintwork on this item has been damaged or worn exposing the metal underneath which is rusting / corroding

Action: Treat affected areas and repaint

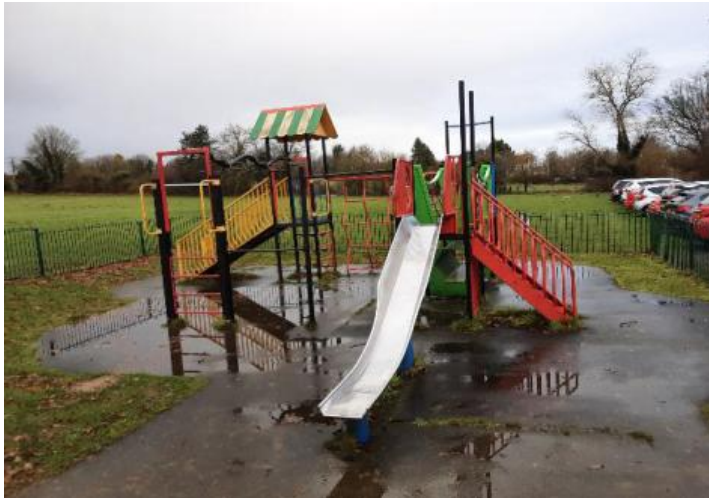
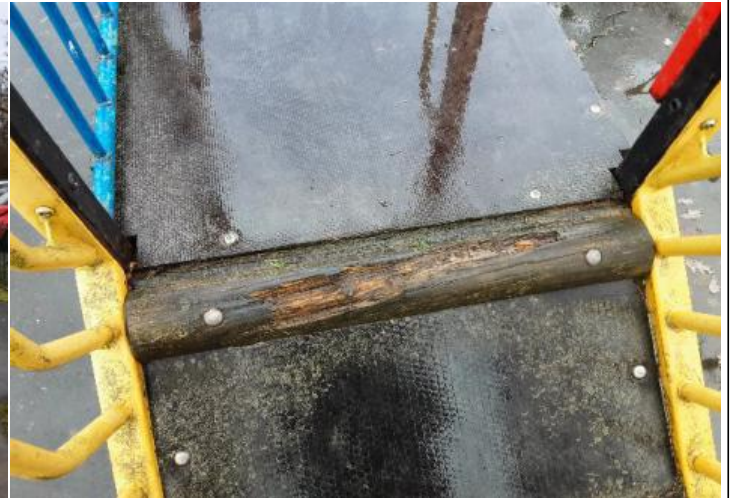
Finding: There are areas or parts of the timber on the ramp treads that have rotted
Action: Replace all affected timbers

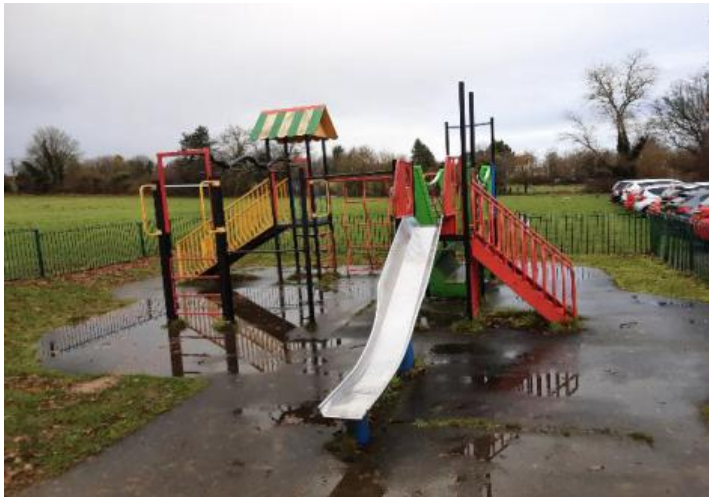
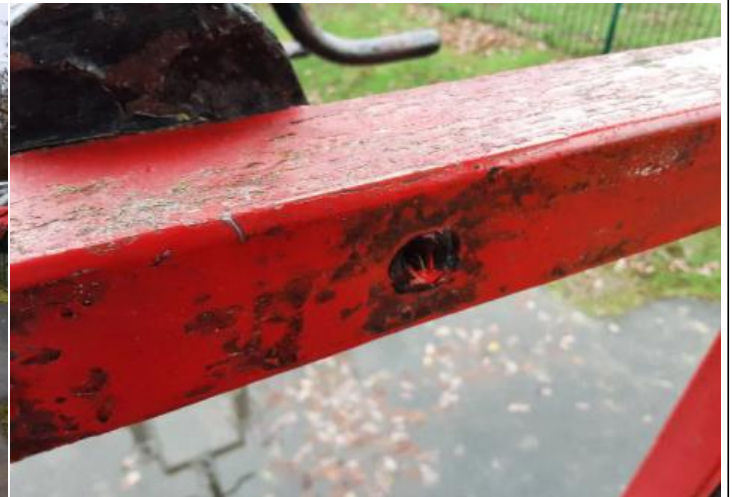
Finding: The fixings have corroded excessively
Action: Replace all corroded fixings

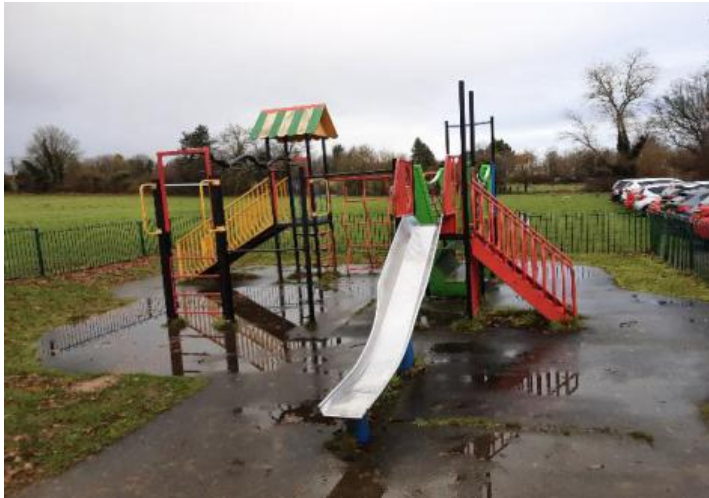
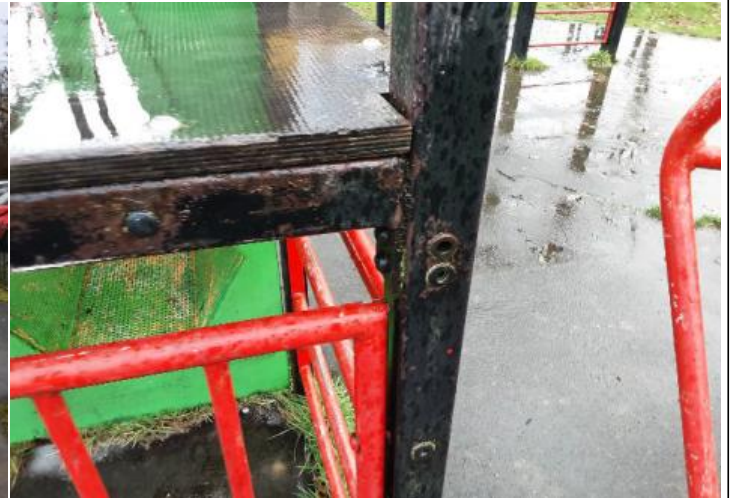
Finding: There is/are inserts missing

Action: Replace missing inserts

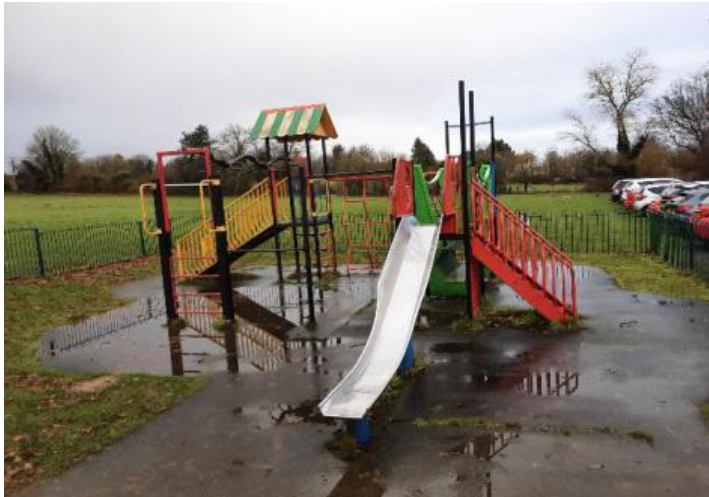
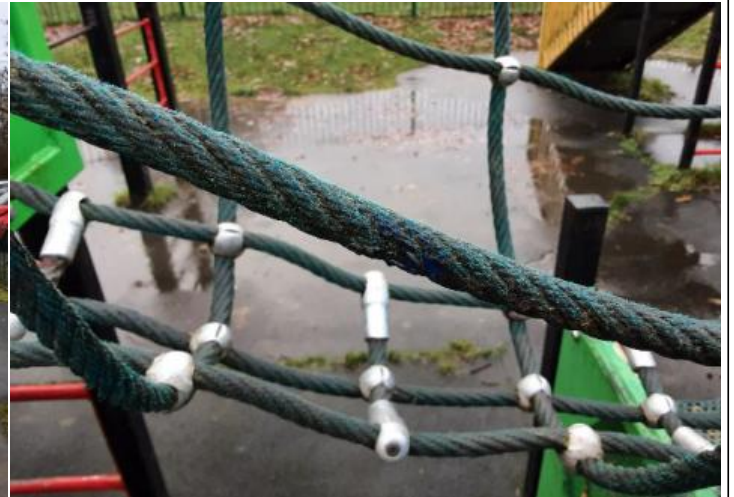
Finding: There is some evidence of fire damage to the item

Action: Monitor for any further deterioration and repair as required

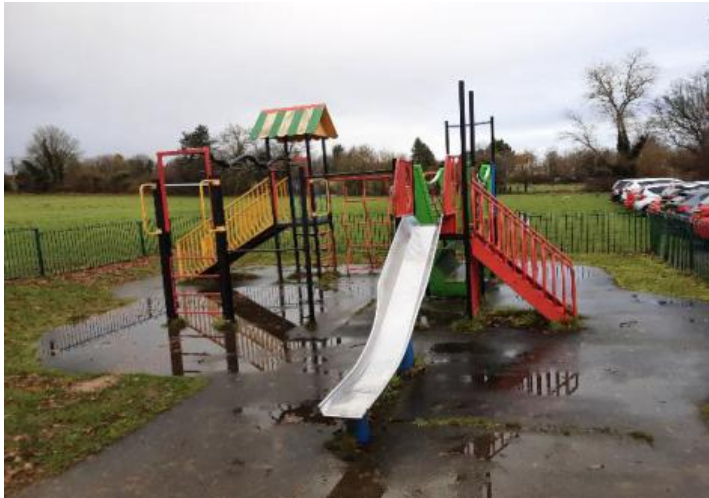
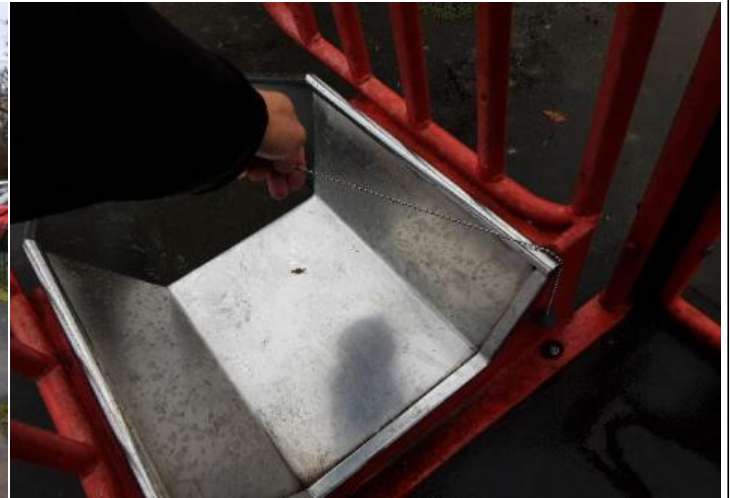
Finding: There is / are toggle entrapment/s present in contravention of the recommendations set out in BS EN 1176 Part 1

Action: Monitor - No action given the risk assessment

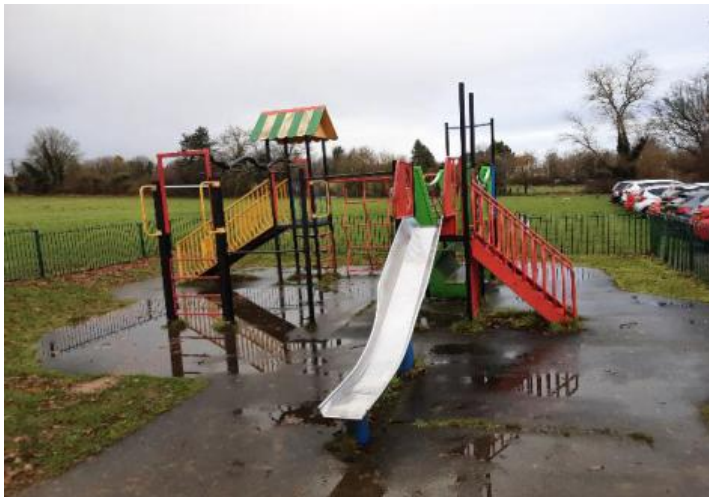
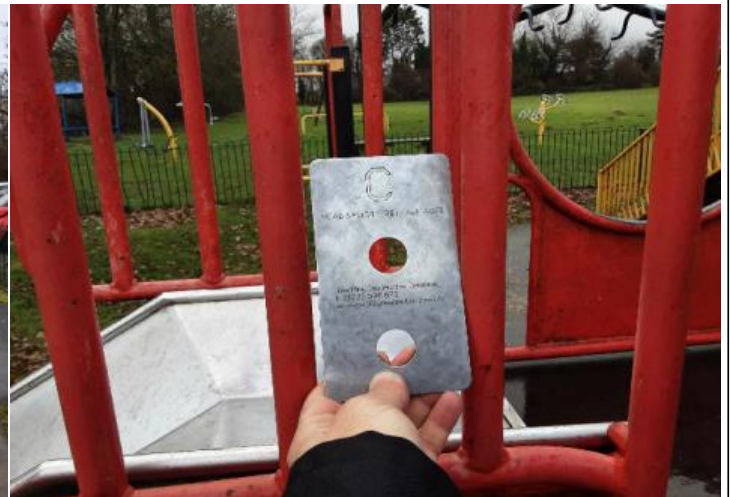
Finding: The item fails to meet the requirements of BS EN 1176 Part 1 4.2.7.2 head and neck entrapment in the barriers and/or steps

Action: Monitor - No action given the risk assessment

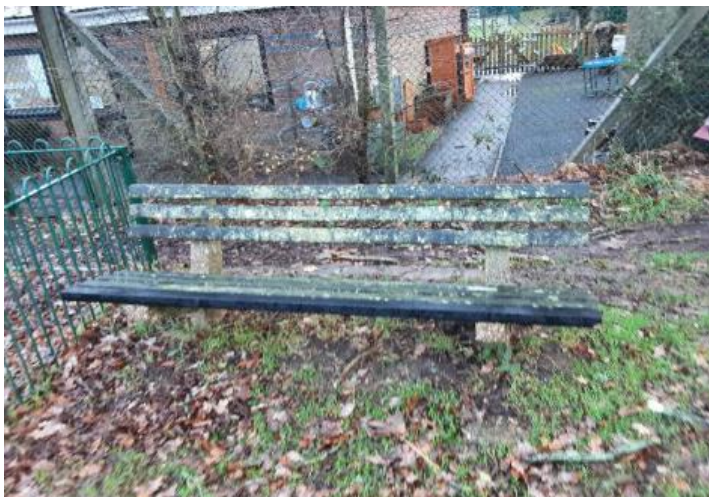
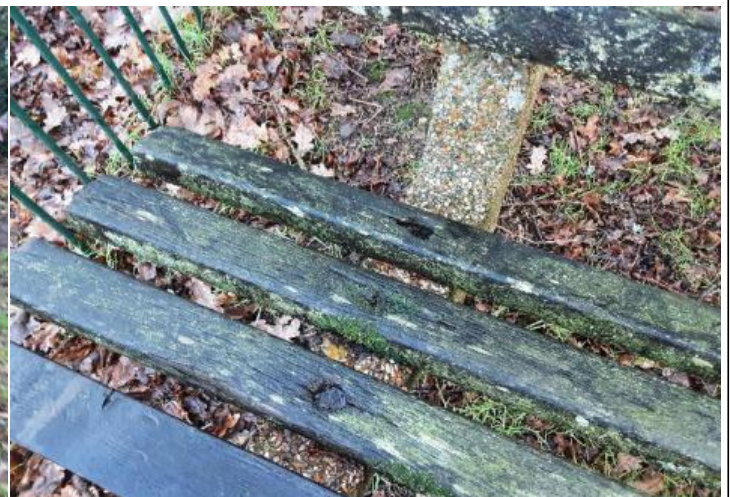
Finding: There is some evidence of rot in the timber

Action: Monitor for any further deterioration and replace as required

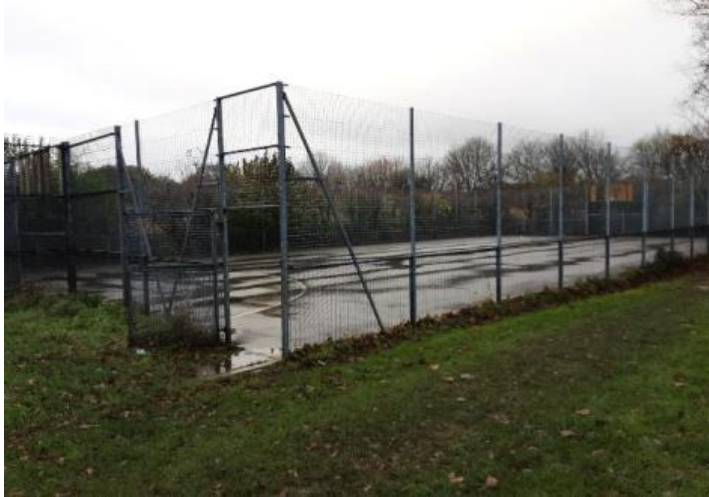
Finding: A clearly visible facility sign should be provided in a prominent position with the wording as detailed BS EN 15312- the equipment is not intended for children less than 3 years old- the warning - Do not climb on the framework or nets- the warning - Do not hang on the ring (if provided)- the warning - Do not wear rings or other jewellery- name and telephone number of the administrator- number to call in case of accident

Action: Provide signage to BS EN 15312

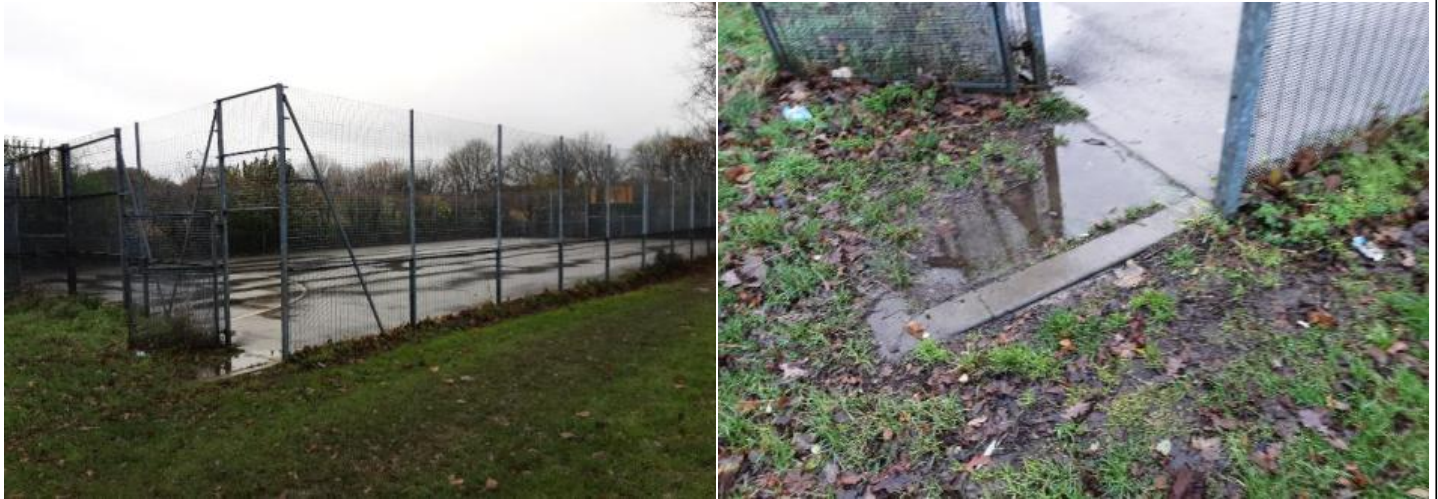
Finding: There are trip hazards at the edges of the surface **Action:** Remove trip hazard

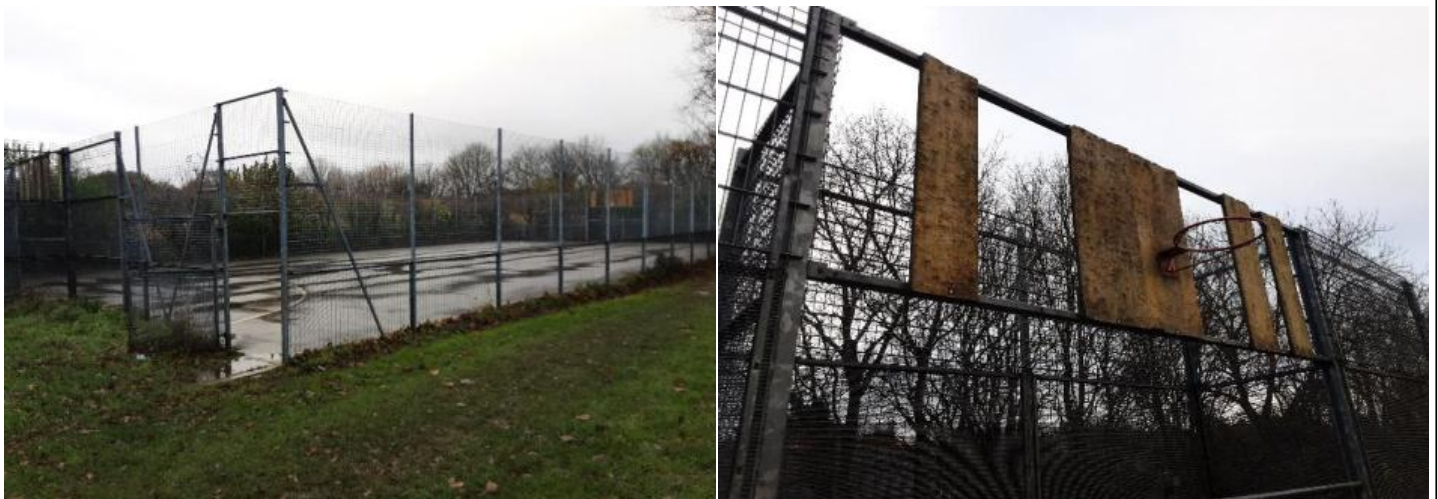
Finding: A number of panels are missing above the goal **Action:** Replace

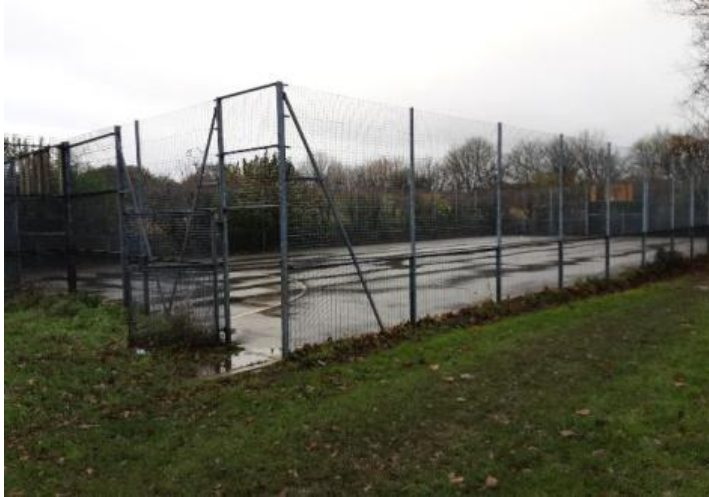
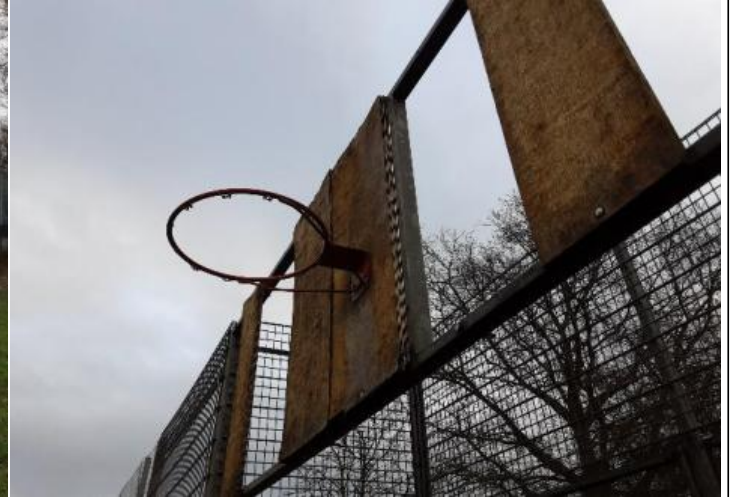
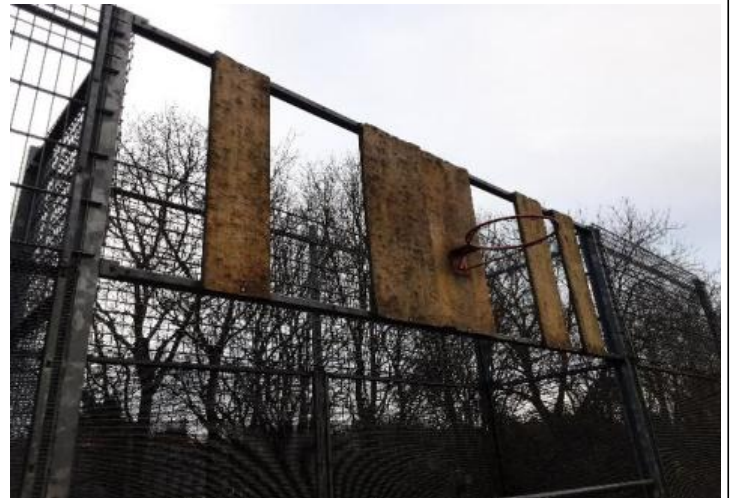
Finding: There are areas or parts of the timber on the structure that have rotted

Action: Replace all affected timbers

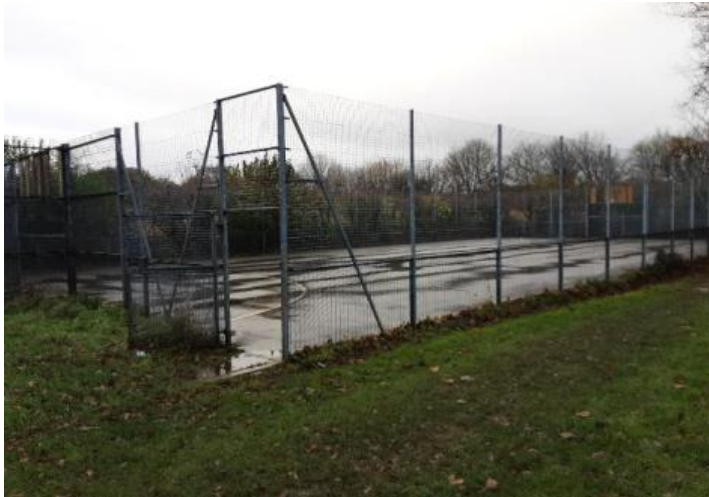
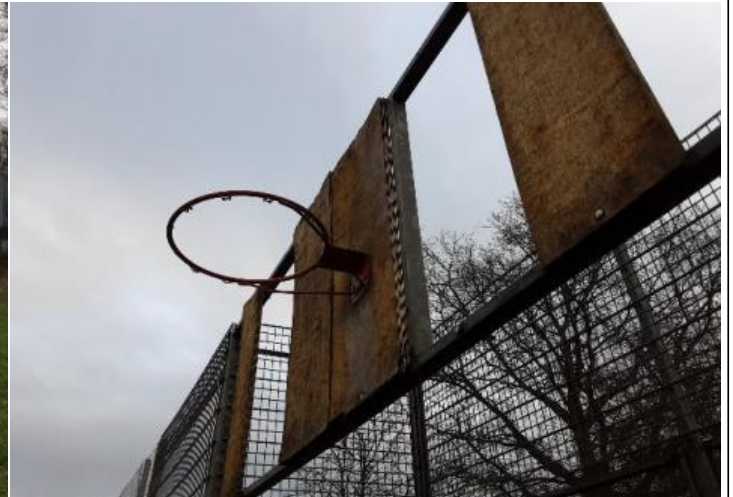
Finding: The free space between the backboard and the framework is less than 600mm and fails the requirements of BS EN15312:2007 +A1 2010

Action: Monitor - No action given the risk assessment
