the **play inspection** company

Annual Inspection

Adisham Parish Council

Adisham Recreation Ground

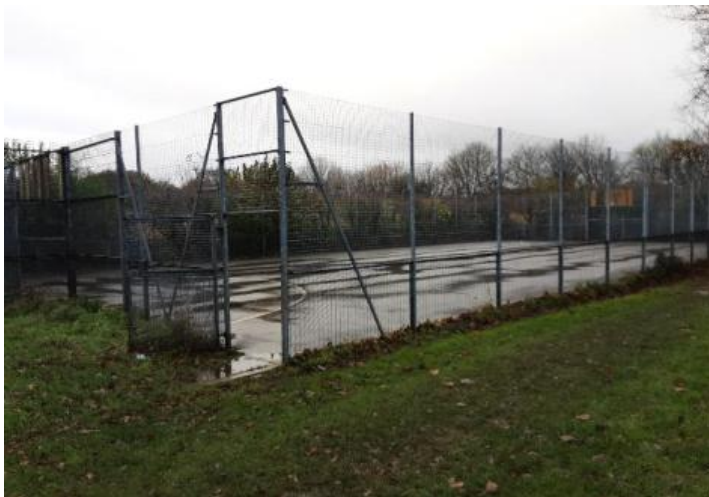
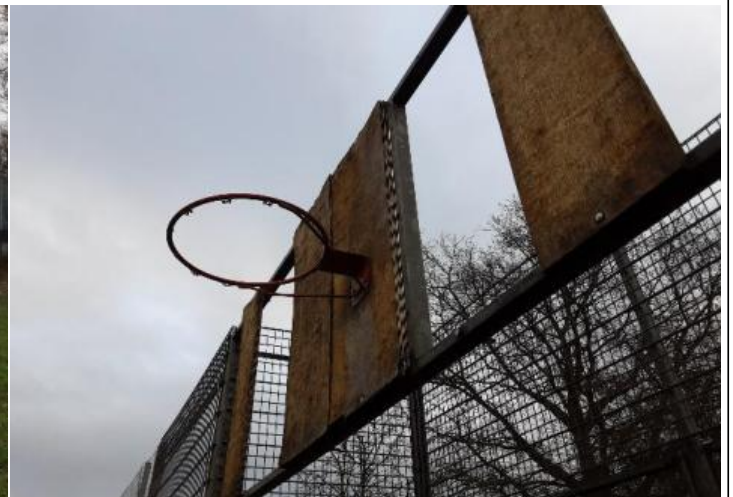
Finding: The ring is not fixed to the framework and force from the ring can be transmitted directly to the backboard in contravention of BS EN 15312:2007+A1:2010 - 5.2.2.1

Action: Monitor condition and replace as required

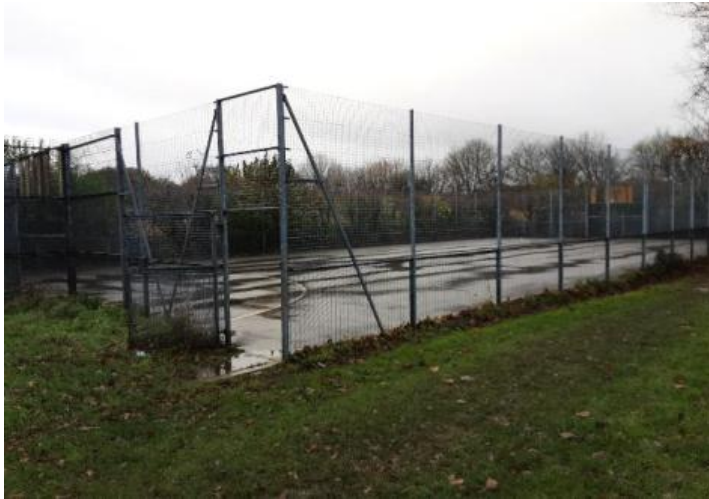
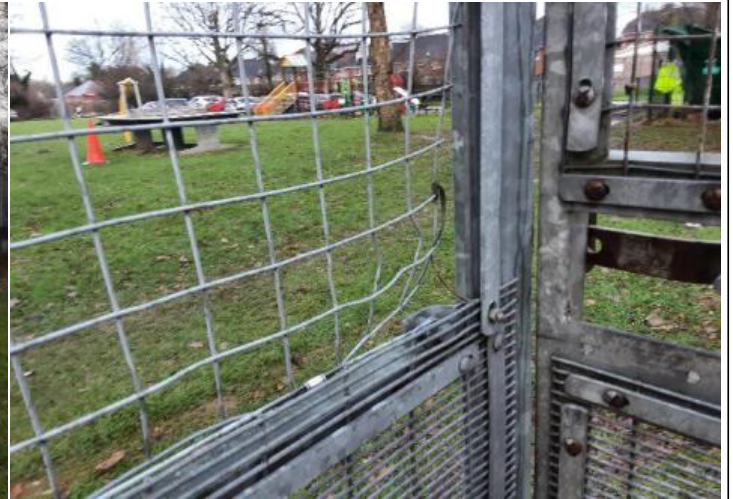
Finding: The fence is severely damaged in places

Action: Repair or replace all affected sections

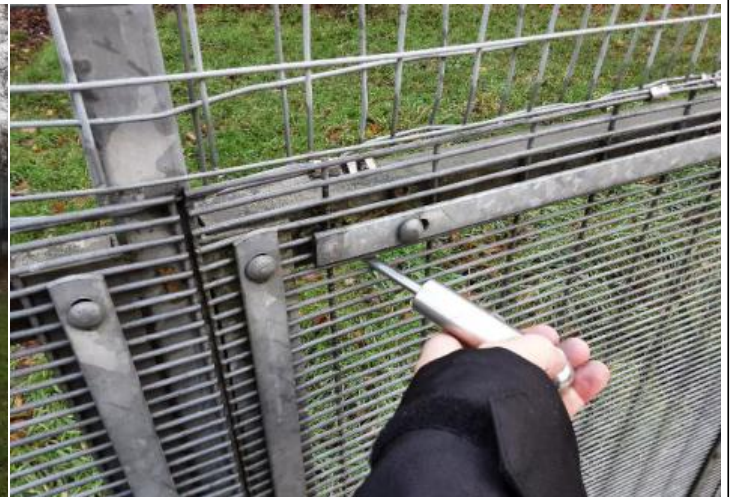
Finding: There is/are finger entrapments in the panels and the item fails to meet the requirements of BS EN 15312 Clause 4.4.2.2 Entrapment of fingers

Action: Monitor - No action given the risk assessment

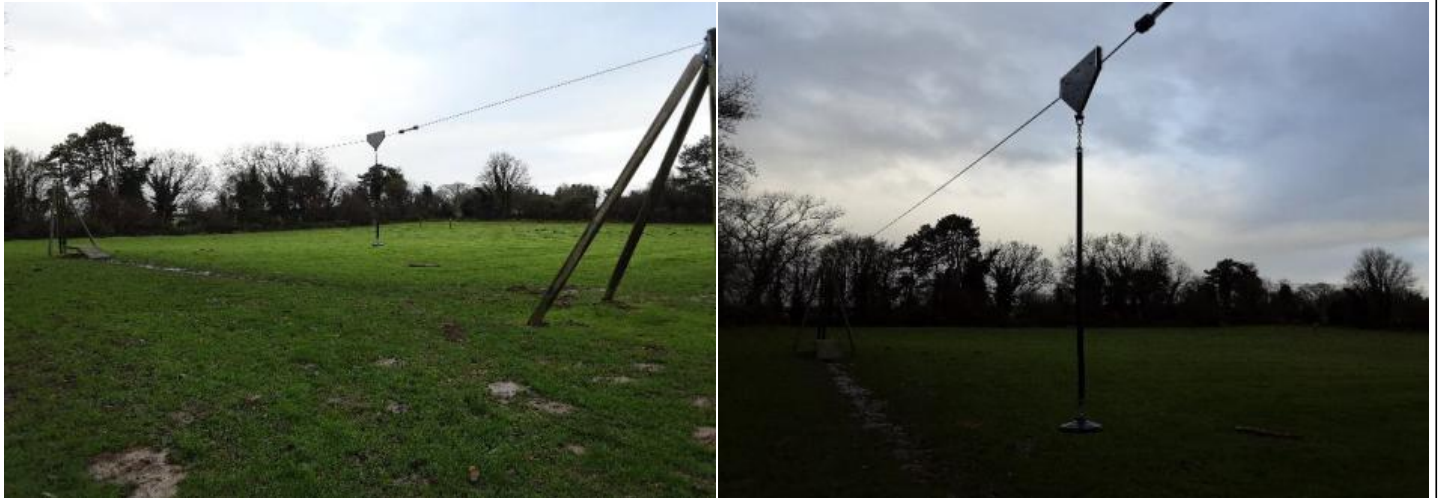
Finding: We have completed a visual inspection of the suspension links, cable and fixing points from ground level, however it is not possible to fully inspect these areas without either hiring equipment to gain access or removing the cable and suspension and inspecting at ground level. We recommend that the main cable and fixing security is thoroughly inspected at least in accordance with the manufacturers recommendations to check for wear, damage, security or internal rusting; this will help to ensure the continued safe use of the equipment

Action: Inspect in accordance with the manufacturers recommendations

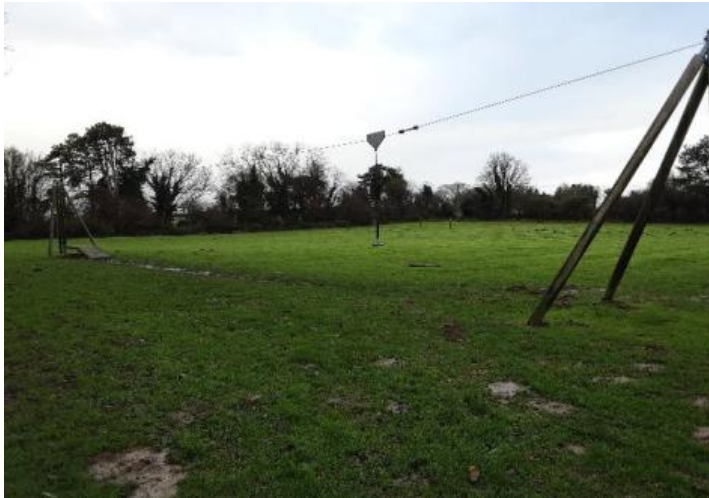
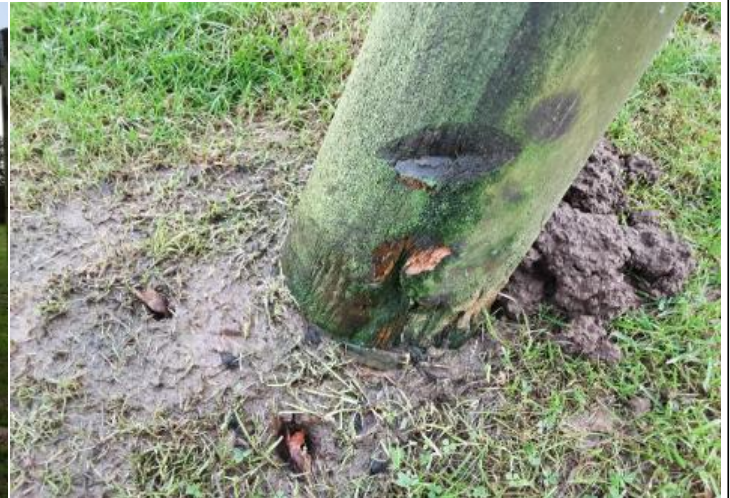
Finding: There is some evidence of rot in the timber

Action: Monitor for any further deterioration and replace as required

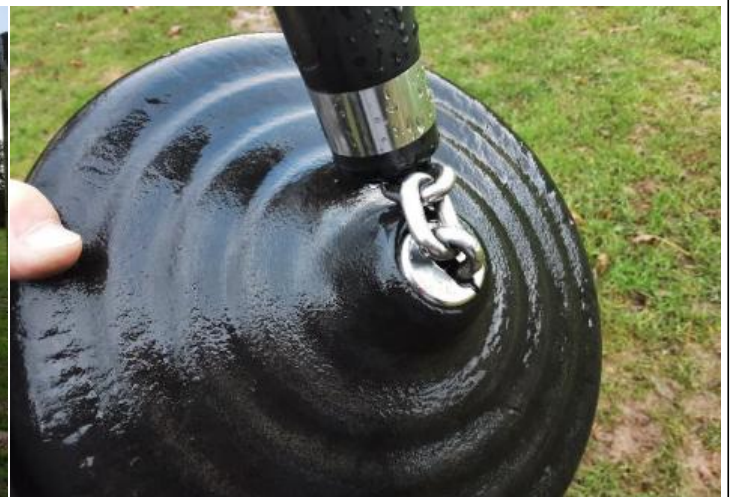
Finding: There is some notable evidence of chain wear

Action: Monitor for any further deterioration and replace when 40% worn

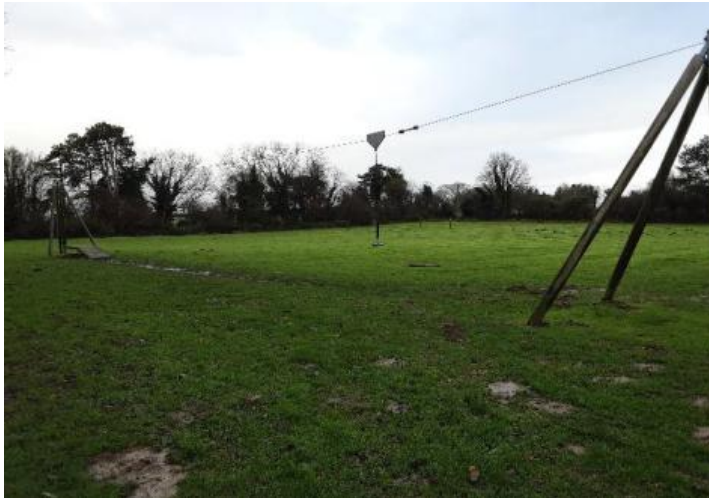
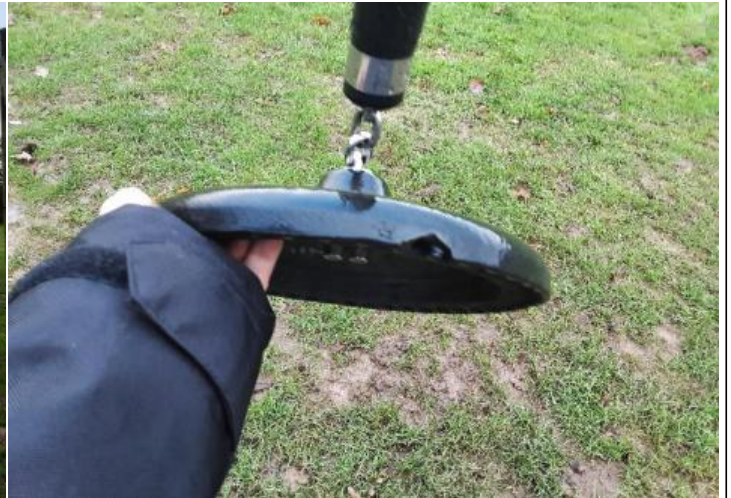
Finding: The cableway seat has been damaged

Action: Monitor for any further deterioration and replace as required

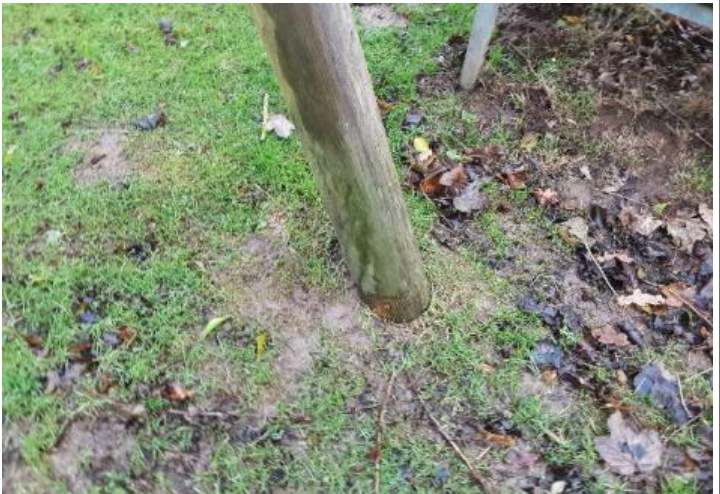
Finding: There is some strimmer / machinery damage apparent on the posts, this can penetrate the preservative applied to the timber and accelerate the rotting process		Action: Monitor for any deterioration (rot) and replace as required
