Annual Inspection

Adisham Parish Council

Adisham Recreation Ground

Annual Inspection - 16 October 2017 at 10:00 Inspector: Robert Baldock (RPII Annual Inspector)

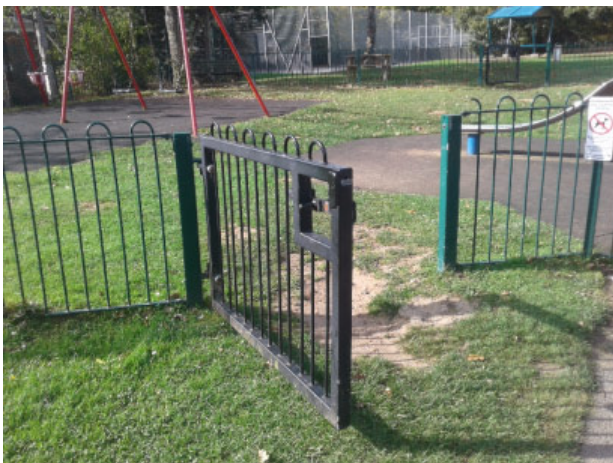
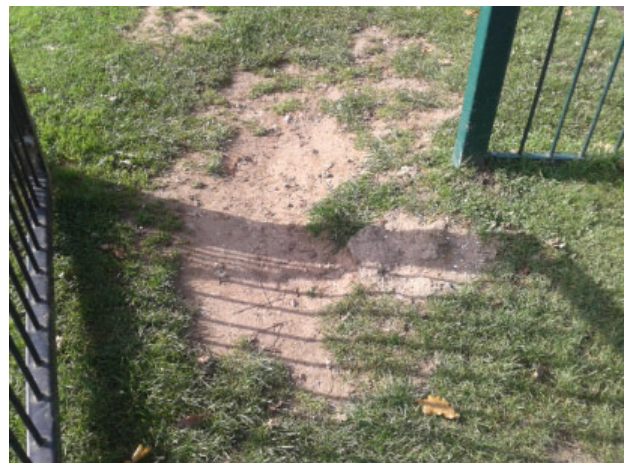
8 - Low Risk (Finding 2)

Finding: The area under the gate has eroded leaving uneven areas, or the concrete foundations exposed, resulting in trip hazards at the entrance/exit to the playground

Action: Reinstate to level with surrounding surfaces

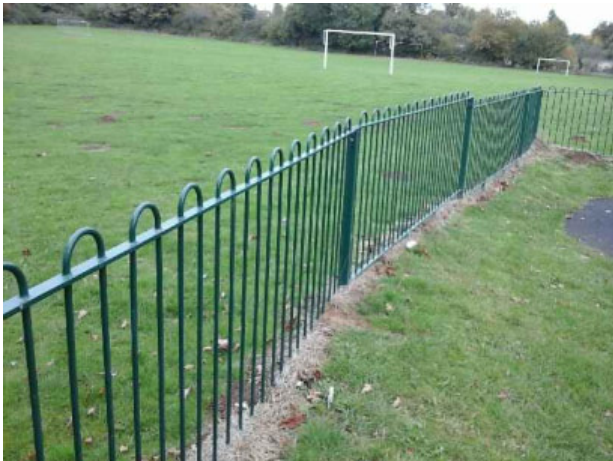
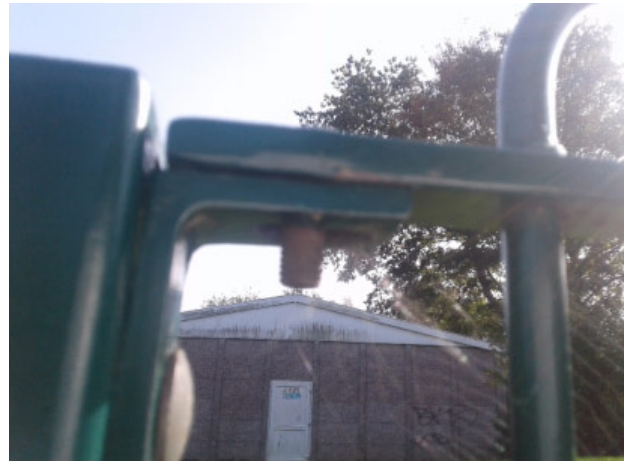
6 - Low Risk (Finding 1)

Finding: There are a number of fixings missing from the fence
Action: Replace missing fixings

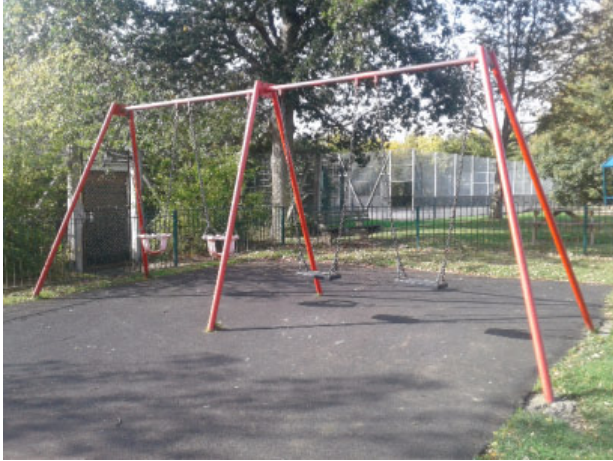
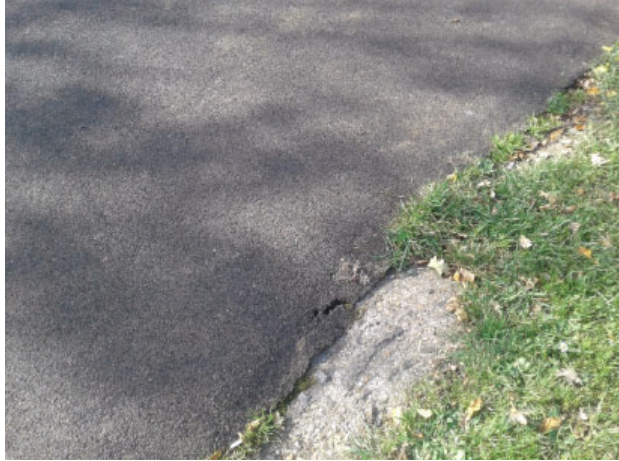
8 - Low Risk (Finding 1)

Finding: The surfacing around the item is damaged **Action:** Repair the damaged areas of surfacing

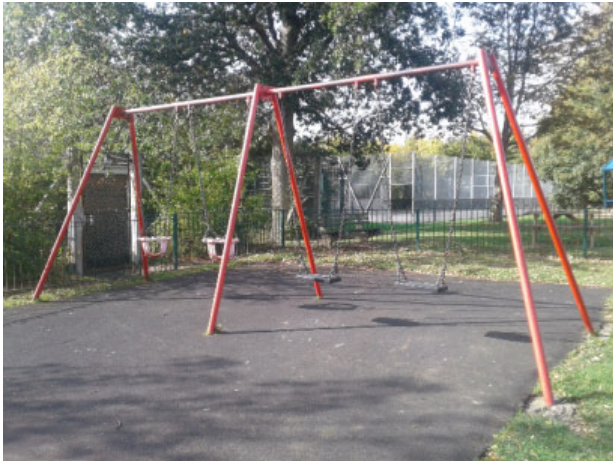
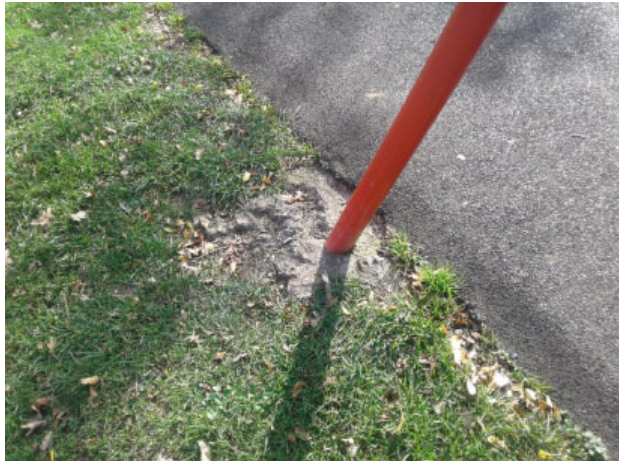
8 - Low Risk (Finding 2)

Finding: The surface has eroded and the foundations are exposed **Action:** Reinstate surrounding surfaces to cover the foundations

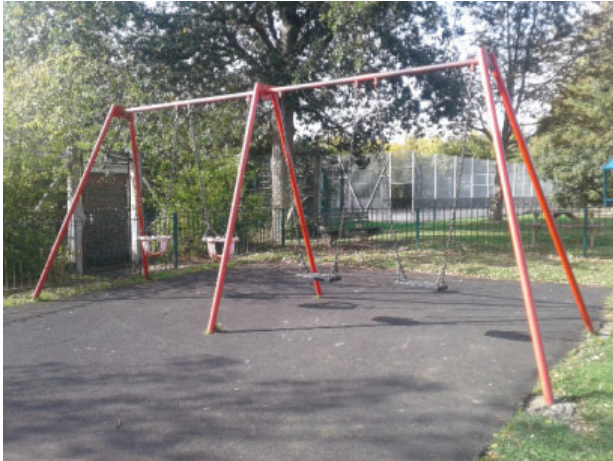
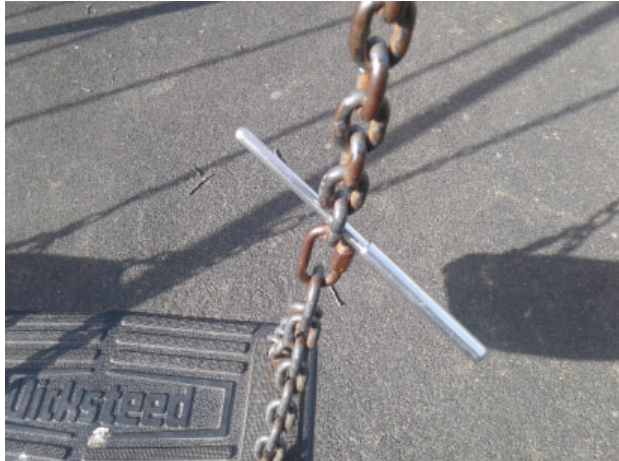
5 - Very Low Risk (Finding 3)

Finding: The chain openings are in excess of the 8.6mm as recommended by BS EN 1176
Action: Monitor use

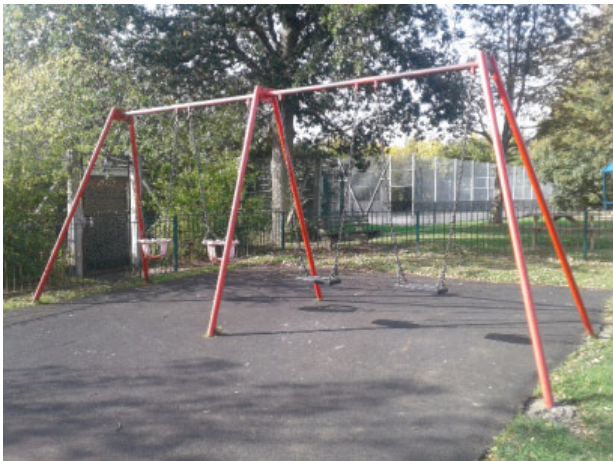
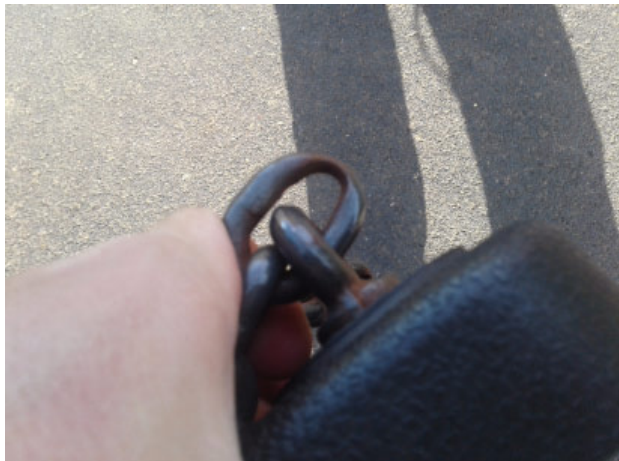
8 - Low Risk (Finding 4)

Finding: The chain links are worn in excess of 40% and require renewing
Action: Replace worn chains

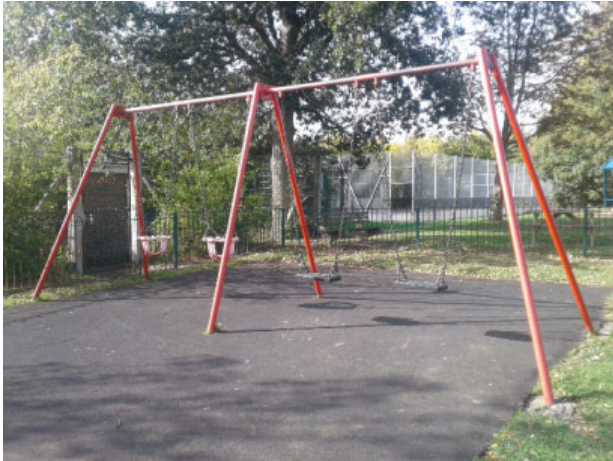
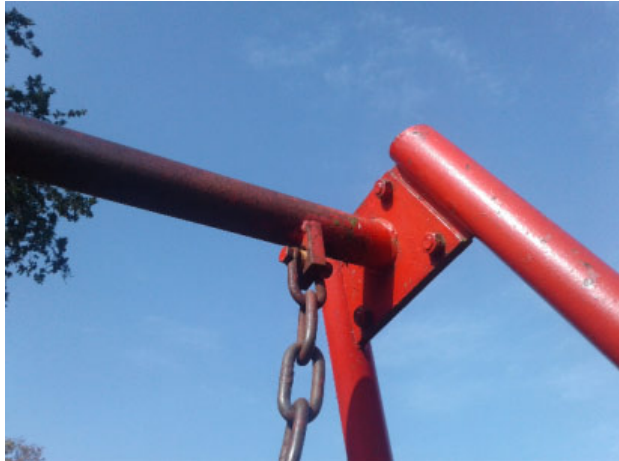
8 - Low Risk (Finding 5)

Finding: The bushes are worn or missing

Action: Replace worn or missing bushes

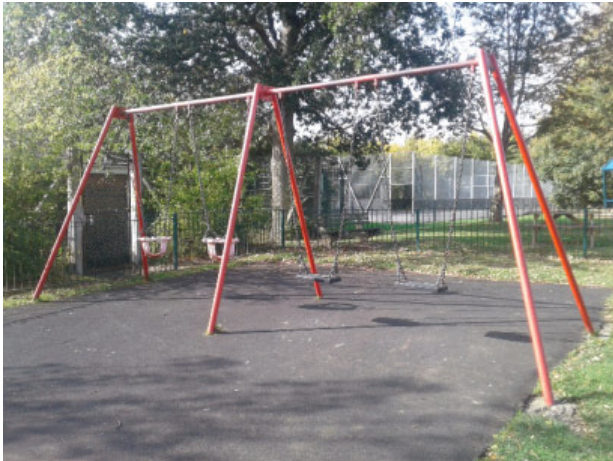
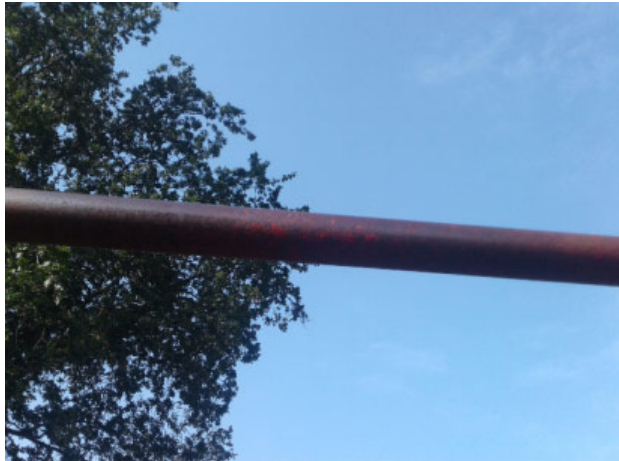
6 - Low Risk (Finding 6)

Finding: The paintwork on this item has been damaged or worn exposing the metal underneath which is rusting

Action: Treat any rusting components and repaint

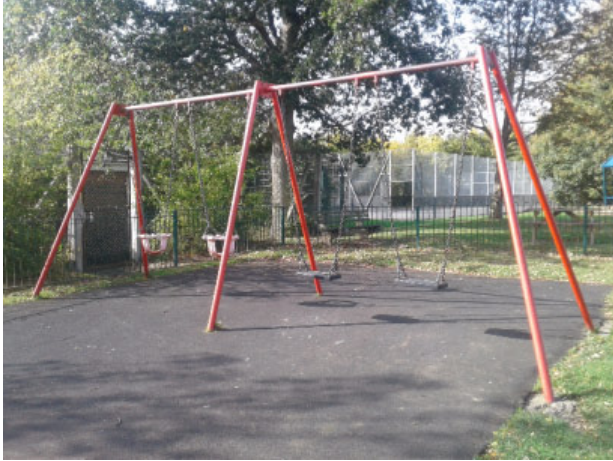
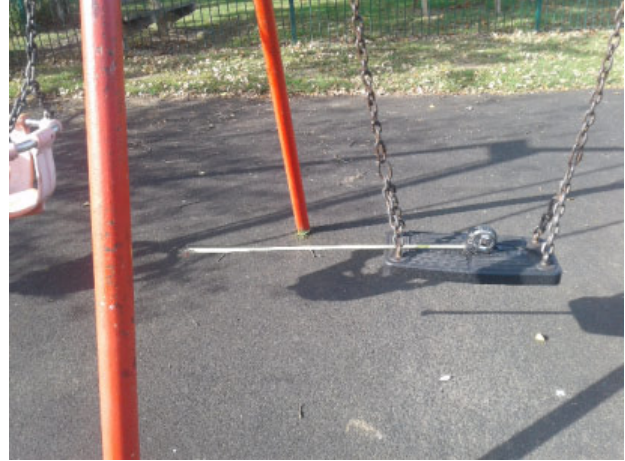
4 - Very Low Risk (Finding 7)

Finding: The seats are too close to the frame as defined in BS EN 1176 Part 2; this is a low risk failure and no remedial action is required

Action: Monitor use

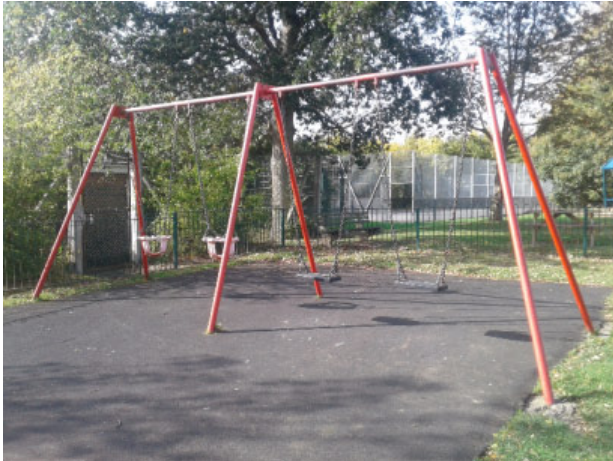
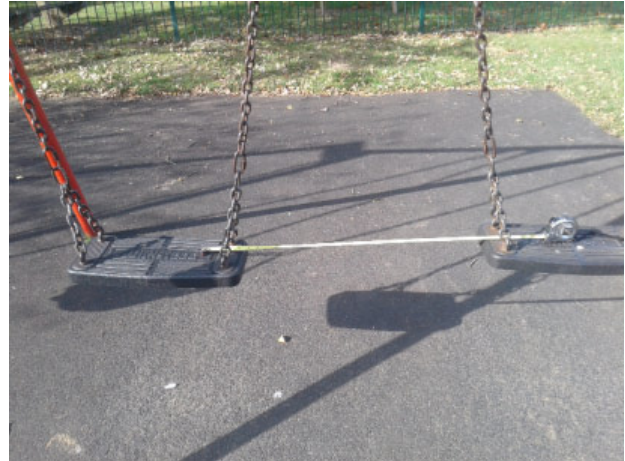
4 - Very Low Risk (Finding 8)

Finding: The seats are too close to each other as defined in BS EN 1176 Part 2; this is a low risk failure and no remedial action is required

Action: Monitor use

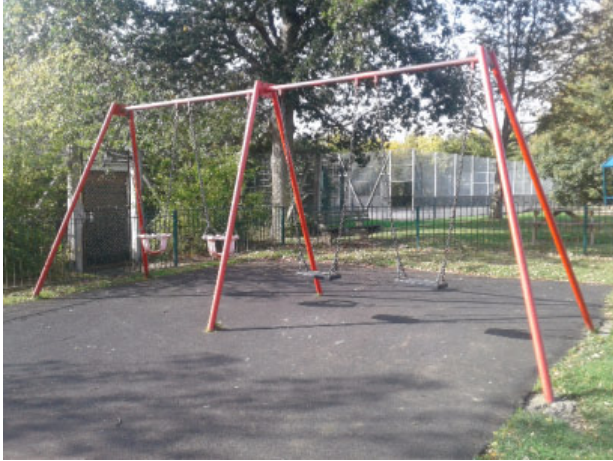
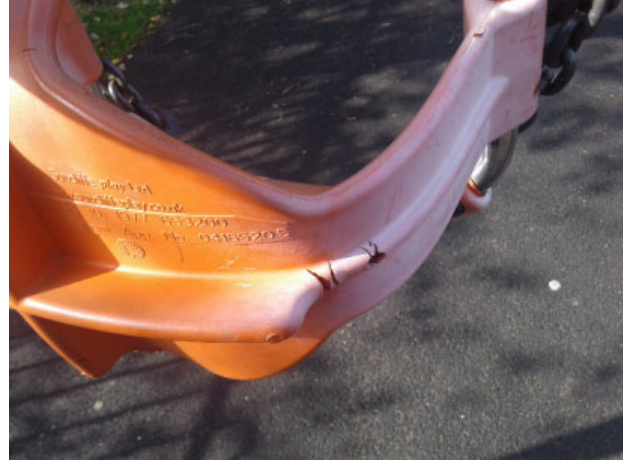
6 - Low Risk (Finding 9)

Finding: The seat has minor damage or wear
Action: Monitor for any further deterioration and replace as required

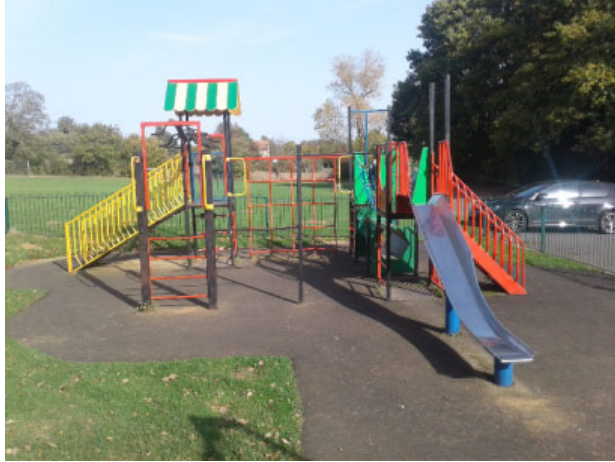
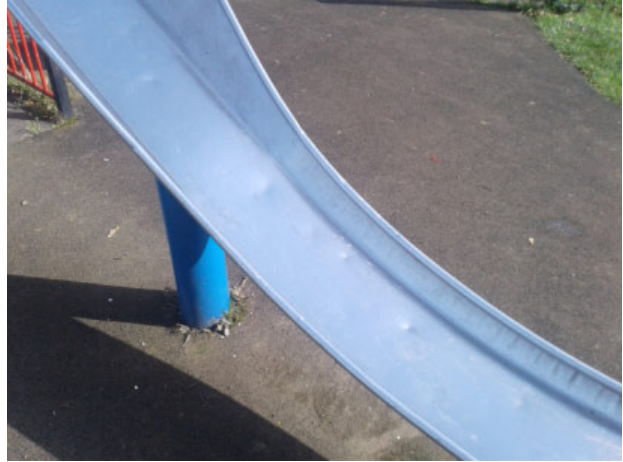
6 - Low Risk (Finding 1)

Finding: There are a number of dents in the slide surface

Action: Monitor for any further deterioration and repair as required

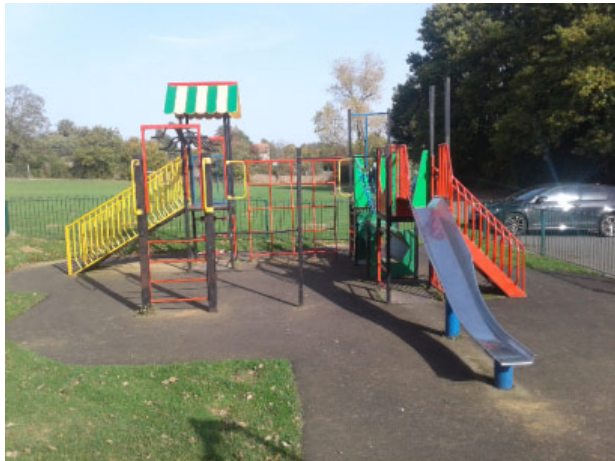
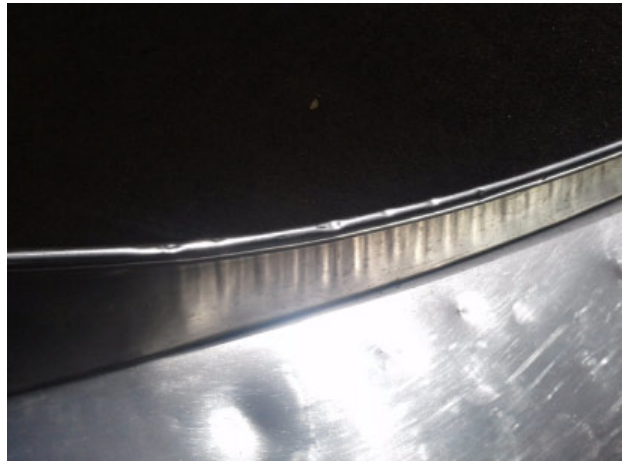
6 - Low Risk (Finding 2)

Finding: The side of the slide is damaged

Action: Monitor for any further deterioration and repair as required

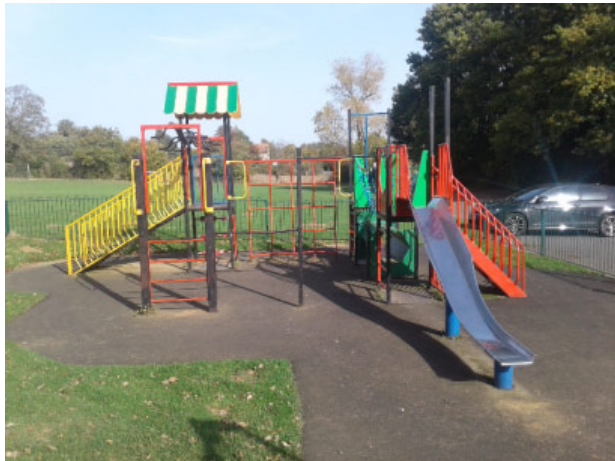
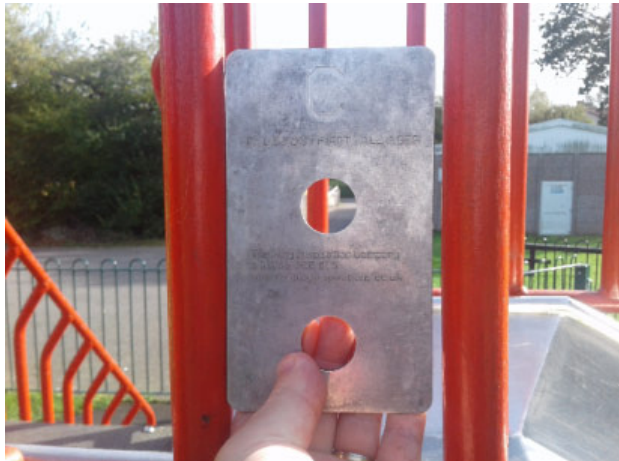
5 - Very Low Risk (Finding 4)

Finding: The item fails to meet the requirements of BS EN 1176:2008 Part 1 4.2.7.2 head and neck entrapment in the barriers and/or steps **Action:** Monitor use

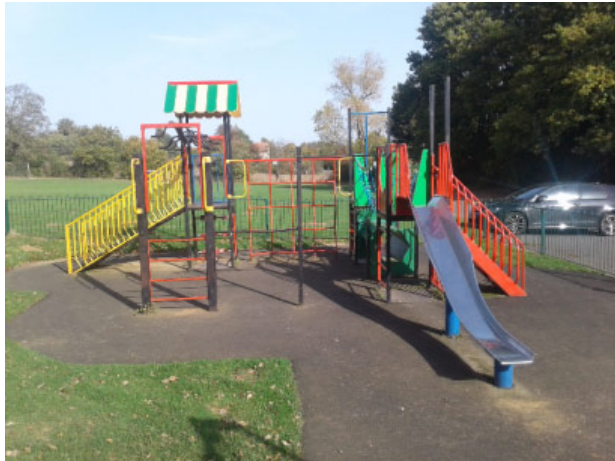
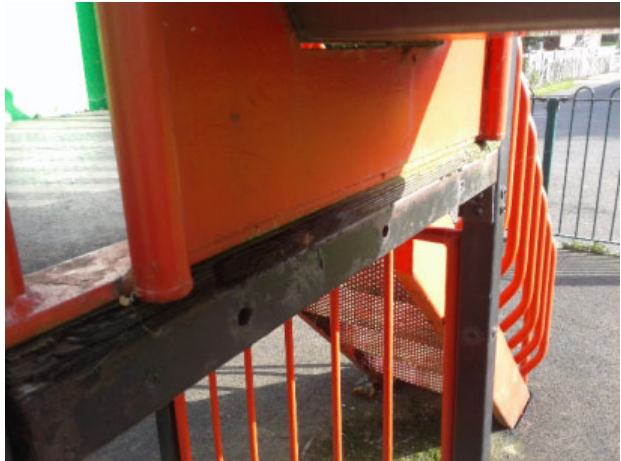
6 - Low Risk (Finding 5)

Finding: There is/are several inserts missing

Action: Replace missing inserts

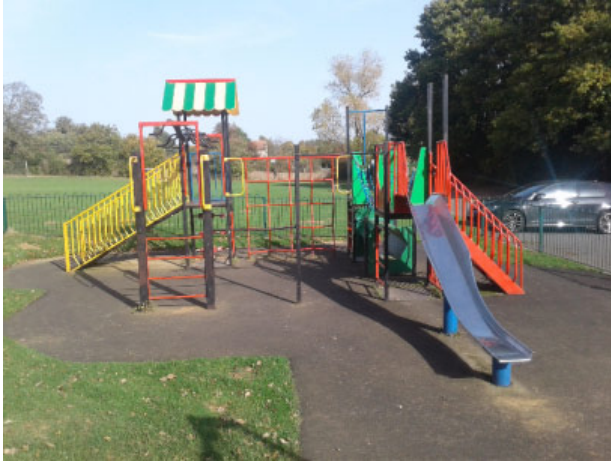
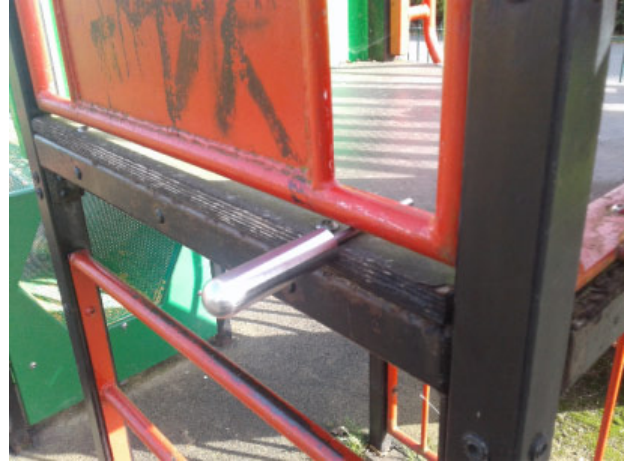
5 - Very Low Risk (Finding 7)

Finding: There is/are finger entrapment/s in the frame and the item fails to meet the requirements of BS EN 1176:2008 Part 1 4.2.7.6 Entrapment of fingers

Action: Monitor use

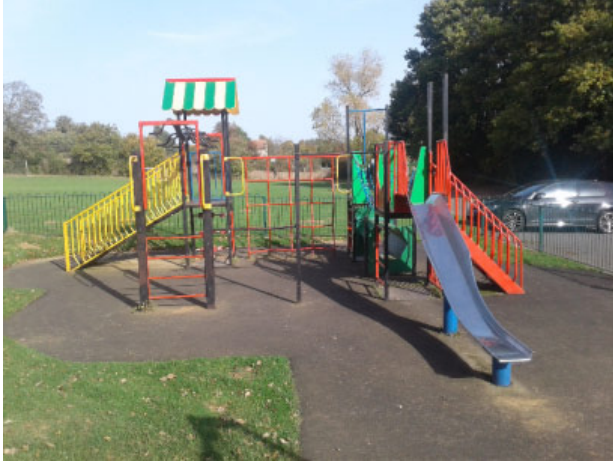
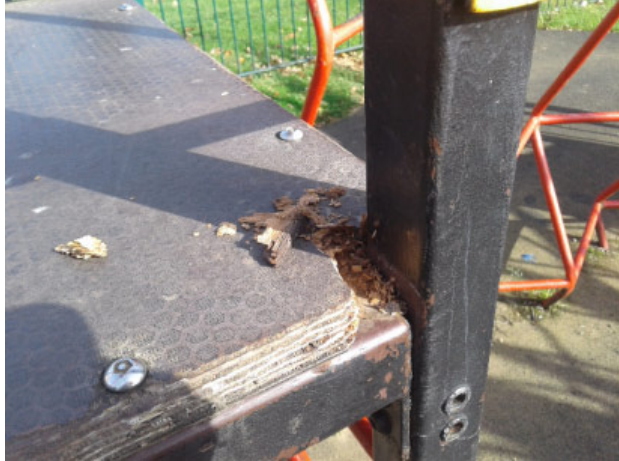
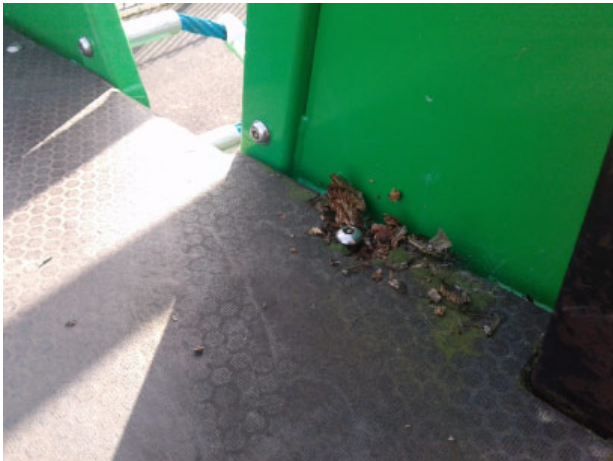
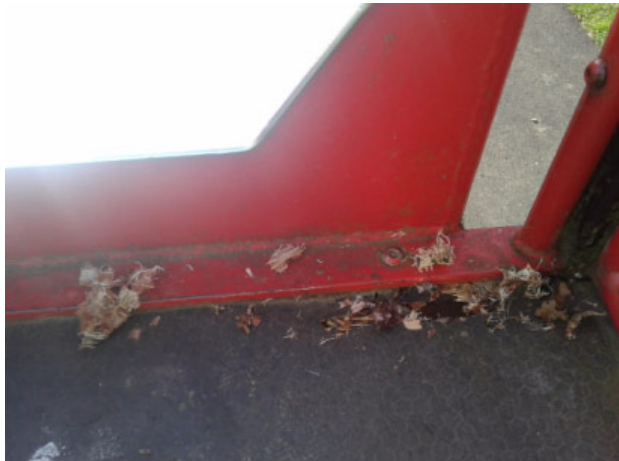
12 - Moderate Risk (Finding 8)

Finding: The platforms have severely rotted

Action: Replace all affected timber

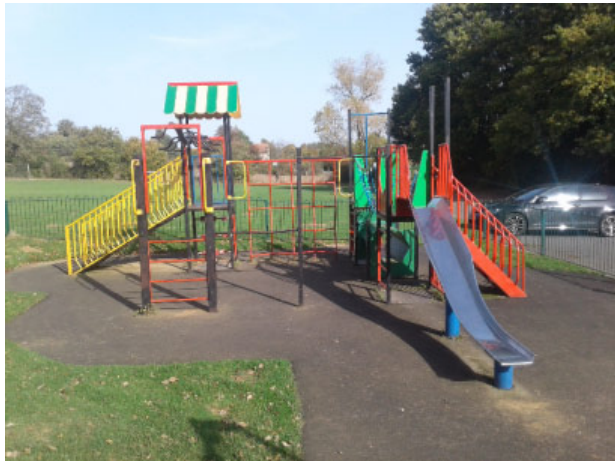
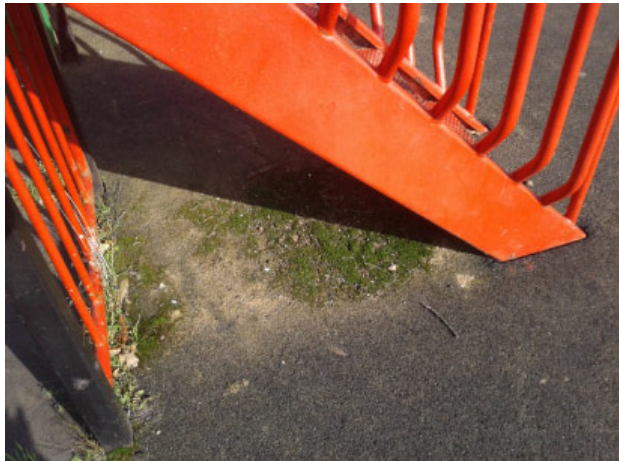
8 - Low Risk (Finding 10)

Finding: There is algae or moss growth on the surface resulting in slippery conditions **Action:** Clean and treat appropriately

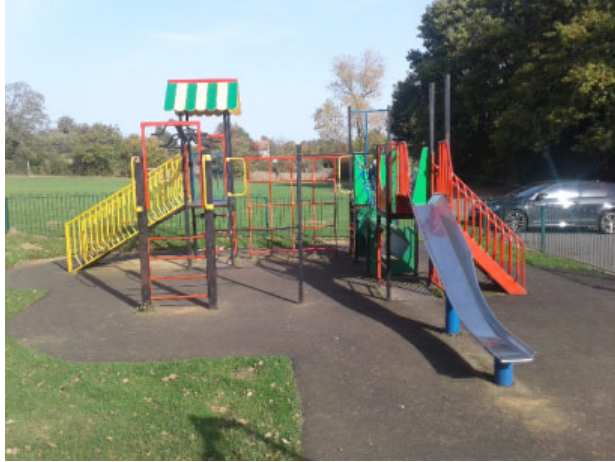
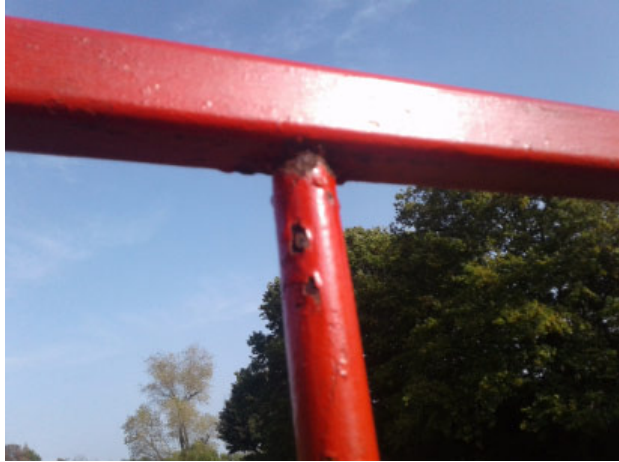
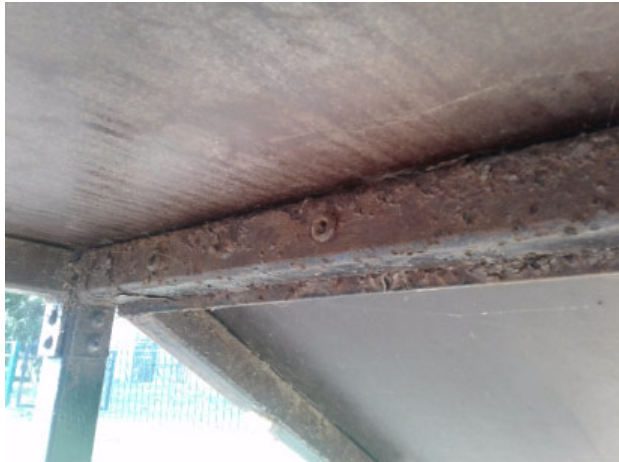
6 - Low Risk (Finding 11)

Finding: The paintwork on this item has been damaged or worn exposing the metal underneath which is rusting

Action: Treat any rusting components and repaint

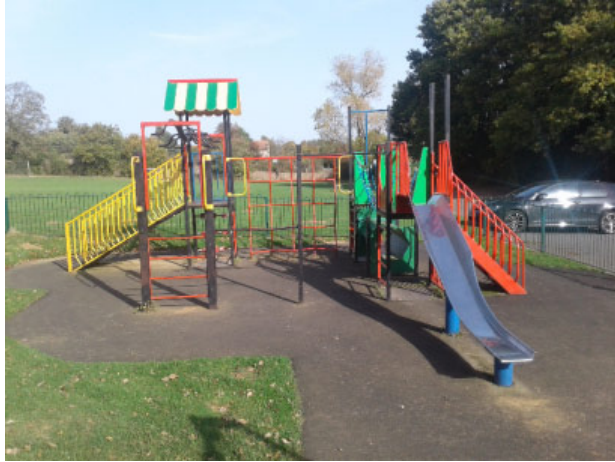
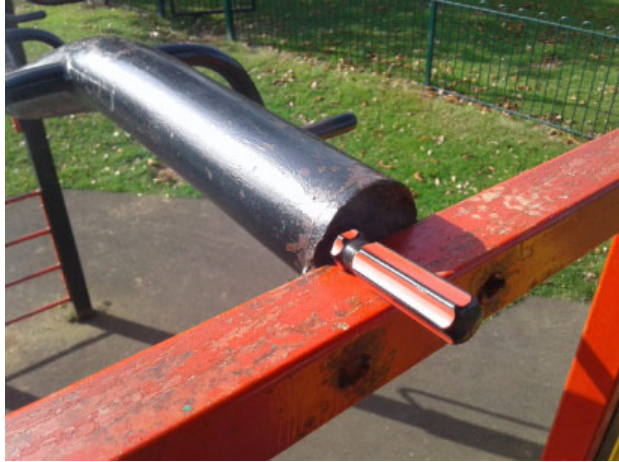
9 - Low Risk (Finding 12)

Finding: Parts of the steel on this item have corroded excessively and the metal has perforated in places
Action: Ensure all affected areas are treated and repaired

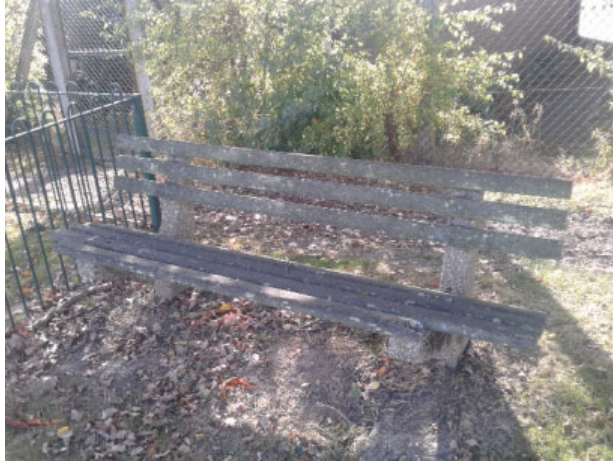
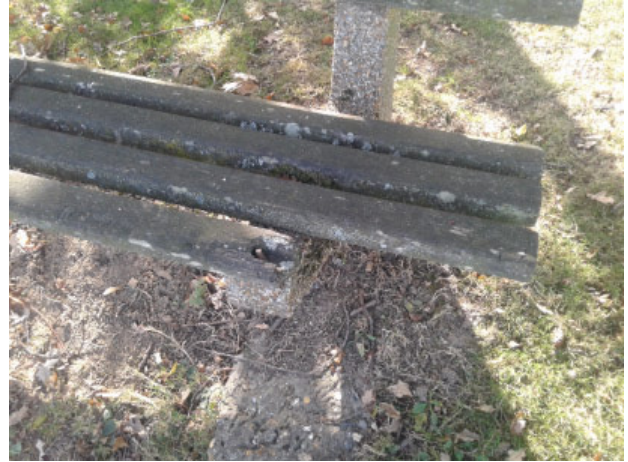
8 - Low Risk (Finding 1)

Finding: The bench is damaged

Action: Repair or replace as required

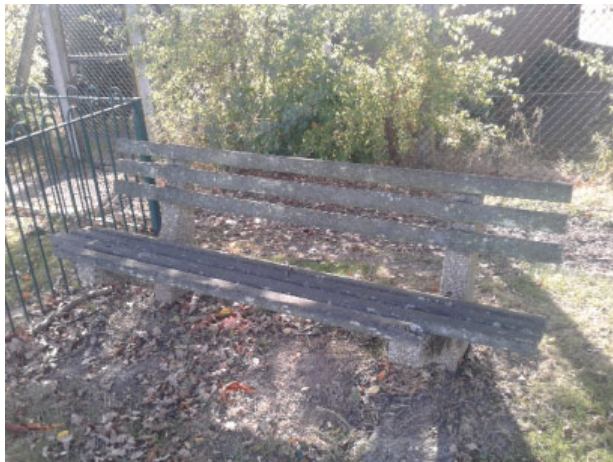
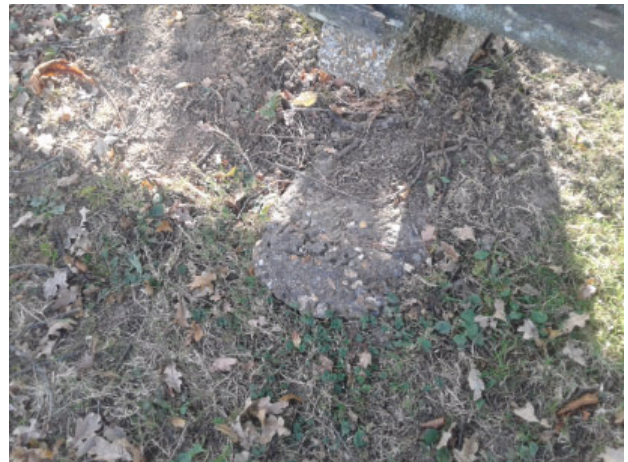
8 - Low Risk (Finding 2)

Finding: The surface has eroded and the foundations are exposed

Action: Reinststate surrounding surfaces to cover the foundations

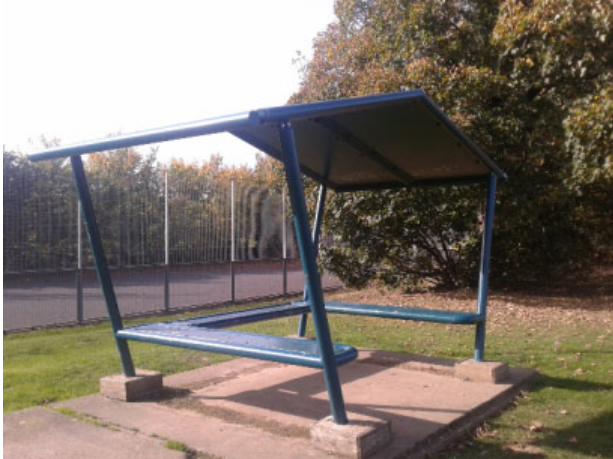
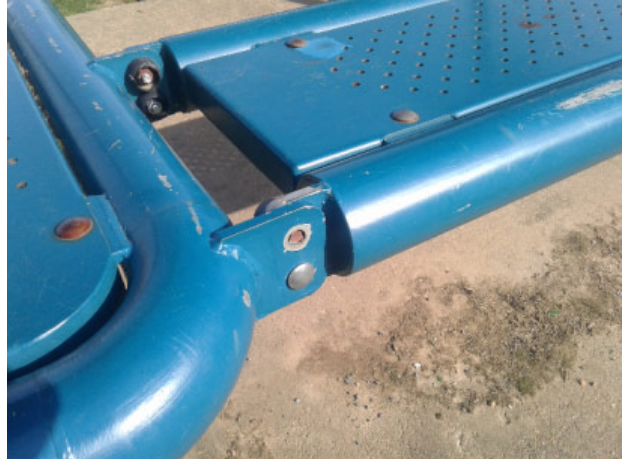
6 - Low Risk (Finding 2)

Finding: There is or are fixings missing on the item

Action: Replace all missing fixings

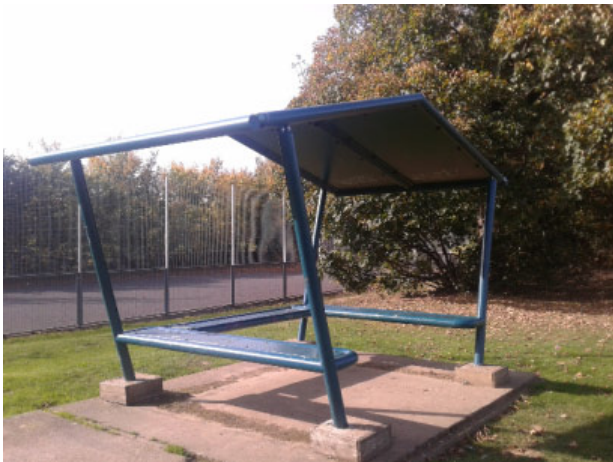
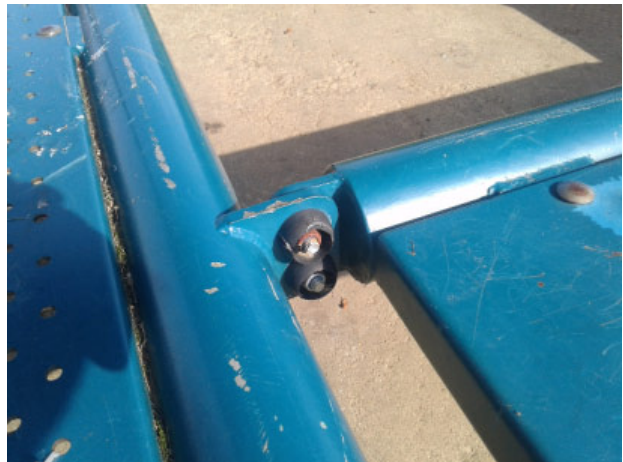
6 - Low Risk (Finding 3)

Finding: There is/are bolt cap covers missing or damaged on the item

Action: Replace missing or damaged bolt cap covers

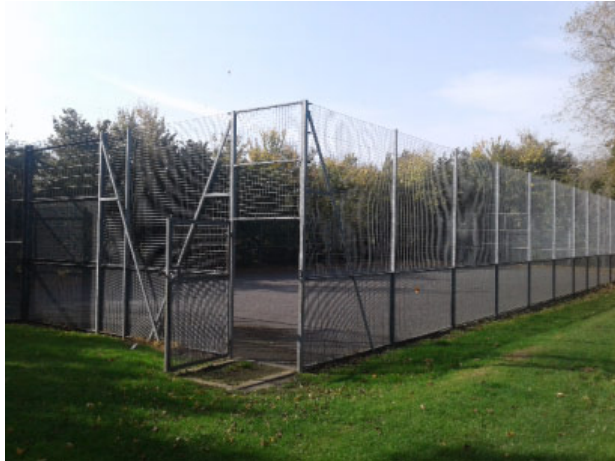
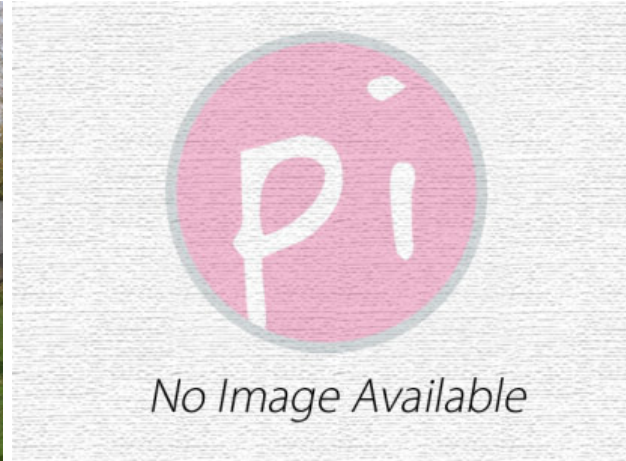
5 - Very Low Risk (Finding 1)

Finding: A clearly visible sign should be provided in a prominent position with the wording as detailed BS EN 15312- the equipment is not intended for children less than 3 years old- the warning Do not climb on the framework or nets- the warning Do not hang on the ring (if provided)- the warning Do not wear rings or other jewellery- name and telephone number of the administrator- number to call in case of accident

Action: Provide signage to BS EN 15312

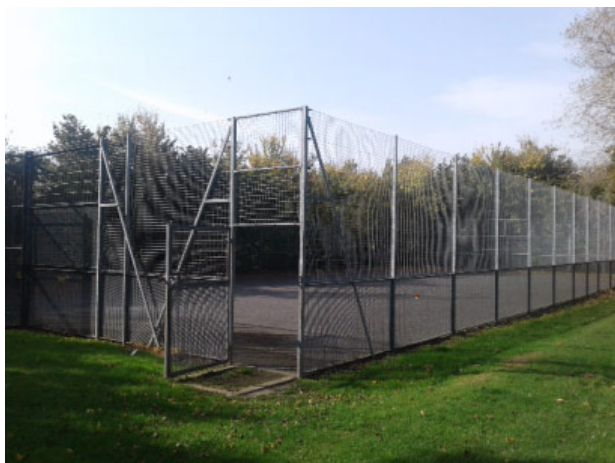
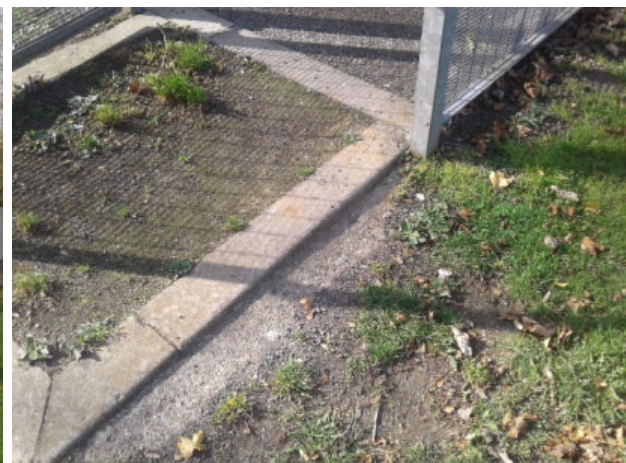
8 - Low Risk (Finding 2)

Finding: There are trip hazards present at the gate entrance

Action: Reinstate surrounding surfaces to level to remove the trip points

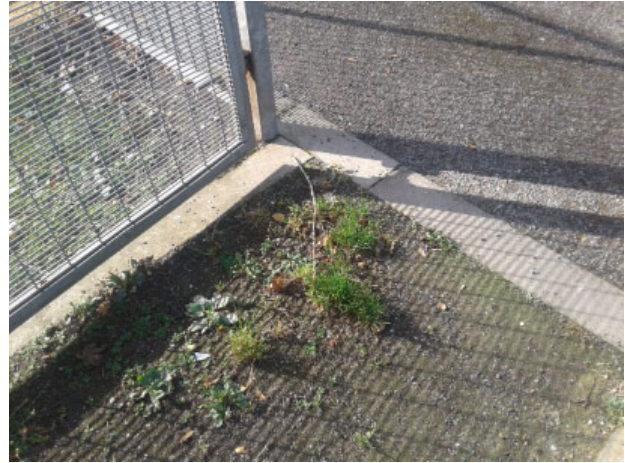
6 - Low Risk (Finding 3)

Finding: There are weeds/vegetation growth between or around the edges of the surfacing

Action: Remove weeds/vegetation growth

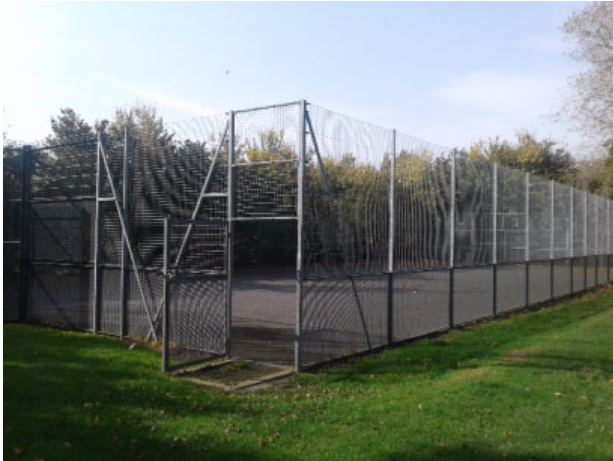
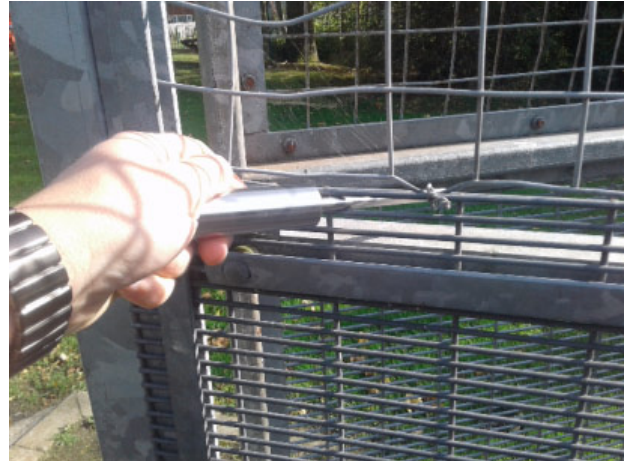
5 - Very Low Risk (Finding 4)

Finding: There is/are finger entrapments in the panels and the item fails to meet the requirements of BS EN 15312 Clause 4.4.2.2 Entrapment of fingers

Action: Monitor use

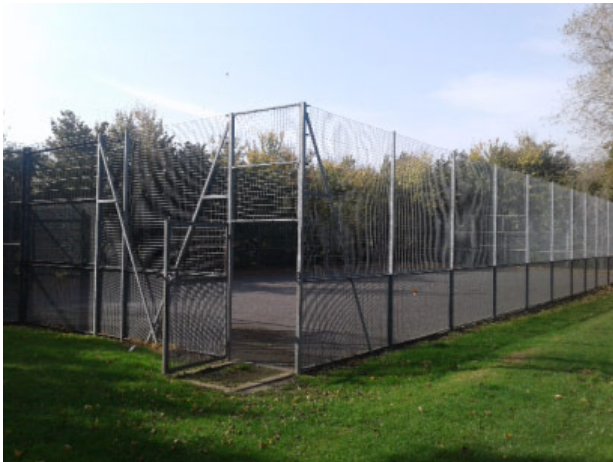
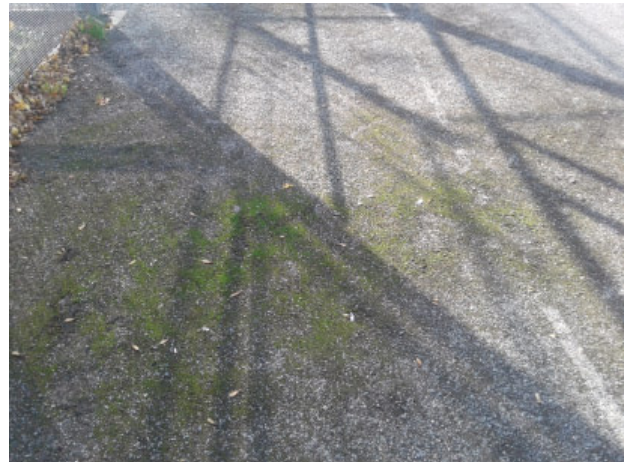
8 - Low Risk (Finding 5)

Finding: There is algae or moss growth on the surface resulting in slippery conditions

Action: Clean and treat appropriately

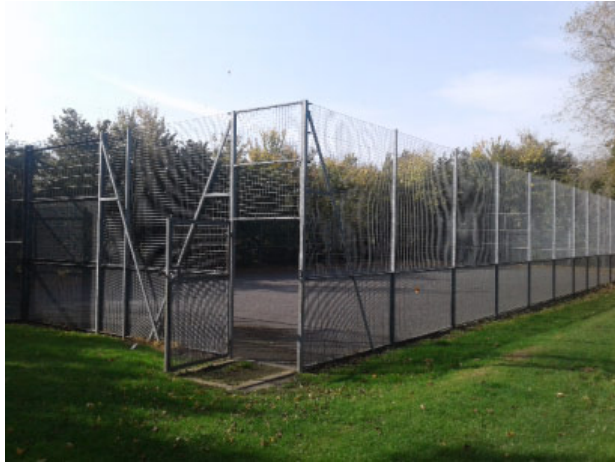
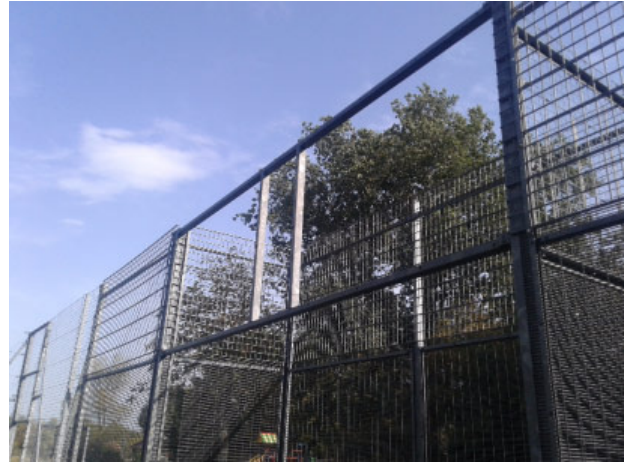
Finding: There are a number of missing panels

Action: Replace

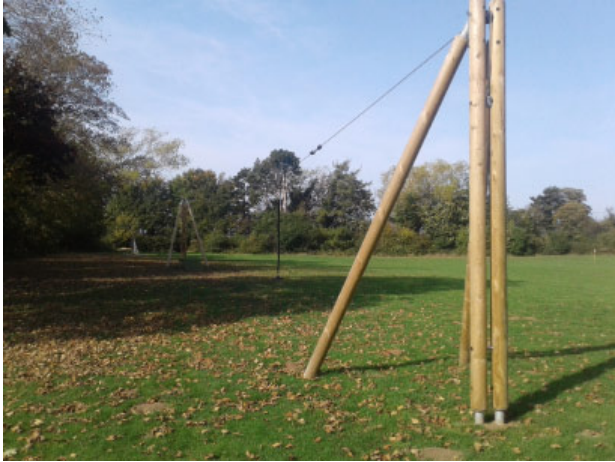
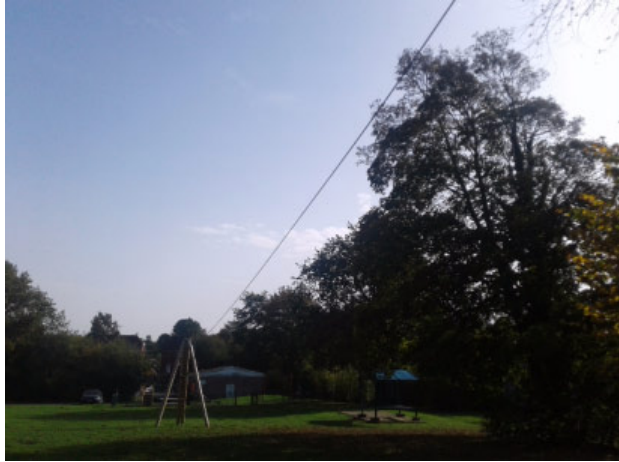
0 - Risk Assessment not Undertaken (Finding 2)

Finding: We recommend that the main cable is thoroughly inspected at least once every 2 years this; will involve either removing the cable or gaining access by ladders and/or steps to inspect for damage or internal rusting, this will help to ensure the continued safe use of the equipment

Action: Inspect cable every 24 months
