the **play inspection** company

Annual Inspection

Adisham Parish Council

Adisham Recreation Ground

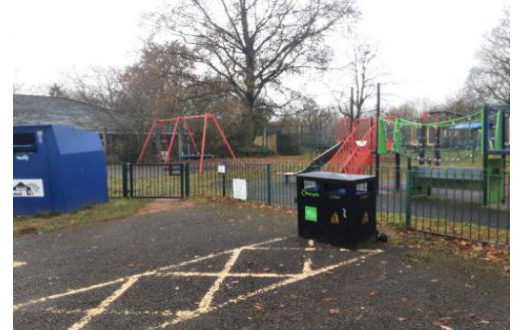
Item: Site General
Manufacturer: Owner/Operator
Surface Type: N/A
Item Quantity: 1
Equipment Compliance: N/A
Surface Area Compliance: N/A

There is weed / vegetation growth on, between, or around the edges of the surfacing - Remove weed / vegetation growth

There are a number of molehills within the area and these may present unforeseen hazards for users - Remove moles by appropriate means, reinstate surfaces to level and maintain the area

It is recommended that Adult Outdoor Fitness equipment is installed a minimum of 25m away from a childrens playground or separated and screened to discourage access by younger children - Monitor use and review risk assessment regularly

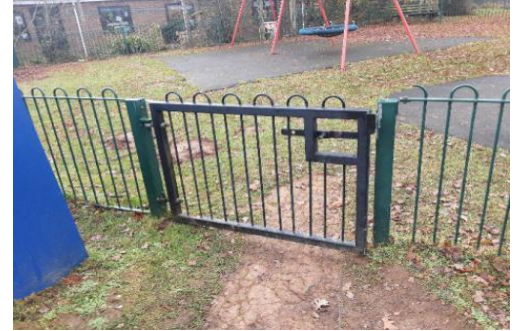
Item: Gate
Manufacturer: Not Identified
Surface Type: Grass
Item Quantity: 1
Equipment Compliance: N/A
Surface Area Compliance: N/A

There is moderate damage to the surface - Repair the damaged areas of surfacing

Cable ties have been used on the item and there are sharp projecting ends - Remove if not required or replace with a more appropriate alternative fixing method if used as a fixing

The rubber buffer is missing from the latch plate - Replace rubber buffer

The gate rebounds when opened quickly and could strike the next user entering the area - Monitor use and adjust/replace as required

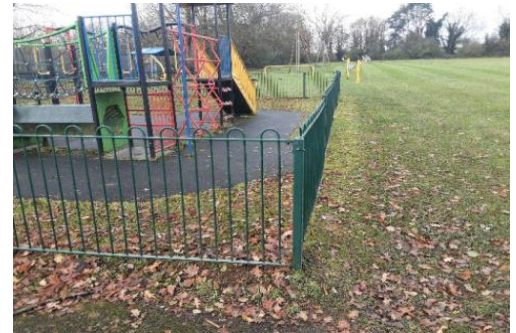
Item: Fence - Bow Top
Manufacturer: Not Identified
Surface Type: Grass
Item Quantity: 1
Equipment Compliance: N/A
Surface Area Compliance: N/A

A number of fixings have worked loose around the fencing - Secure all loose fixings

Cable ties have been used on the item and there are sharp projecting ends - Remove if not required or replace with a more appropriate alternative fixing method if used as a fixing

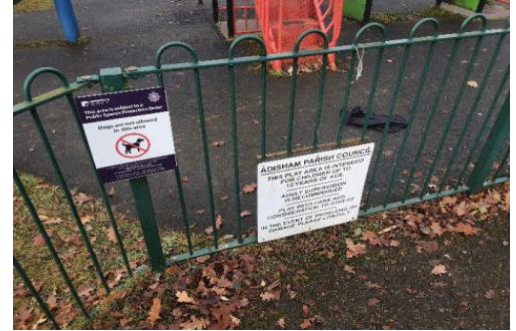
Item: Sign
Manufacturer: Not Identified
Surface Type: N/A
Item Quantity: 1
Equipment Compliance: N/A
Surface Area Compliance: N/A

There are projecting bolt thread(s) present - Remove excess thread length and deburr or provide cap

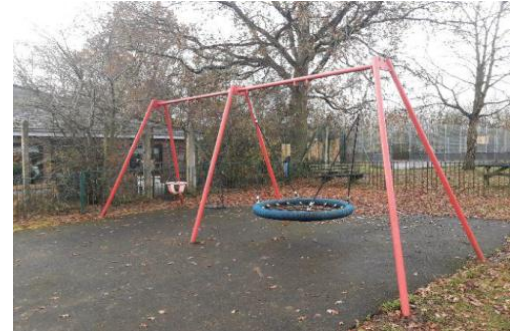
Item: 2 Bay Swing
Manufacturer: Not Identified
Surface Type: Wet Pour
Item Quantity: 1
Equipment Compliance: No
Surface Area Compliance: Yes

The crossbar lugs are worn in excess of 90% which has worn the bushes and shackles on the basket seat suspension, client informed - Remove the basket seat and replace the crossbar and connections

The basket swing has been installed into incorrect frame design and is wearing the connecting points excessively - Remove the basket seat and replace with compatible seats once all required repairs are completed

The seat clearance from finished surface level to the underside of the seat is too low and does not meet the requirements of BS EN 1176 Part 2 (350mm minimum clearance required) - Adjust seat height/s (400mm-500mm is recommended)

The seats are too close to the frame as defined in BS EN 1176 Part 2; this is a low risk failure and no remedial action is required - Monitor - No remedial work recommended

The chain openings are in excess of the 8.6mm as recommended by BS EN 1176 - Monitor - No remedial work recommended

There is some notable evidence of chain wear - Monitor for any further deterioration and replace when 40% worn

The seat has minor damage or wear - Monitor for any further deterioration and replace as required

The safety surface around the area is beginning to wear - Monitor for any further deterioration and repair as required

The surface is lifting at the edges and creating trip points - Repair perimeter of surfacing to remove trip points

The surface has eroded and the foundations are exposed - Reinstate surrounding surfaces to cover the foundations

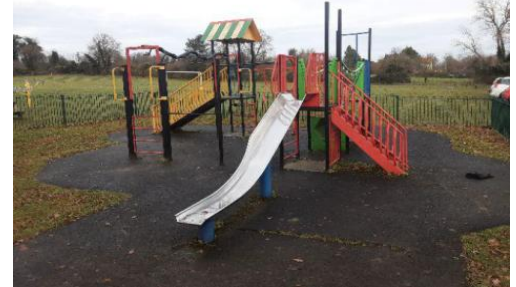
Item: Multi Play (Junior)
Manufacturer: Not Identified
Surface Type: Wet Pour
Item Quantity: 1
Equipment Compliance: No
Surface Area Compliance: Yes

<p>Finding 1 There is moderate damage to the surface - Repair the damaged areas of surfacing</p>	<p>Finding 2 There are a number of dents in the slide surface - Monitor for any further deterioration and repair as required</p>
<p>Finding 3 This item has no slide bar fitted as required by BS EN 1176 Part 3 - Monitor - No remedial work recommended</p>	<p>Finding 4 Parts of the steel on this item have corroded excessively and the metal has perforated in places - Ensure all affected areas are treated and repaired</p>
<p>Finding 5 The paintwork on this item has been damaged or worn exposing the metal underneath which is rusting / corroding - Treat affected areas and repaint</p>	<p>Finding 6 There is / are toggle entrapment/s present in contravention of the recommendations set out in BS EN 1176 Part 3 - Monitor - no remedial work recommended</p>
<p>Finding 7 There is/are inserts missing - Replace missing inserts</p>	<p>Finding 8 The tube(s) on this item have corroded from the inside and split the steel - Replace all affected parts</p>

<p>Finding 9 The unit is easily accessible and has an opening in the barrier to steep play elements in excess of 500mm in contravention of BS EN 1176 Part 1 - Monitor - No remedial work recommended</p>	<p>Finding 10 There is some damage to the item - Monitor for any further deterioration and repair as required</p>
<p>Finding 11 The item fails to meet the requirements of BS EN 1176 Part 1 4.2.7.2 head and neck entrapment in the barriers and/or steps - Monitor - No remedial work recommended</p>	<p>Finding 12 The fixings have corroded excessively - Replace all corroded fixings</p>
<p>Finding 13 There are areas or parts of the timber on the ramp treads that have rotted - Replace all affected timbers</p>	<p>Finding 14 There is some evidence of fire damage to the item - Monitor for any further deterioration and repair as required</p>

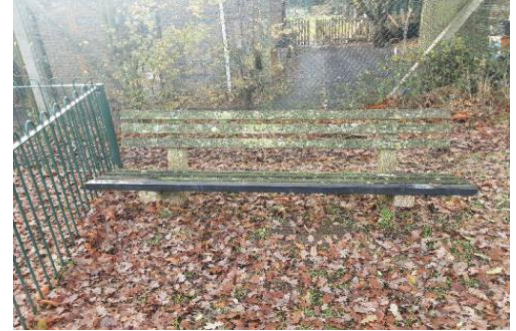
Item: Bench
Manufacturer: Not Identified
Surface Type: Grass
Item Quantity: 1
Equipment Compliance: N/A
Surface Area Compliance: N/A

There is some evidence of rot in the timber - Monitor for any
further deterioration and replace as required

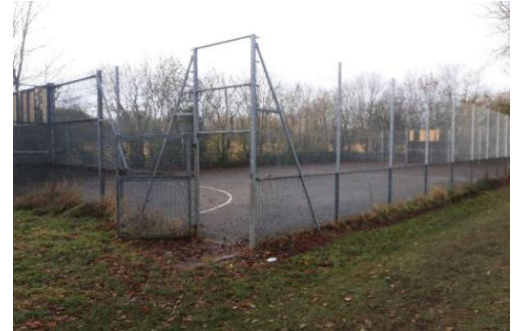
Item: Multi Use Games Area (MUGA)
Manufacturer: Not Identified
Surface Type: Bitmac
Item Quantity: 1
Equipment Compliance: No
Surface Area Compliance: N/A

A clearly visible facility sign should be provided in a prominent position with the wording as detailed BS EN 15312- the equipment is not intended for children less than 3 years old- the warning - Do not climb on the framework or nets- the warning - Do not hang on the ring (if provided)- the warning - Do not wear rings or other jewellery- name and telephone number of the administrator- number to call in case of accident - Provide signage to BS EN 15312

The fence is severely damaged in places - Repair or replace all affected sections

There is/are finger entrapments in the panels and the item fails to meet the requirements of BS EN 15312 Clause 4.4.2.2 Entrapment of fingers - Monitor - No remedial work recommended

There is or are fixings missing on the item - Replace all missing fixings

There are areas or parts of the timber on the structure that have rotted - Replace all affected timbers

The free space between the backboard and the framework is less than 600mm and fails the requirements of BS EN15312:2007 +A1 2010 - Monitor - No remedial work recommended

A number of panels are missing above the goal - Replace

There are trip hazards at the edges of the surface - Reinstate surrounding surface levels to remove the trip points

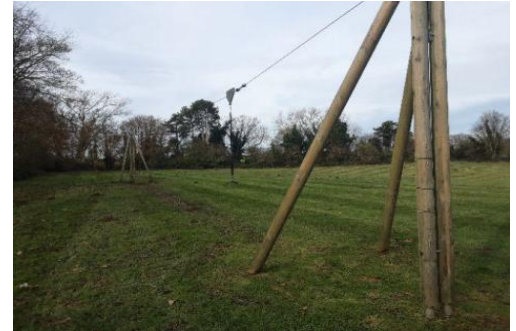
Item: Cable Runway
Manufacturer: Playdale Playgrounds Ltd
Surface Type: Grass Matrix Tiles
Item Quantity: 1
Equipment Compliance: Yes
Surface Area Compliance: Yes

There is some strimmer / machinery damage apparent on the posts, this can penetrate the preservative applied to the timber and accelerate the rotting process - Monitor for any deterioration (rot) and replace as required

Cable ties have been used on the item and there are sharp projecting ends - Remove if not required or replace with a more appropriate alternative fixing method if used as a fixing

We have completed a visual inspection of the suspension links, cable and fixing points from ground level, however it is not possible to fully inspect these areas without either hiring equipment to gain access or removing the cable and suspension and inspecting at ground level. We recommend that the main cable and fixing security is thoroughly inspected at least in accordance with the manufacturers recommendations to check for wear, damage, security or internal rusting; this will help to ensure the continued safe use of the equipment - Inspect in accordance with the manufacturers recommendations

The cableway seat has been damaged - Monitor for any further deterioration and replace as required

There is some notable evidence of chain wear - Monitor for any further deterioration and replace when 40% worn

There is some evidence of fire damage to the item - Monitor for any further deterioration and repair as required

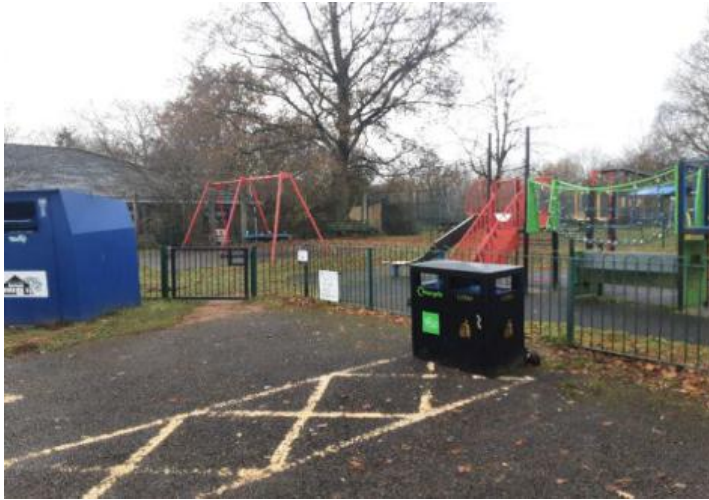
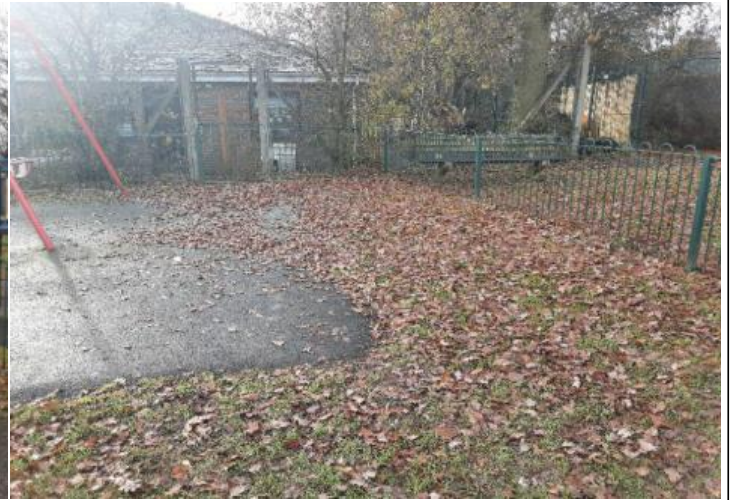
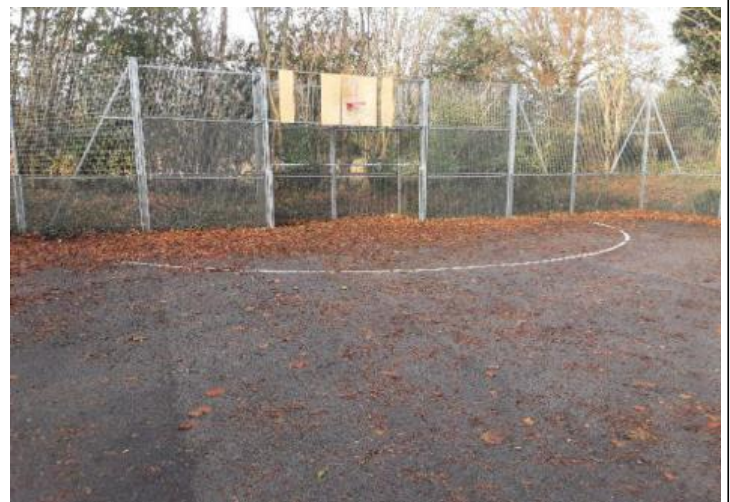
Item: Ancillary Items - Site General
Manufacturer: Owner/Operator

Finding: There is some tree debris on the surfacing

Action: Remove and maintain

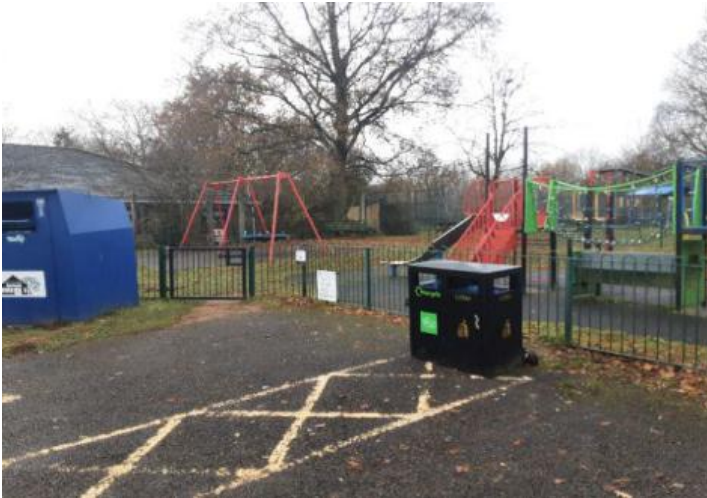
Item: Ancillary Items - Site General
Manufacturer: Owner/Operator

Finding: There are a number of molehills within the area and these may present unforeseen hazards for users

Action: Remove moles by appropriate means, reinstate surfaces to level and maintain the area

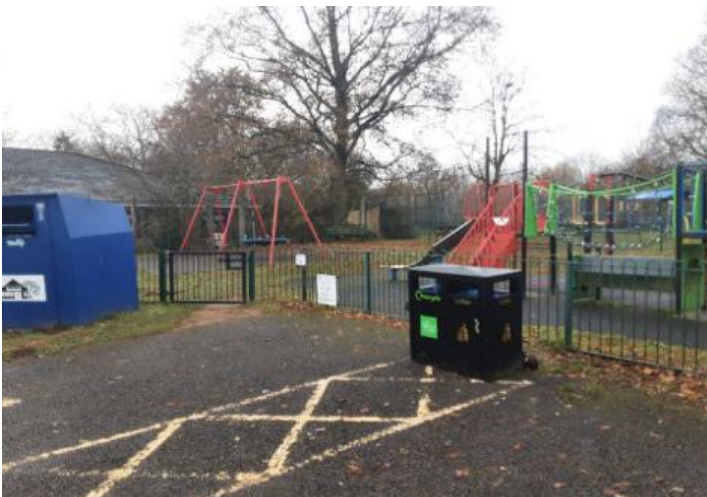
Item: Ancillary Items - Site General
Manufacturer: Owner/Operator

Finding: It is recommended that Adult Outdoor Fitness equipment is installed a minimum of 25m away from a childrens playground or separated and screened to discourage access by younger children

Action: Monitor use and review risk assessment regularly

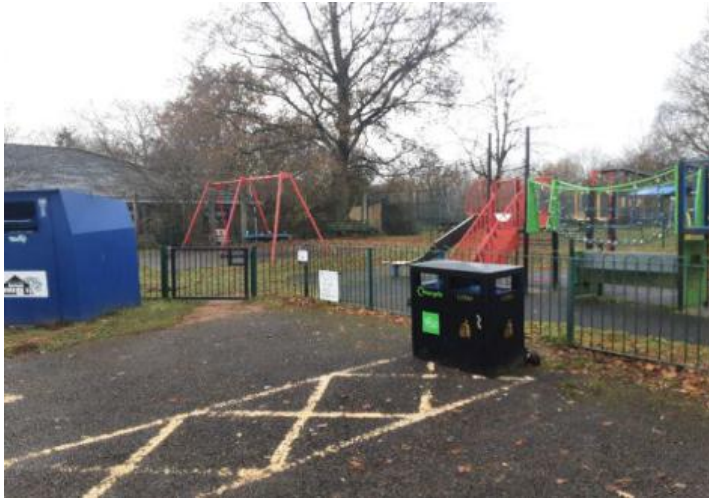
Item: Ancillary Items - Site General
Manufacturer: Owner/Operator

Finding: Signage should be provided for the outdoor fitness equipment in accordance with the requirements of BS EN 16630, key requirements of the sign include, but are not limited to, intended users, medical safety and emergency contact details
Action: Provide appropriate signage

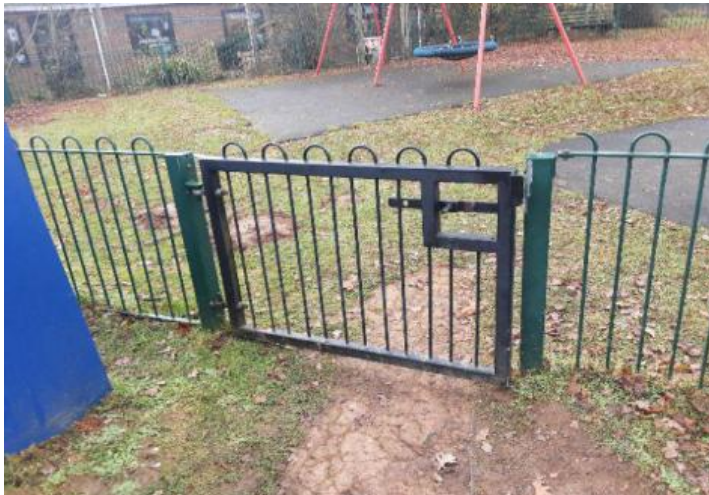
Item: Gates - Gate
Manufacturer: Not Identified

Finding: There is moderate damage to the surface
Action: Repair the damaged areas of surfacing

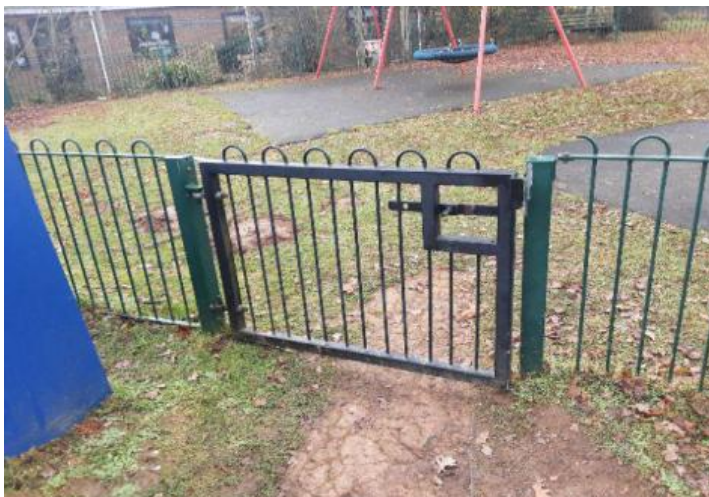
Item: Gates - Gate
Manufacturer: Not Identified

Finding: The rubber buffer is missing from the latch plate

Action: Replace rubber buffer

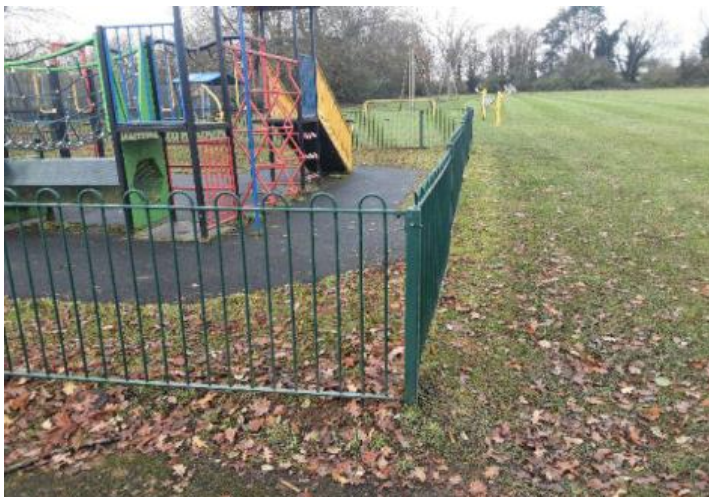
Item: Fences - Fence - Bow Top
Manufacturer: Not Identified

Finding: A number of fixings have worked loose around the fencing
Action: Secure all loose fixings

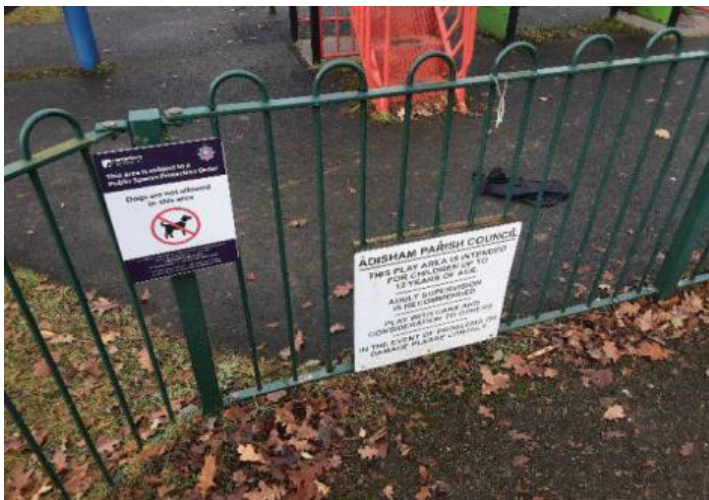
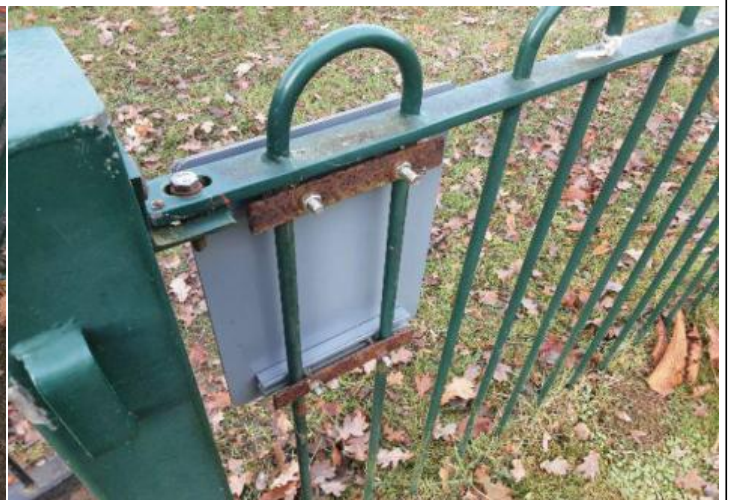
Item: Ancillary Items - Sign
Manufacturer: Not Identified

Finding: There are projecting bolt thread(s) present

Action: Remove excess thread length and deburr or provide cap

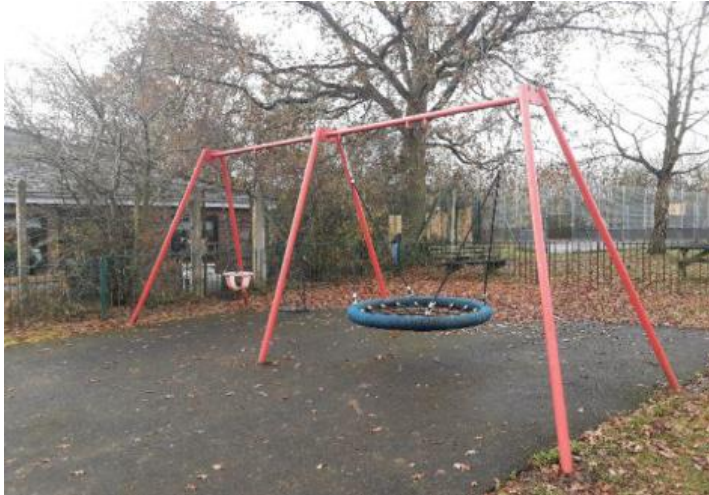
Item: Swings - 2 Bay Swing
Manufacturer: Not Identified

Finding: The basket swing has been installed into incorrect frame design and is wearing the connecting points excessively

Action: Remove the basket seat and replace with compatible seats once all required repairs are completed

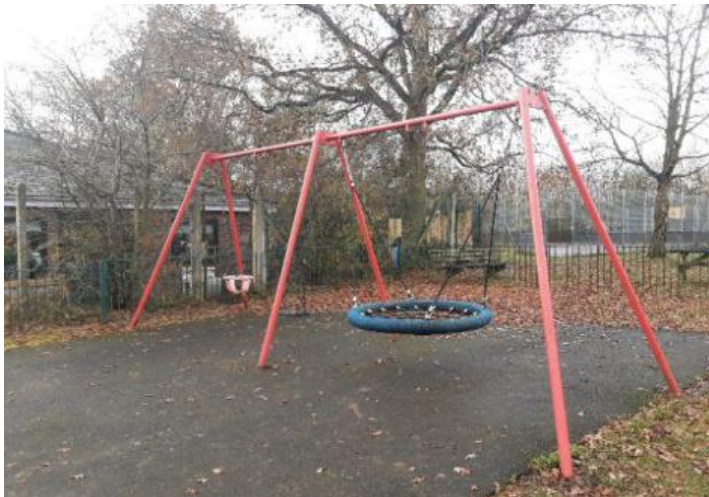
Item: Swings - 2 Bay Swing
Manufacturer: Not Identified

Finding: The seat clearance from finished surface level to the underside of the seat is too low and does not meet the requirements of BS EN 1176 Part 2 (350mm minimum clearance required)

Action: Adjust seat height/s (400mm-500mm is recommended)

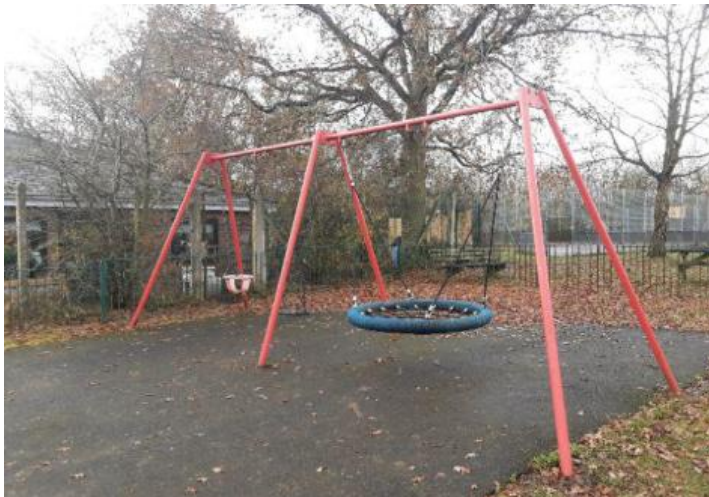
Item: Swings - 2 Bay Swing
Manufacturer: Not Identified

Finding: The chain openings are in excess of the 8.6mm as recommended by BS EN 1176

Action: Monitor - No remedial work recommended

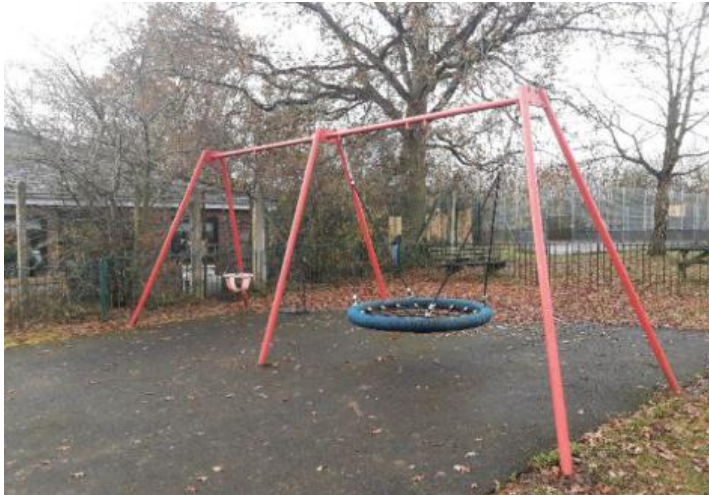
Item: Swings - 2 Bay Swing
Manufacturer: Not Identified

Finding: There is some notable evidence of chain wear

Action: Monitor for any further deterioration and replace when 40% worn

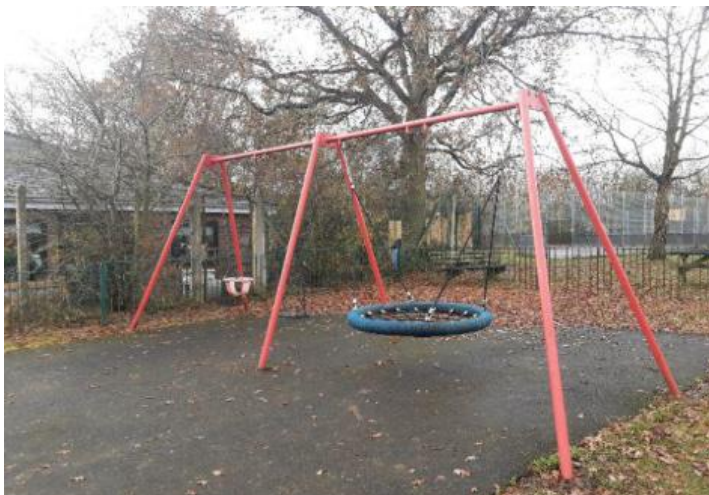
Item: Swings - 2 Bay Swing
Manufacturer: Not Identified

Finding: The seat has minor damage or wear

Action: Monitor for any further deterioration and replace as required

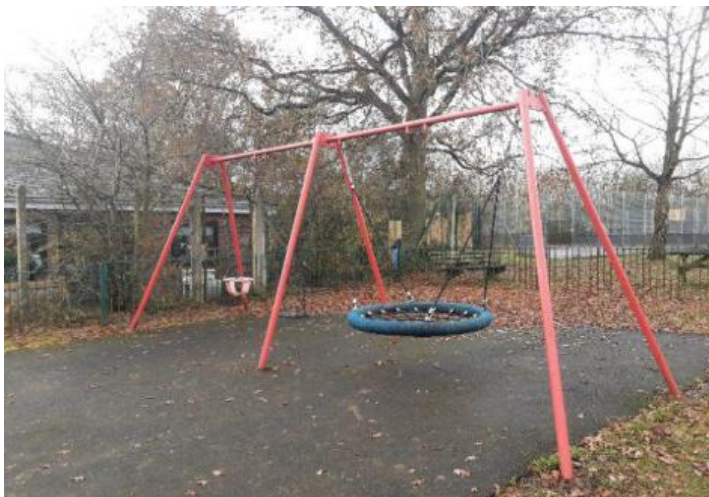
Item: Swings - 2 Bay Swing
Manufacturer: Not Identified

Finding: The surface is lifting at the edges and creating trip points

Action: Repair perimeter of surfacing to remove trip points

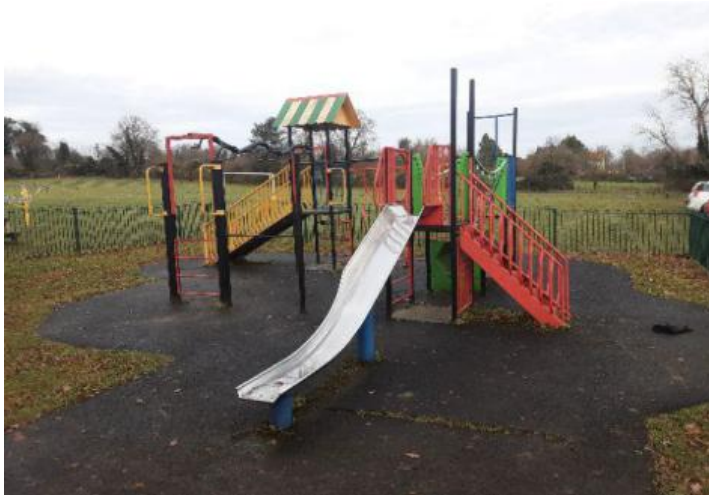
Item: Activity Equipment - Multi Play (Junior)
Manufacturer: Not Identified

Finding: There is moderate damage to the surface

Action: Repair the damaged areas of surfacing

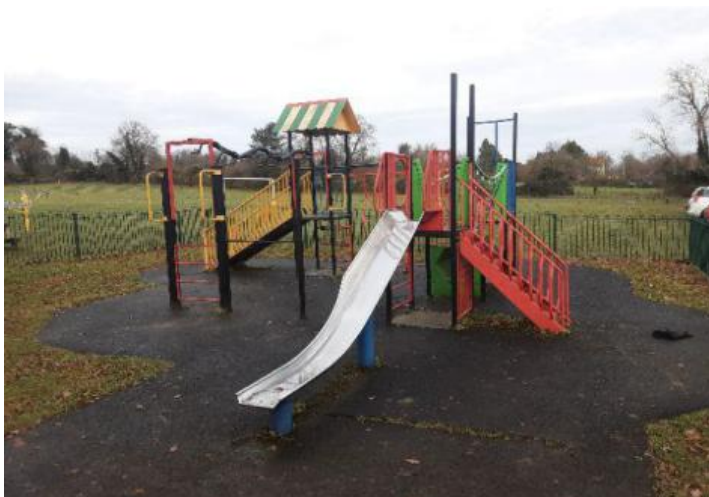
Item: Activity Equipment - Multi Play (Junior)
Manufacturer: Not Identified

Finding: This item has no slide bar fitted as required by BS EN 1176 Part 3

Action: Monitor - No remedial work recommended

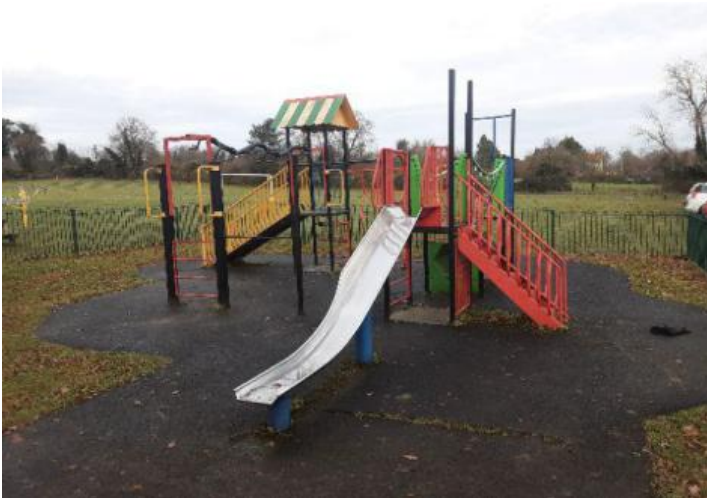
Item: Activity Equipment - Multi Play (Junior)
Manufacturer: Not Identified

Finding: Parts of the steel on this item have corroded excessively and the metal has perforated in places

Action: Ensure all affected areas are treated and repaired

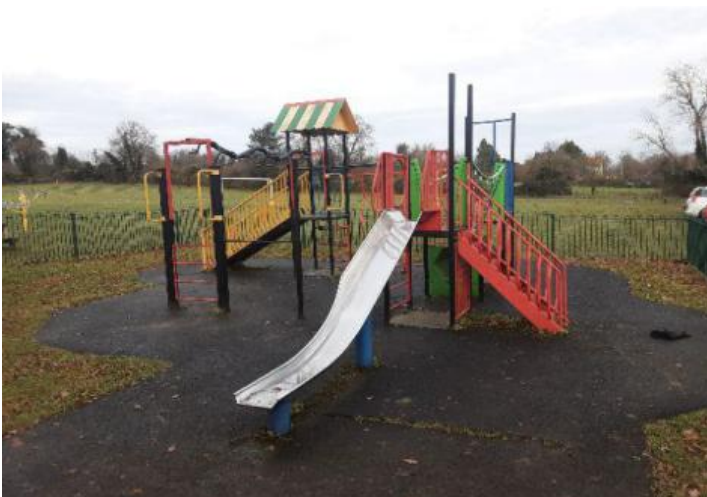
Finding: The paintwork on this item has been damaged or worn exposing the metal underneath which is rusting / corroding

Action: Treat affected areas and repaint

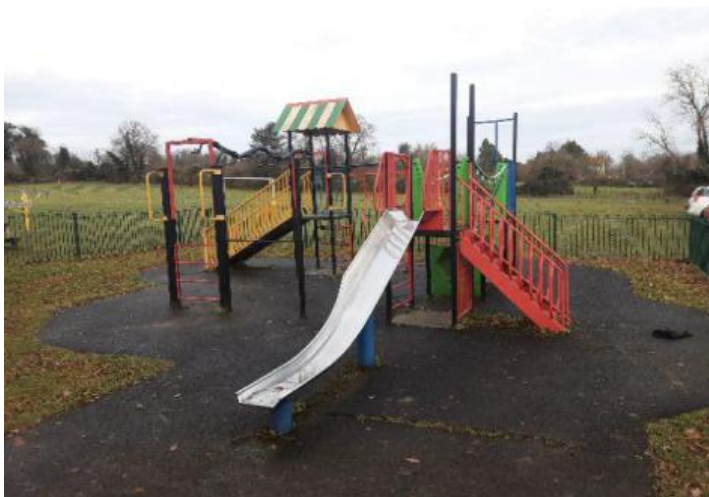
Finding: There is/are inserts missing

Action: Replace missing inserts

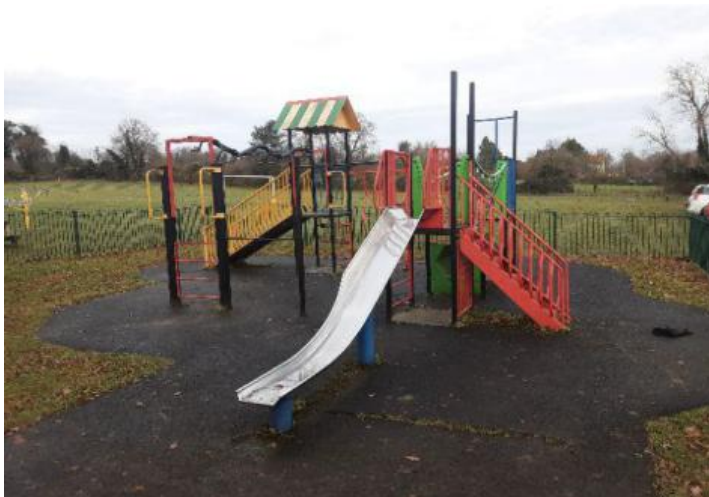
Finding: There is some damage to the item

Action: Monitor for any further deterioration and repair as required

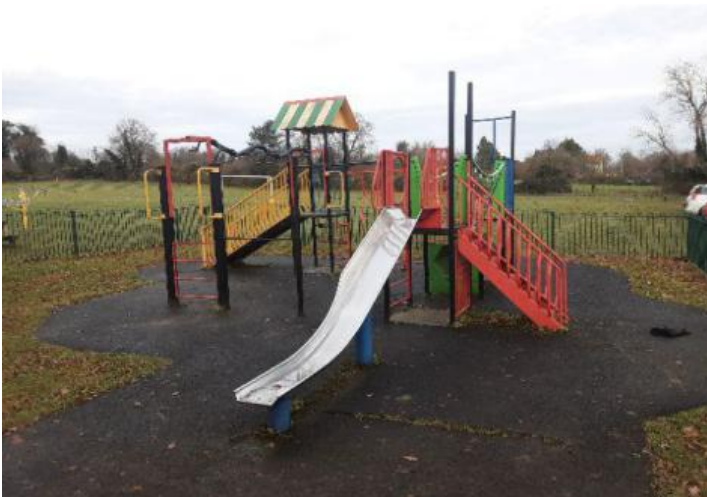
Finding: The fixings have corroded excessively

Action: Replace all corroded fixings

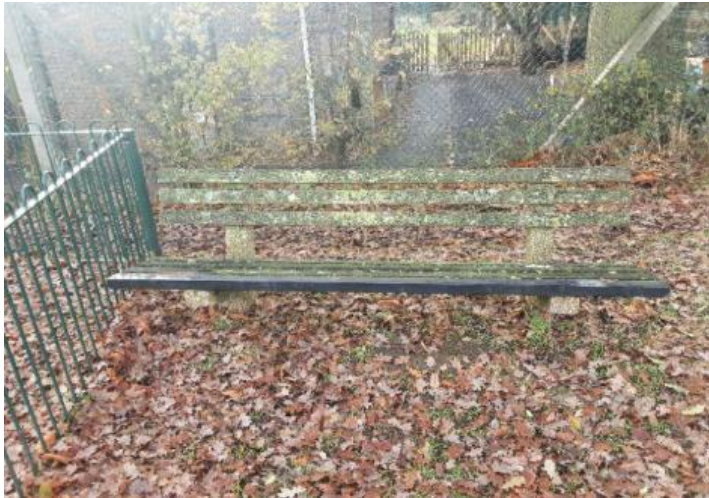
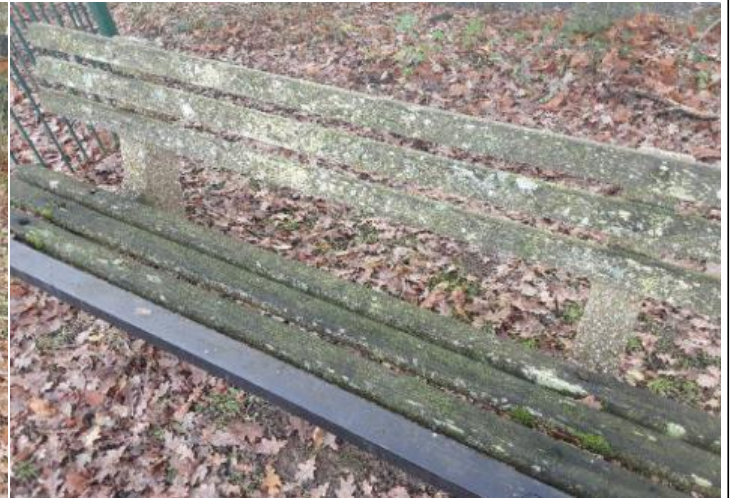
Finding: There is algae or moss on the surface of the equipment

Action: Clean and treat appropriately

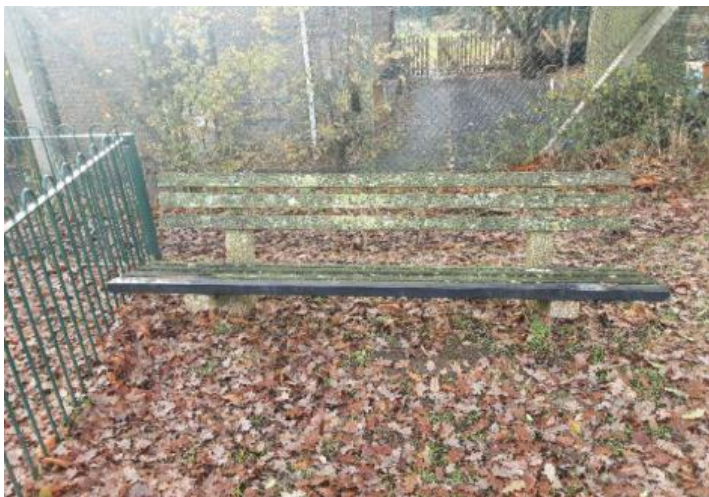
Finding: There is some evidence of rot in the timber

Action: Monitor for any further deterioration and replace as required

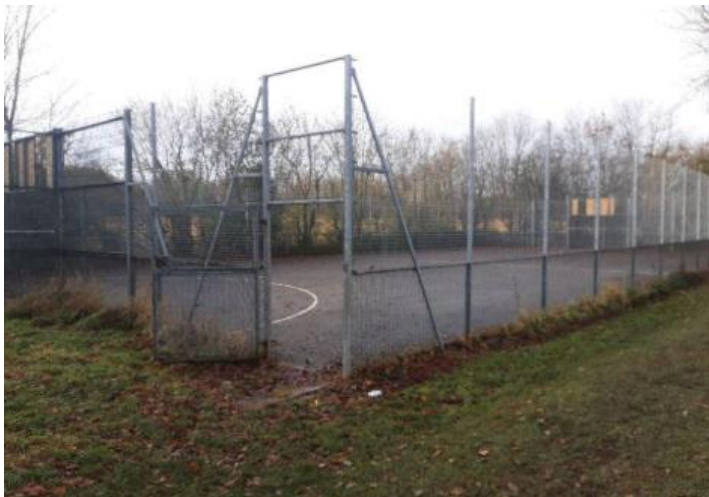
Finding: There is or are fixings missing on the item

Action: Replace all missing fixings

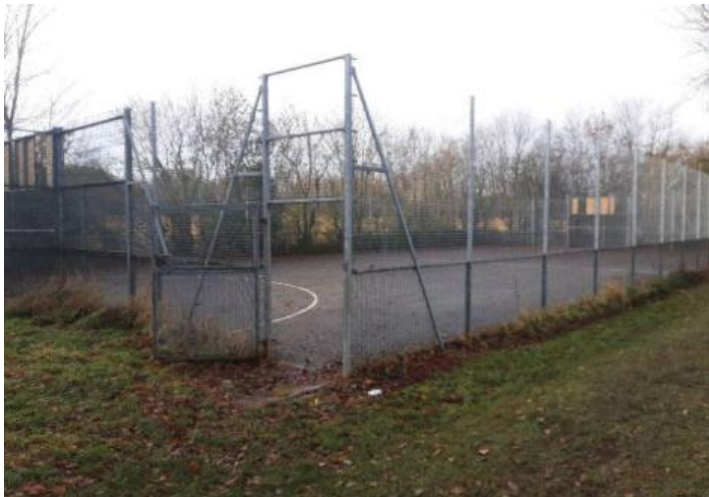
Finding: The free space between the backboard and the framework is less than 600mm and fails the requirements of BS EN15312:2007 +A1 2010

Action: Monitor - No remedial work recommended

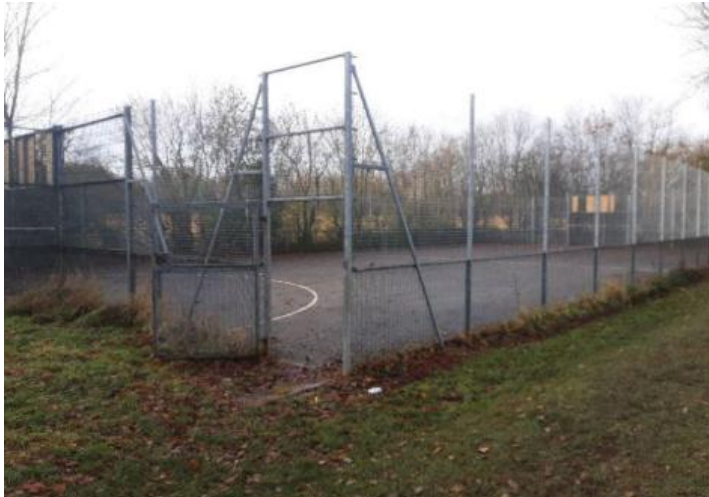
i 8 - Low Risk (Finding 7)

Finding: A number of panels are missing above the goal **Action:** Replace

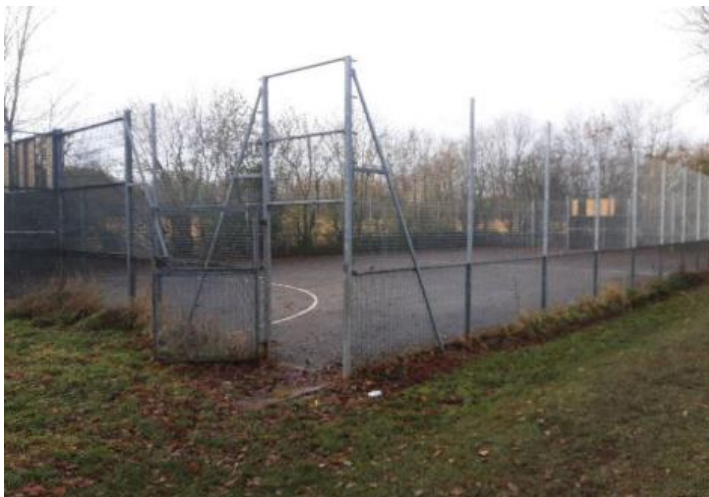
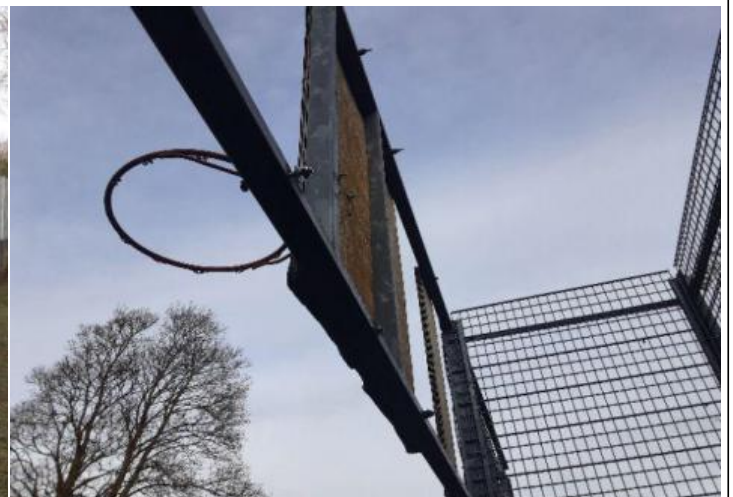
i 6 - Low Risk (Finding 8)

Finding: There are projecting bolt thread(s) present **Action:** Remove excess thread length and deburr or provide cap

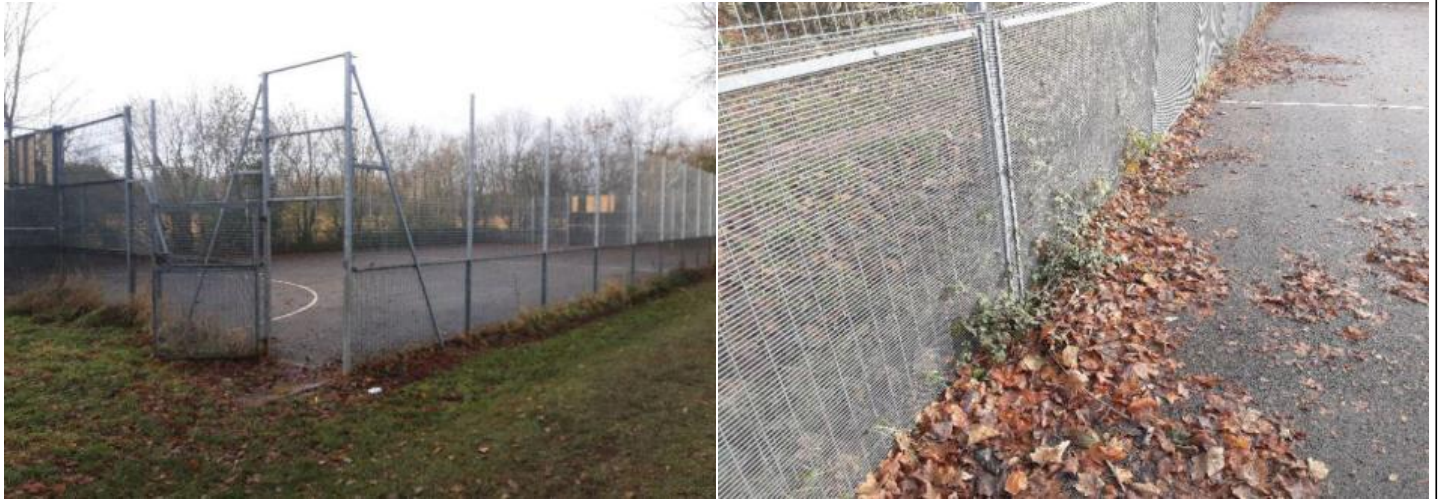
i 6 - Low Risk (Finding 9)

Finding: The adjacent foliage is overhanging

Action: Cut back and maintain

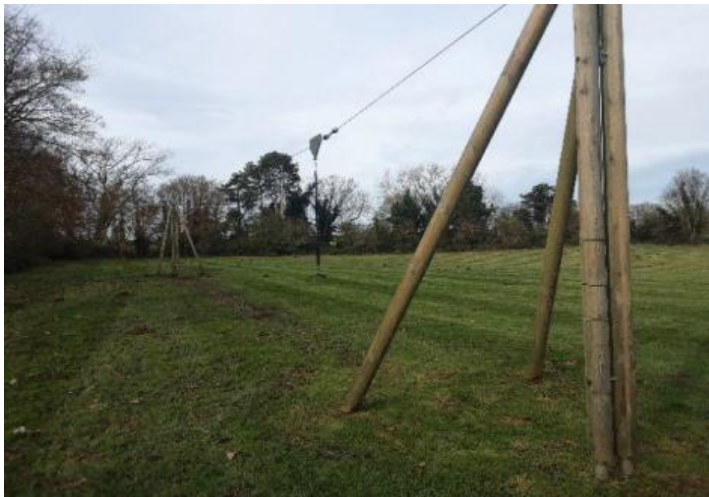
Finding: Cable ties have been used on the item and there are sharp projecting ends

Action: Remove if not required or replace with a more appropriate alternative fixing method if used as a fixing

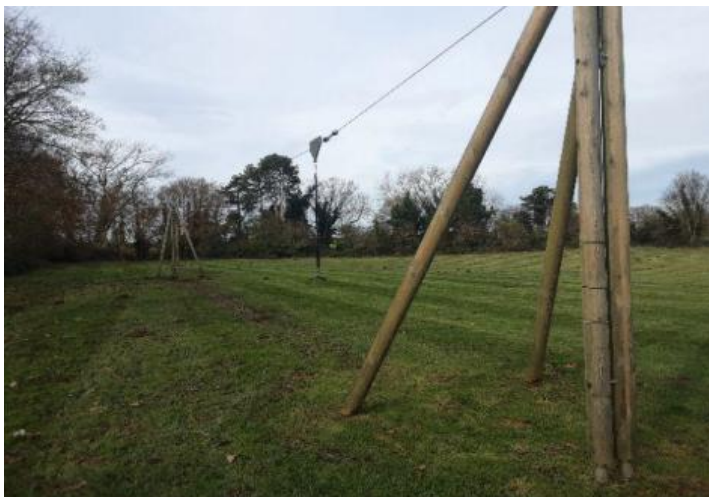
Finding: There is some notable evidence of chain wear

Action: Monitor for any further deterioration and replace when 40% worn

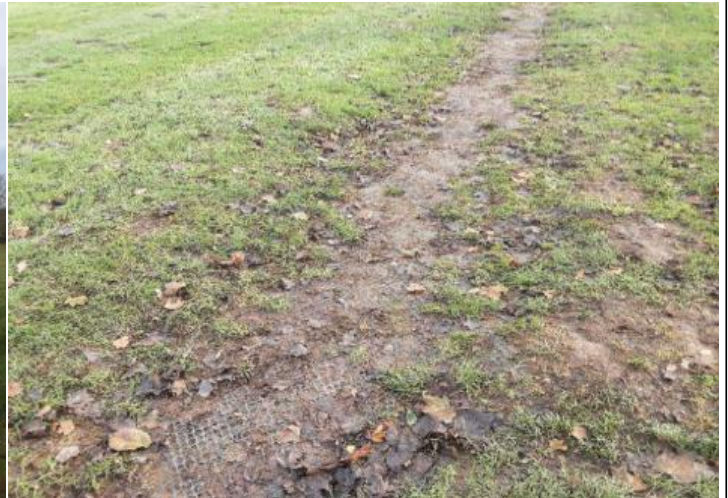
Finding: The grass mats are silted up and the soil is compacted; this may have an effect on the impact absorbing properties of the surface. Consideration should be given to HIC testing the surface to verify impact attenuating properties (<https://playinspections.co.uk/inspection-services/safety-surface-testing/>)

Action: Contact our office for a quotation for this service

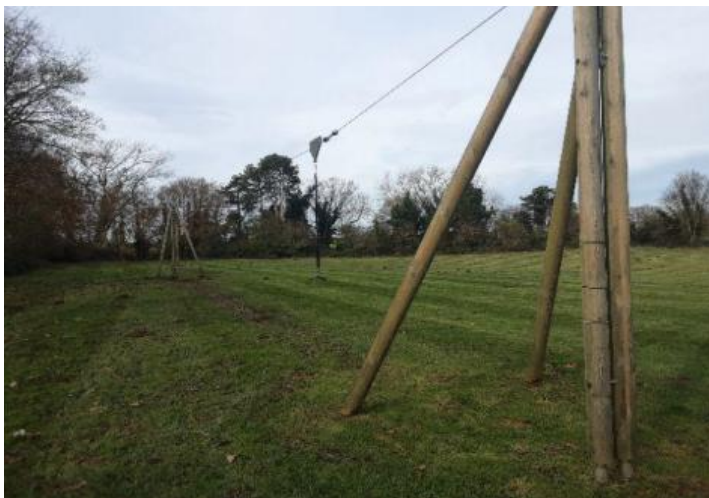
Finding: There is some evidence of fire damage to the item

Action: Monitor for any further deterioration and repair as required

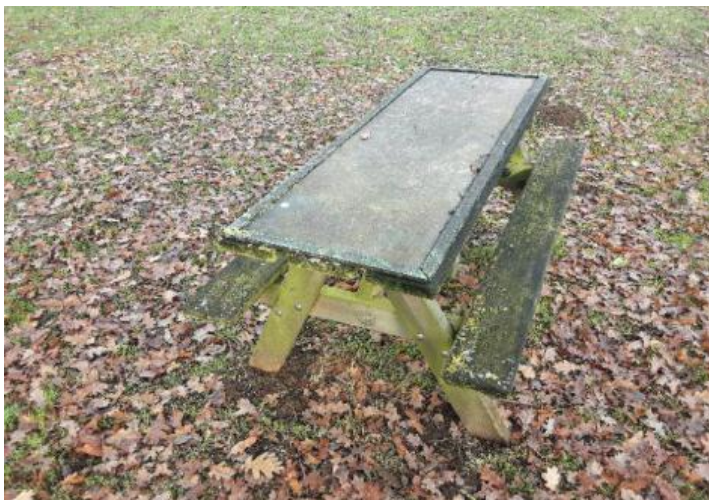
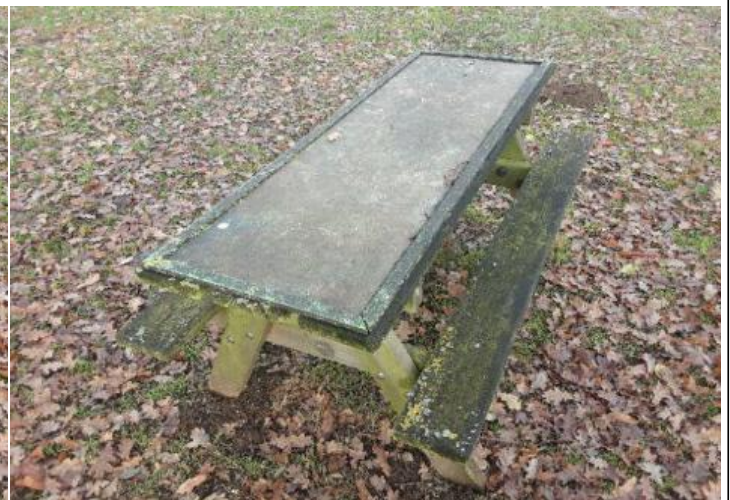
Finding: There is algae or moss on the surface of the equipment

Action: Clean and treat appropriately

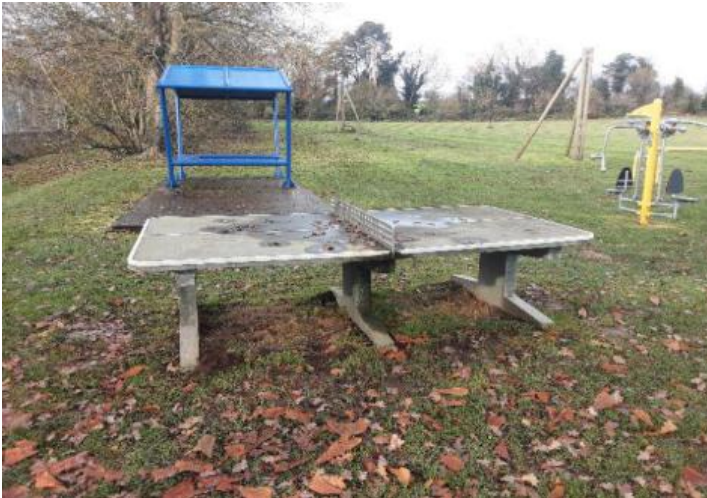
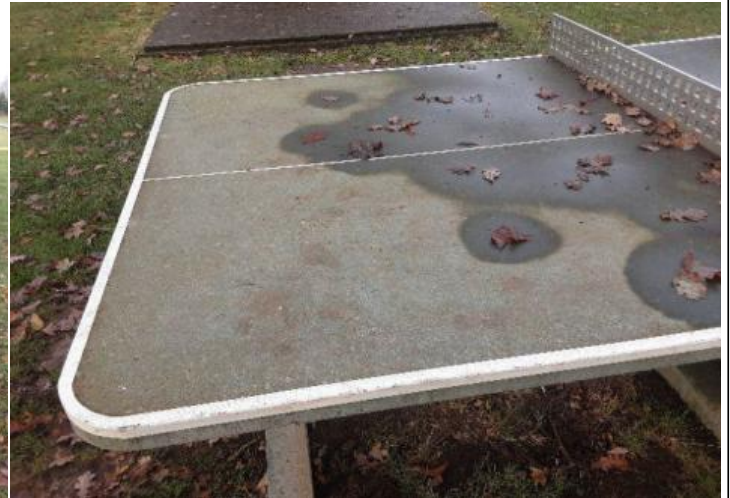
Finding: There is algae or moss on the surface of the equipment

Action: Clean and treat appropriately
