the **play inspection** company

Annual Inspection

Adisham Parish Council

Adisham Recreation Ground

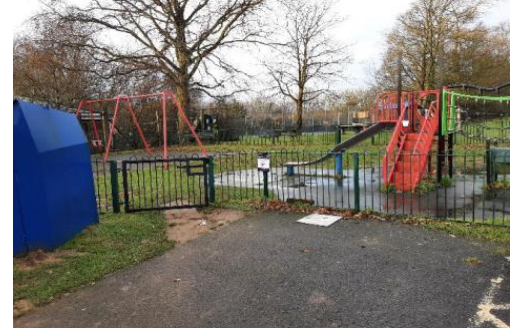
Item: Site General
Manufacturer: Owner/Operator
Surface Type: N/A
Item Quantity: 1
Equipment Compliance: N/A
Surface Area Compliance: N/A

There is algae, silt or moss growth on the surface resulting in slippery conditions - Clean and treat appropriately

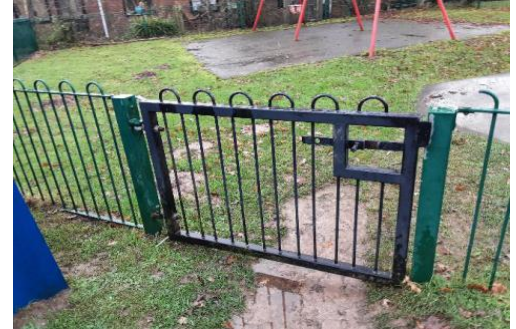
Item: Gate
Manufacturer: Not Identified
Surface Type: Grass
Item Quantity: 1
Equipment Compliance: N/A
Surface Area Compliance: N/A

The area under the gate has eroded leaving uneven areas, or the concrete foundations exposed, resulting in trip hazards at the entrance/exit to the playground - Reinststate to level with surrounding surfaces

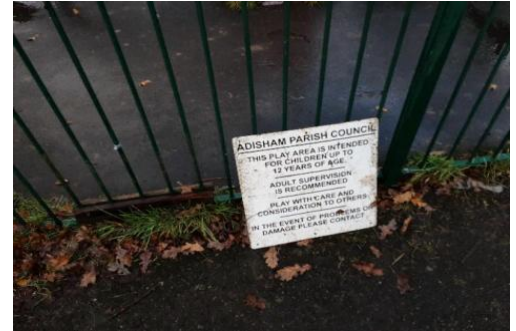
Item: Sign
Manufacturer: Not Identified
Surface Type: N/A
Item Quantity: 1
Equipment Compliance: N/A
Surface Area Compliance: N/A

The sign has detached - Secure the signage

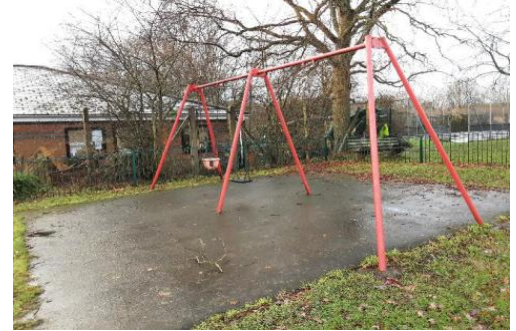
Item: 2 Bay Swing
Manufacturer: Not Identified
Surface Type: Wet Pour
Item Quantity: 1
Equipment Compliance: No
Surface Area Compliance: Yes

The surface has eroded and the foundations are exposed - Reinstate surrounding surfaces to cover the foundations

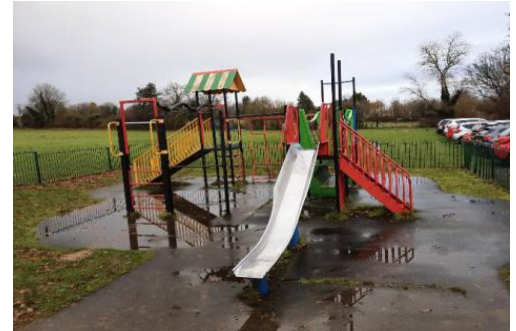
Item: Multi Play (Junior)
Manufacturer: Not Identified
Surface Type: Wet Pour
Item Quantity: 1
Equipment Compliance: No
Surface Area Compliance: Yes

There is moderate damage to the surface - Repair the damaged areas of surfacing

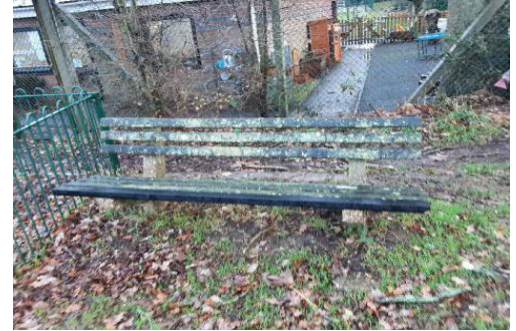
Item: Bench
Manufacturer: Not Identified
Surface Type: Grass
Item Quantity: 1
Equipment Compliance: N/A
Surface Area Compliance: N/A

There is some evidence of rot in the timber - Monitor for any further deterioration and replace as required

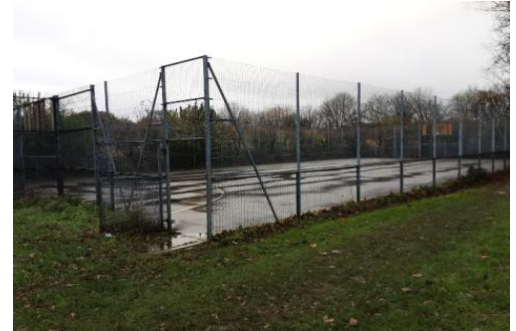
Item: Multi Use Games Area (MUGA)
Manufacturer: Not Identified
Surface Type: Bitmac
Item Quantity: 1
Equipment Compliance: No
Surface Area Compliance: N/A

A clearly visible facility sign should be provided in a prominent position with the wording as detailed BS EN 15312- the equipment is not intended for children less than 3 years old- the warning - Do not climb on the framework or nets- the warning - Do not hang on the ring (if provided)- the warning - Do not wear rings or other jewellery- name and telephone number of the administrator- number to call in case of accident - Provide signage to BS EN 15312

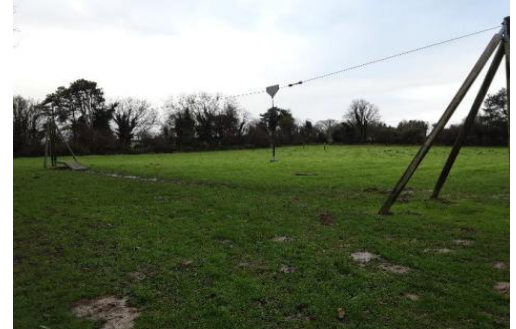
Item: Cable Runway
Manufacturer: Playdale Playgrounds Ltd
Surface Type: Grass Matrix Tiles
Item Quantity: 1
Equipment Compliance: Yes
Surface Area Compliance: Yes

We have completed a visual inspection of the suspension links, cable and fixing points from ground level, however it is not possible to fully inspect these areas without either hiring equipment to gain access or removing the cable and suspension and inspecting at ground level. We recommend that the main cable and fixing security is thoroughly inspected at least in accordance with the manufacturers recommendations to check for wear, damage, security or internal rusting; this will help to ensure the continued safe use of the equipment - Inspect in accordance with the manufacturers recommendations

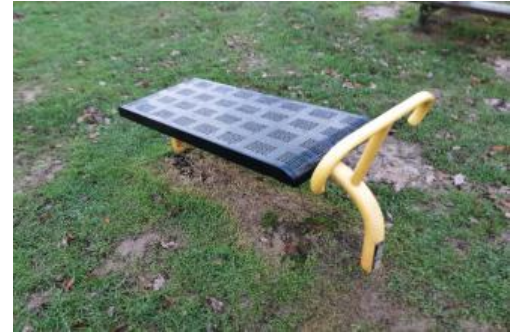
Item: Ab Station
Manufacturer: Hags
Surface Type: Grass Matrix Tiles
Item Quantity: 1
Equipment Compliance: Yes
Surface Area Compliance: Yes

This item is satisfactory - no work required -

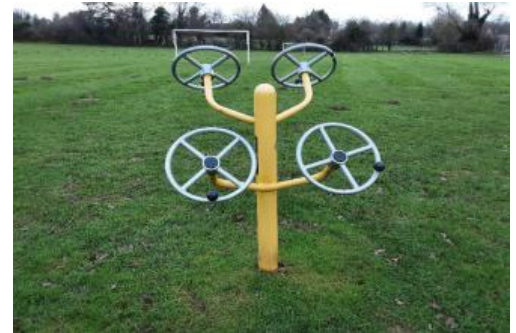
Item: Tai Chi Wheels
Manufacturer: Hags
Surface Type: Grass Matrix Tiles
Item Quantity: 1
Equipment Compliance: Yes
Surface Area Compliance: Yes

This item is satisfactory - no work required -

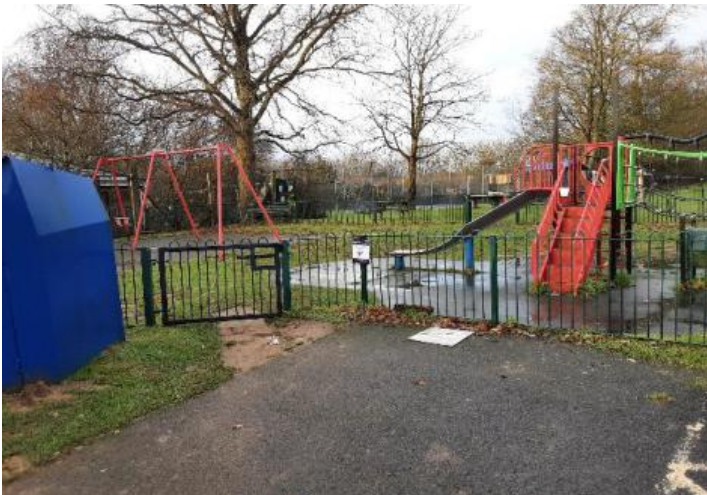
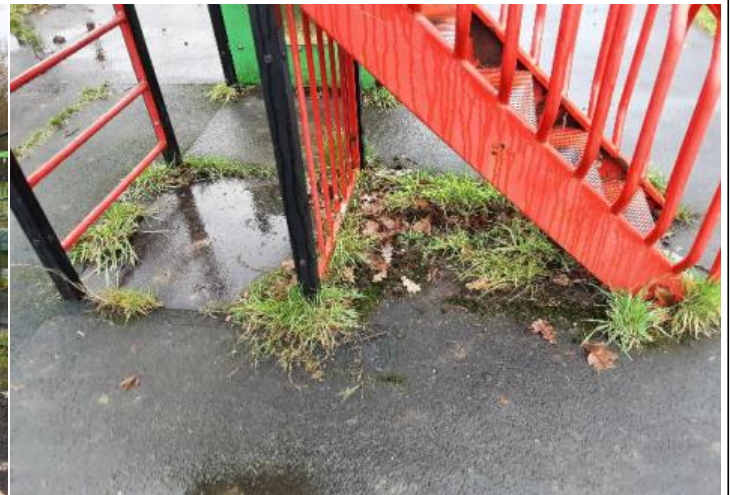
Item: Ancillary Items - Site General
Manufacturer: Owner/Operator

Finding: There is weed / vegetation growth within the surface
Action: Remove weed / vegetation growth

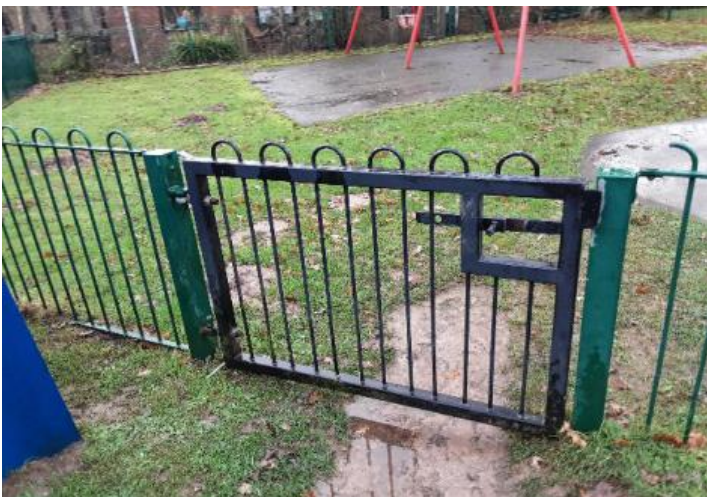
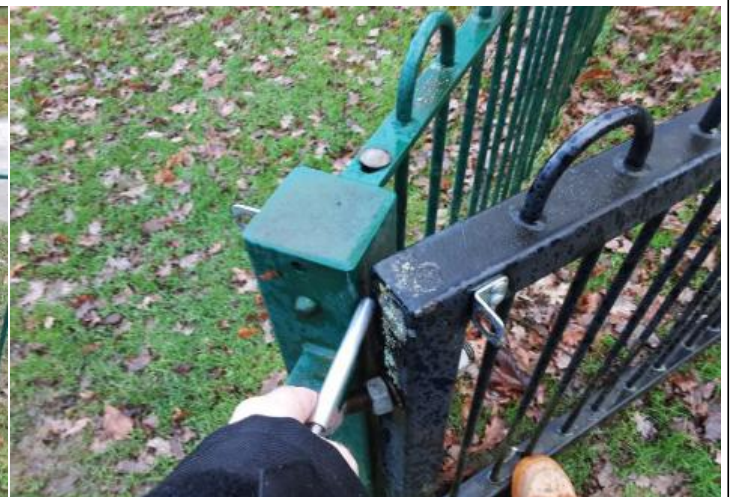
Item: Gates - Gate
Manufacturer: Not Identified

Finding: There are openings that are less than 12mm that could trap or crush fingers
Action: Provide a 12mm gap throughout full range of motion at both sides of gate

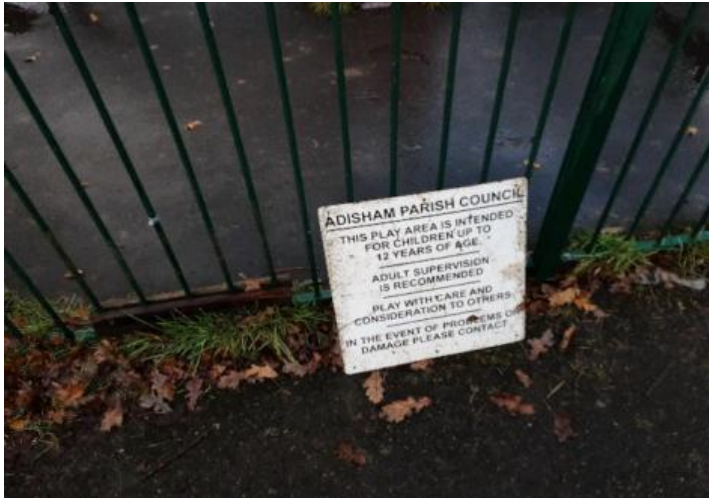
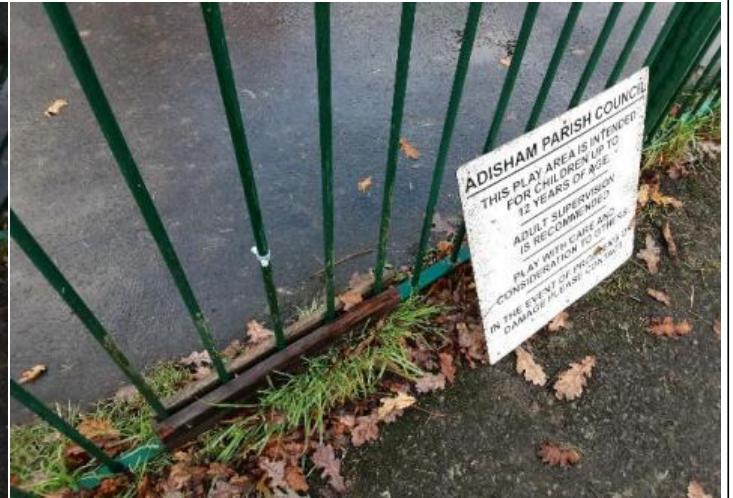
Item: Ancillary Items - Sign
Manufacturer: Not Identified

Finding: The sign has detached

Action: Secure the signage

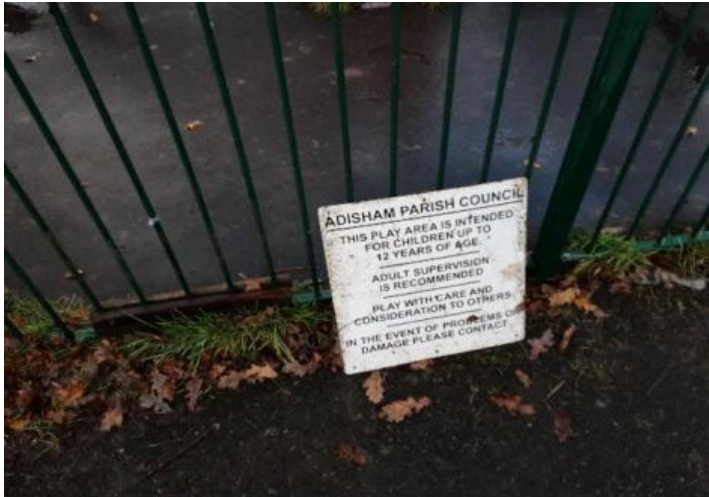
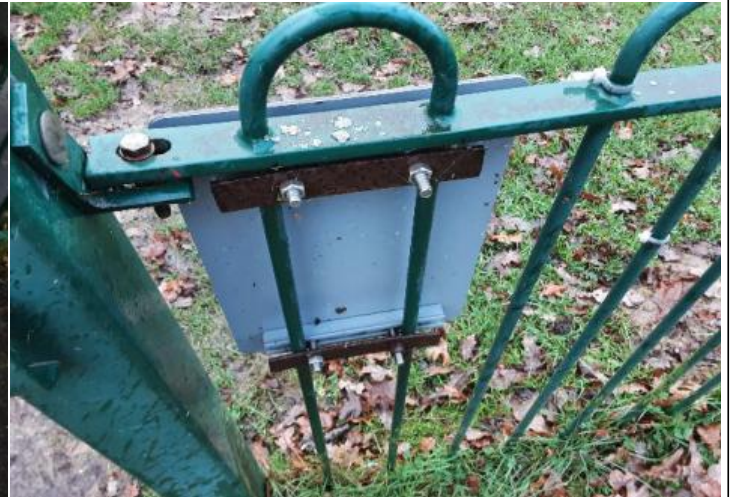
Item: Ancillary Items - Sign
Manufacturer: Not Identified

Finding: There are projecting bolt thread(s) present

Action: Remove excess thread length and deburr or provide cap

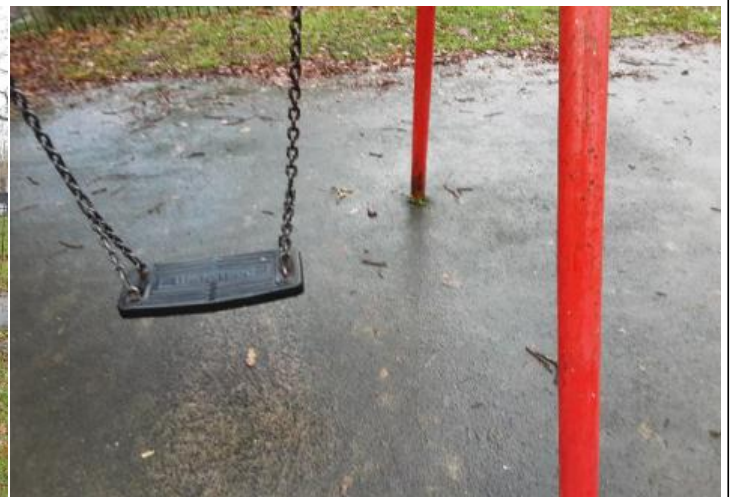
Item: Swings - 2 Bay Swing
Manufacturer: Not Identified

Finding: The seat/s is / are too close to the frame as defined in BS EN 1176 Part 2

Action: Monitor - No action given the risk assessment

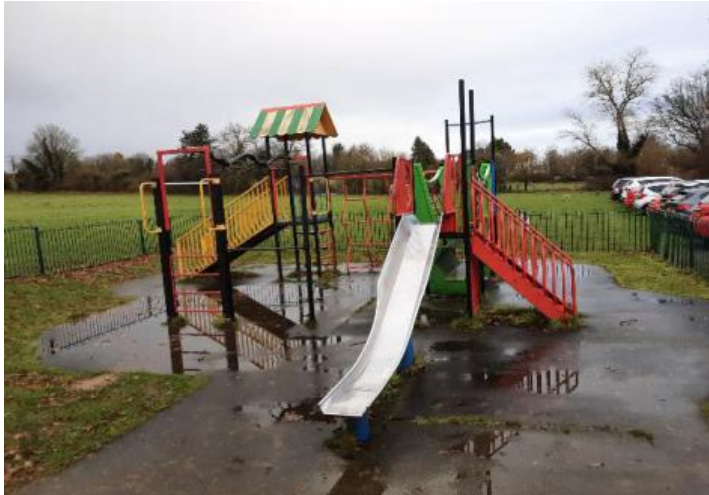
Item: Activity Equipment - Multi Play (Junior)
Manufacturer: Not Identified

Finding: There is moderate damage to the surface

Action: Repair the damaged areas of surfacing

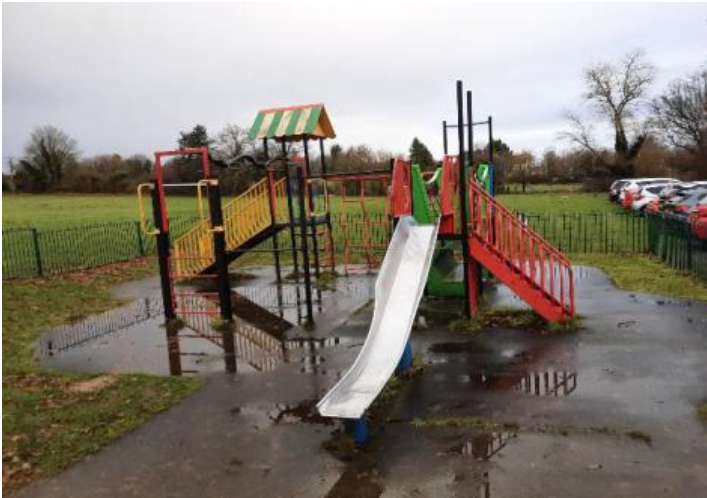
Item: Activity Equipment - Multi Play (Junior)
Manufacturer: Not Identified

Finding: There are a number of dents in the slide surface

Action: Monitor for any further deterioration and repair as required

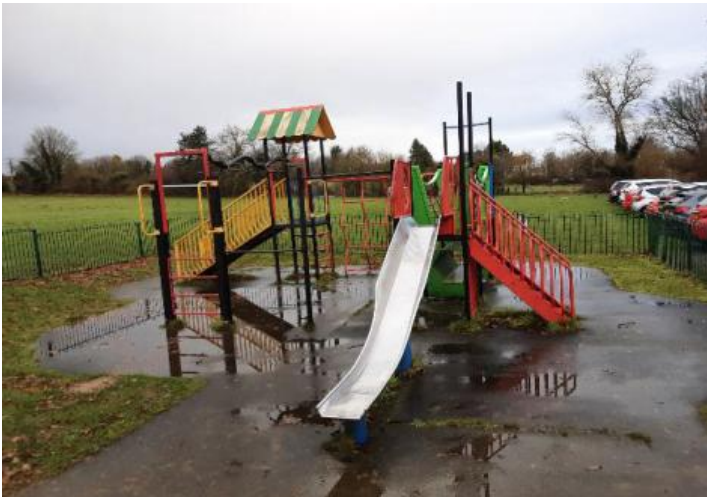
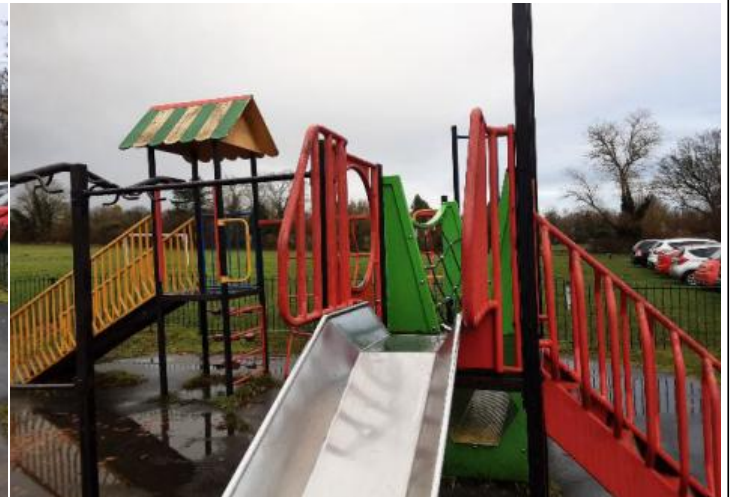
Item: Activity Equipment - Multi Play (Junior)
Manufacturer: Not Identified

Finding: This item has no slide bar fitted as required by BS EN 1176 Part 3

Action: Monitor - No action given the risk assessment

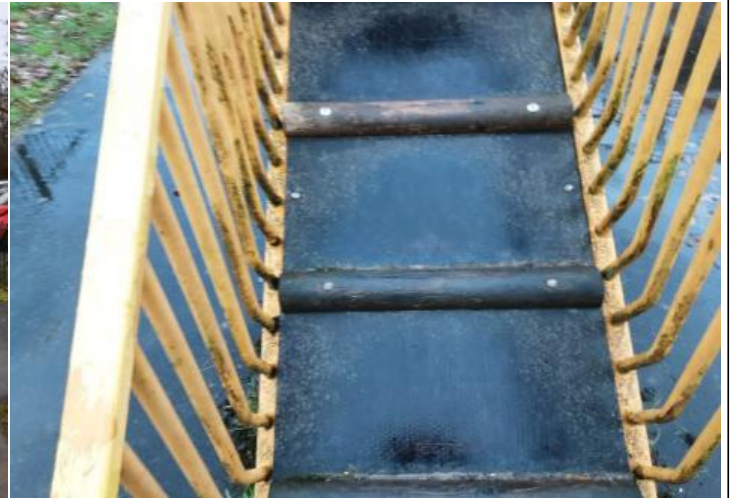
Item: Activity Equipment - Multi Play (Junior)
Manufacturer: Not Identified

Finding: There is algae or moss on the surface of the equipment

Action: Clean and treat appropriately

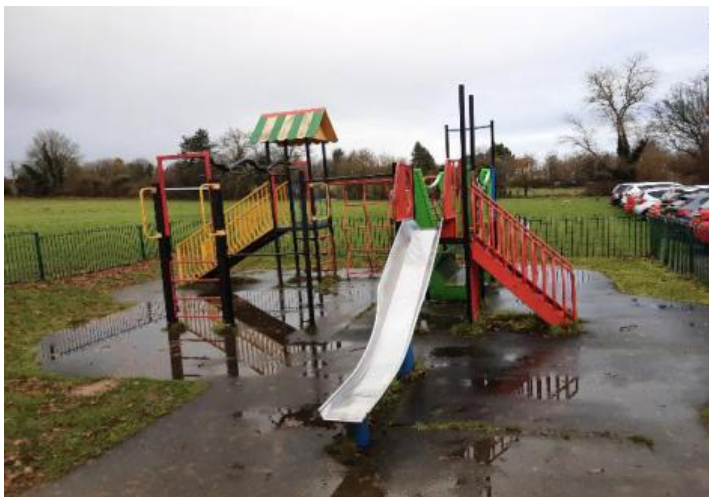
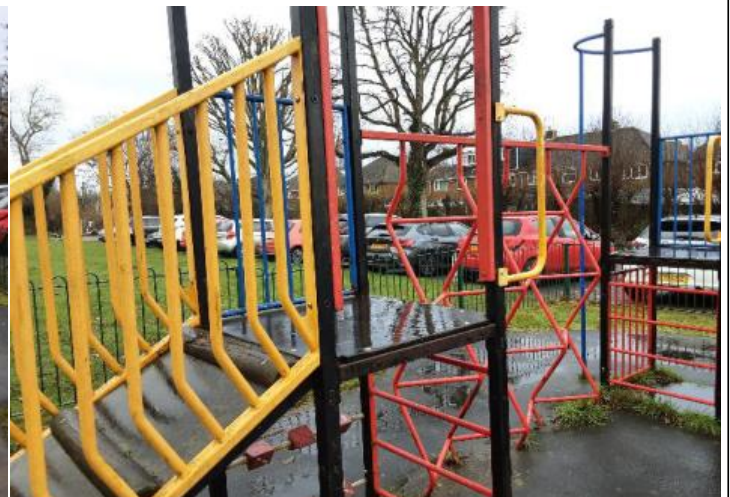
Item: Activity Equipment - Multi Play (Junior)
Manufacturer: Not Identified

Finding: The unit is easily accessible and has an opening in the barrier to steep play elements in excess of 500mm in contravention of BS EN 1176 Part 1

Action: Monitor - No action given the risk assessment

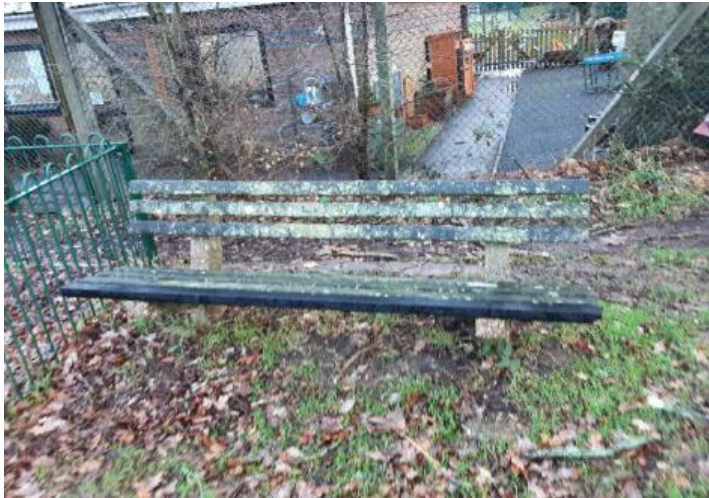
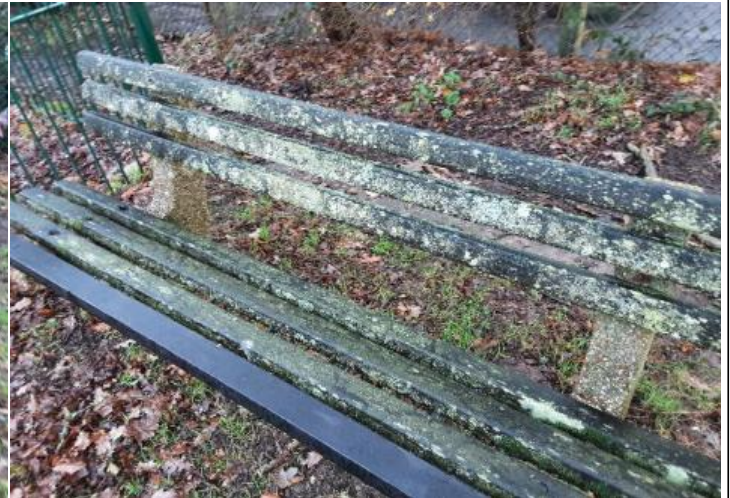
Item: Ancillary Items - Bench
Manufacturer: Not Identified

Finding: There is algae or moss on the surface of the equipment

Action: Clean and treat appropriately

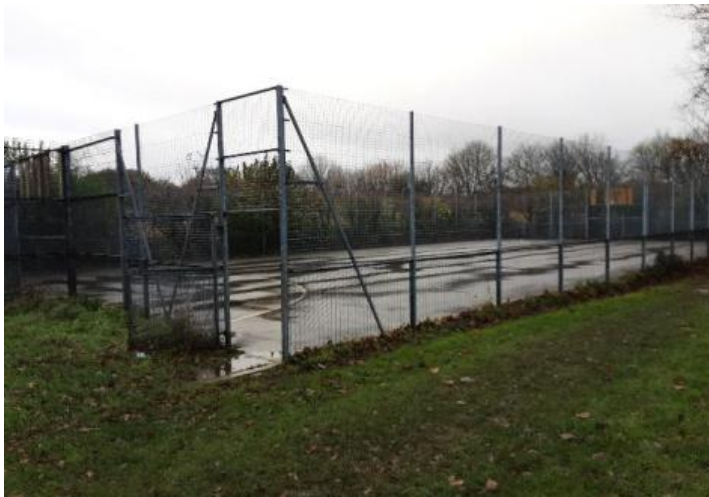
Item: Multi Use Games Area - Multi Use Games Area (MUGA)
Manufacturer: Not Identified

Finding: There is/are finger entrapments in the panels and the item fails to meet the requirements of BS EN 15312 Clause 4.4.2.2 Entrapment of fingers

Action: Monitor - No action given the risk assessment

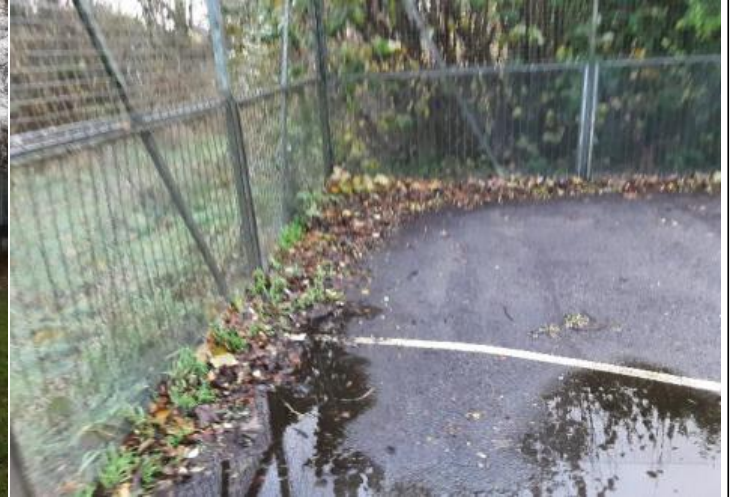
Item: Multi Use Games Area - Multi Use Games Area (MUGA)
Manufacturer: Not Identified

Finding: There is some tree debris on the surfacing

Action: Remove and maintain

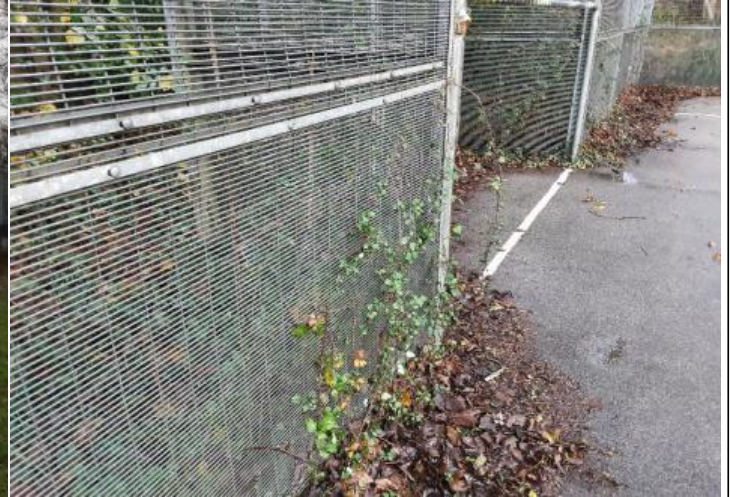
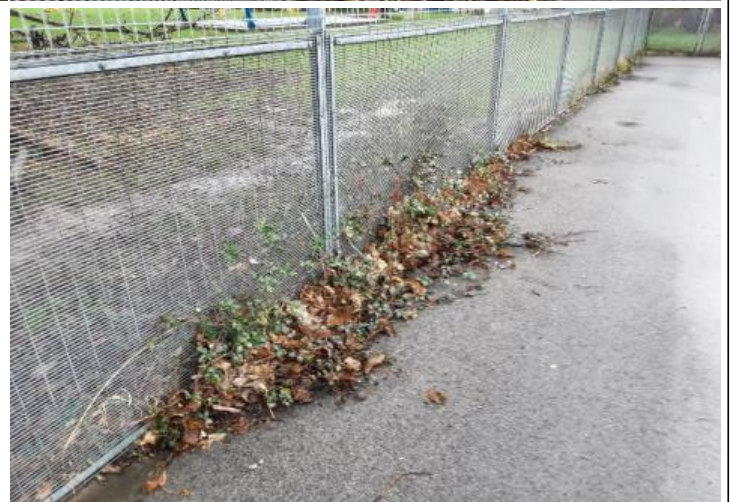
Item: Multi Use Games Area - Multi Use Games Area (MUGA)
Manufacturer: Not Identified

Finding: The adjacent foliage is overhanging

Action: Cut back and maintain

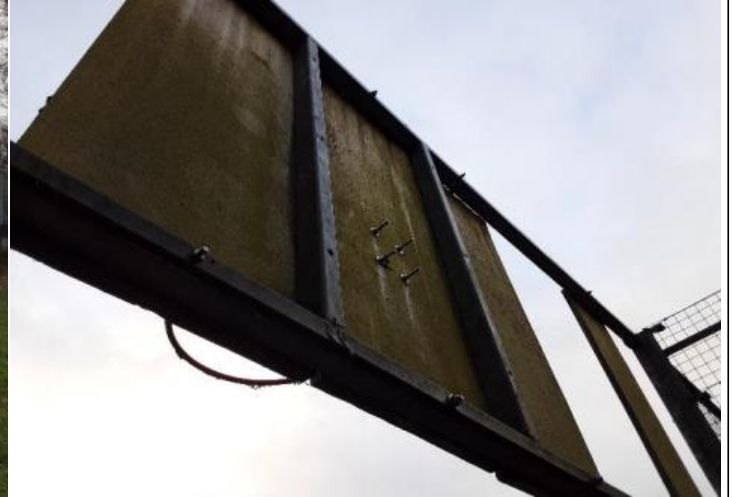
Item: Multi Use Games Area - Multi Use Games Area (MUGA)
Manufacturer: Not Identified

Finding: There are projecting bolt thread(s) present

Action: Remove excess thread length and deburr or provide cap

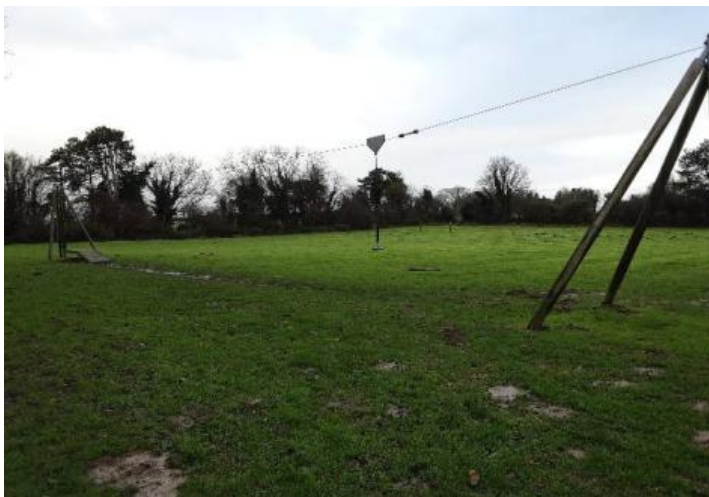
Item: Other - Cable Runway
Manufacturer: Playdale Playgrounds Ltd

Finding: There is some notable evidence of chain wear

Action: Monitor for any further deterioration and replace when 40% worn

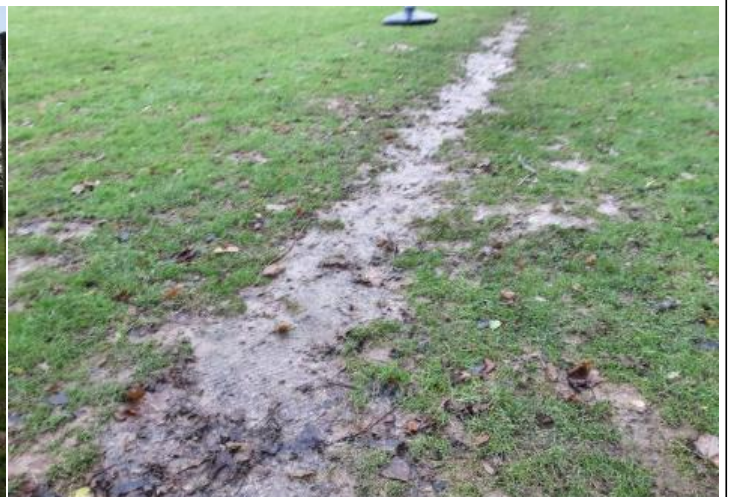
Item: Other - Cable Runway
Manufacturer: Playdale Playgrounds Ltd

Finding: The grass mats are silted up and the soil is compacted; this may have an effect on the impact absorbing properties of the surface. Consideration should be given to HIC testing the surface to verify impact attenuating properties (<https://playinspections.co.uk/inspection-services/safety-surface-testing/>)

Action: Contact our office for a quotation for this service

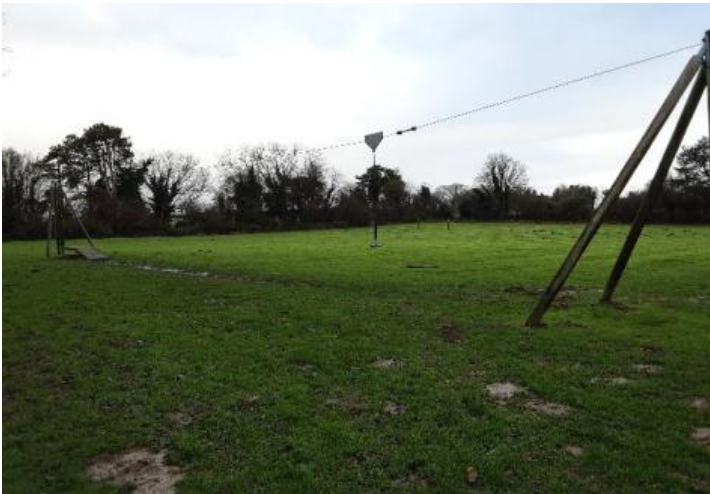
i 6 - Low Risk (Finding 7)			
Item:	Other - Cable Runway	Risk Level:	L - Low Risk
Manufacturer:	Playdale Playgrounds Ltd	Surface:	Grass Matrix Tiles

Finding: There is some strimmer / machinery damage apparent on the posts, this can penetrate the preservative applied to the timber and accelerate the rotting process		Action: Monitor for any deterioration (rot) and replace as required

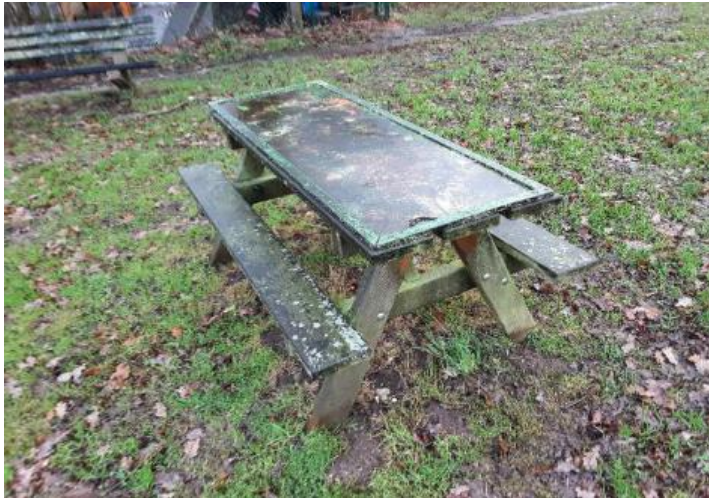
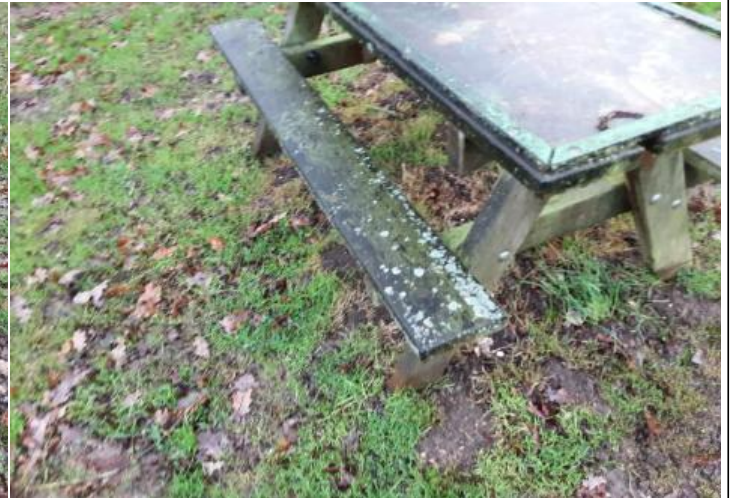
Item: Ancillary Items - Picnic Table
Manufacturer: Playdale Playgrounds Ltd

Finding: There is algae or moss on the surface of the equipment

Action: Clean and treat appropriately

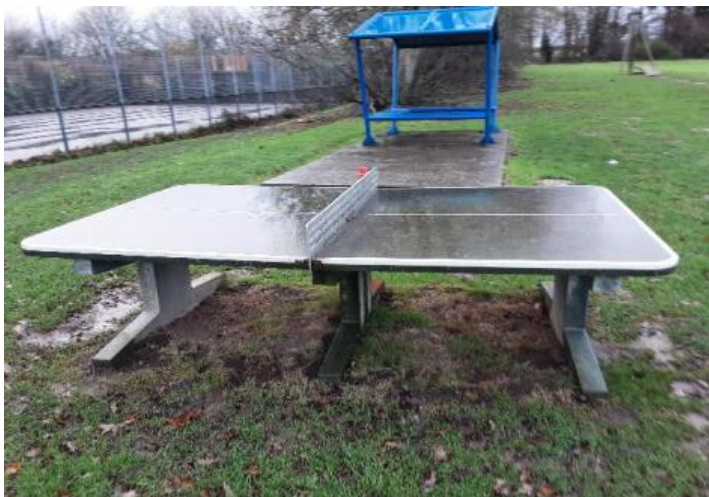
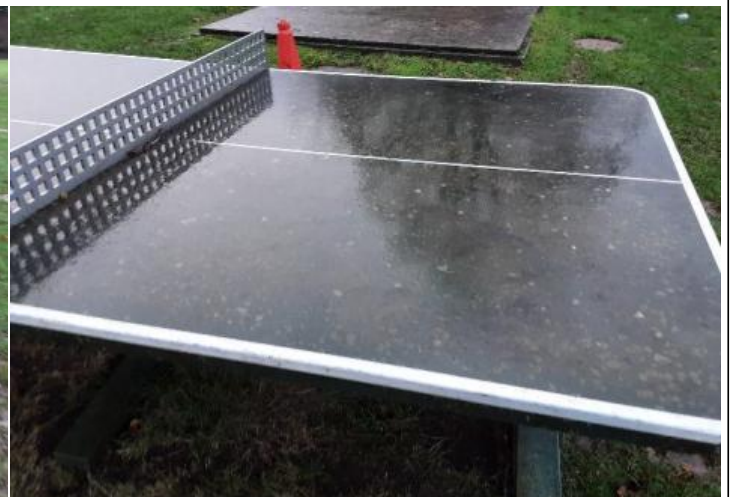
Item: Other - Table Tennis
Manufacturer: Other

Finding: There is algae or moss on the surface of the equipment

Action: Clean and treat appropriately
