Annual Inspection

Adisham Parish Council

Adisham Recreation Ground

Annual Inspection - 16 October 2017 at 10:00 Inspector: Robert Baldock (RPII Annual Inspector)

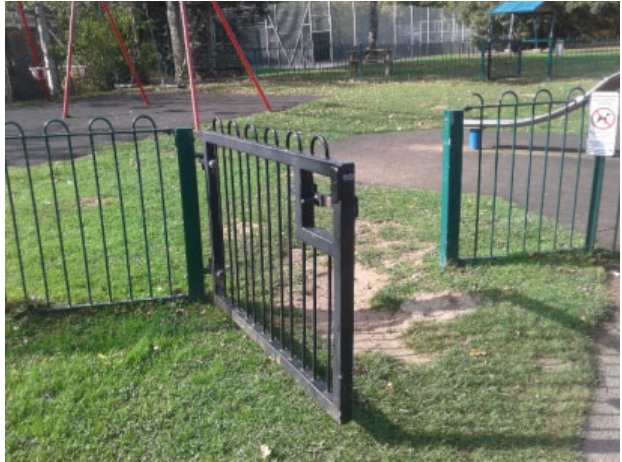
Item: Ancillary Items - Gate
Manufacturer: Not Identified
Surface Type: Grass
Equipment Compliance: N/A
Surface Area Compliance: N/A
Ref/Part Number:
Total Findings: 3

The gate is not operating correctly - Take effective action to ensure the gate closes between 4 and 8 seconds

The area under the gate has eroded leaving uneven areas, or the concrete foundations exposed, resulting in trip hazards at the entrance/exit to the playground - Reinstate to level with surrounding surfaces

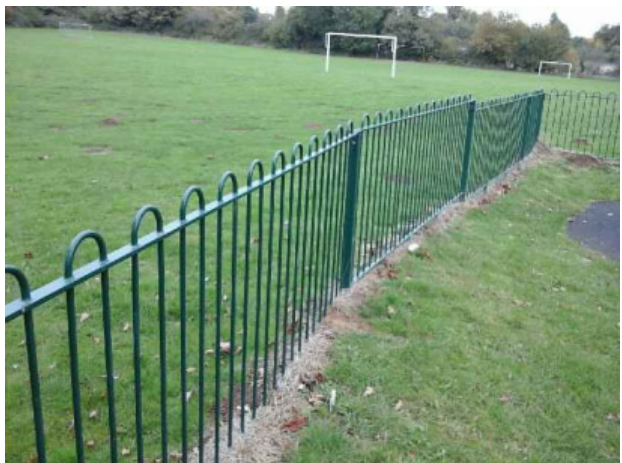
Item: Ancillary Items - Fence - Bow Top
Manufacturer: Not Identified
Surface Type: Grass
Equipment Compliance: N/A
Surface Area Compliance: N/A
Ref/Part Number:
Total Findings: 1

There are a number of fixings missing from the fence - Replace missing fixings

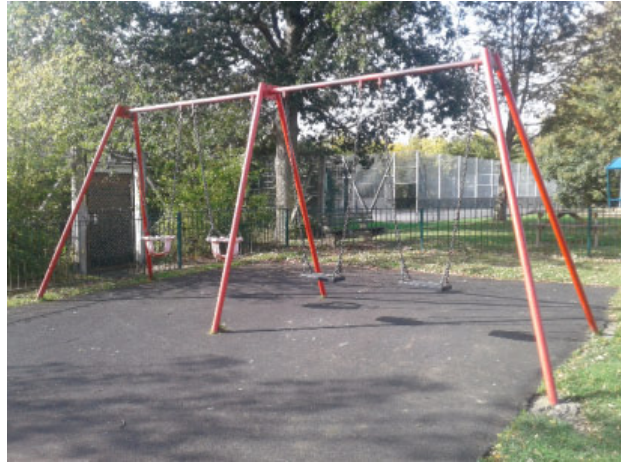
Item: Swings - 1 Bay 1 Seat (Cradle) - Type 1
Manufacturer: Not Identified
Surface Type: Wet Pour
Equipment Compliance: No
Surface Area Compliance: Yes
Ref/Part Number:
Total Findings: 10

The surfacing around the item is damaged - Repair the damaged areas of surfacing

The surface has eroded and the foundations are exposed - Reinststate surrounding surfaces to cover the foundations

The chain openings are in excess of the 8.6mm as recommended by BS EN 1176 - Monitor use

The chain links are worn in excess of 40% and require renewing - Replace worn chains

The bushes are worn or missing - Replace worn or missing bushes

The paintwork on this item has been damaged or worn exposing the metal underneath which is rusting - Treat any rusting components and repaint

The seats are too close to the frame as defined in BS EN 1176 Part 2; this is a low risk failure and no remedial action is required - Monitor use

The seats are too close to each other as defined in BS EN 1176 Part 2; this is a low risk failure and no remedial action is required - Monitor use

The seat has minor damage or wear - Monitor for any further deterioration and replace as required

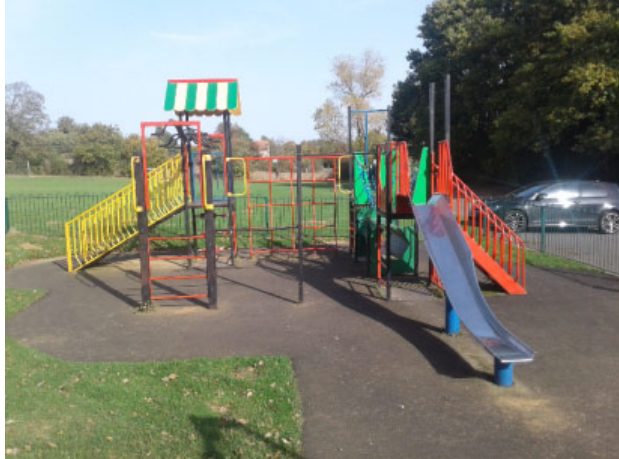
Item: Activity Equipment - Multi Play (Junior)
Manufacturer: Not Identified
Surface Type: Wet Pour
Equipment Compliance: No
Surface Area Compliance: Yes
Ref/Part Number:
Total Findings: 13

There are a number of dents in the slide surface - Monitor for any further deterioration and repair as required

The side of the slide is damaged - Monitor for any further deterioration and repair as required

The item fails to meet the requirements of BS EN 1176:2008 Part 1 4.2.7.2 head and neck entrapment in the barriers and/or steps - Monitor use

There is/are several inserts missing - Replace missing inserts

There is/are finger entrapment/s in the frame and the item fails to meet the requirements of BS EN 1176:2008 Part 1 4.2.7.6 Entrapment of fingers - Monitor use

The platforms have severely rotted - Replace all affected timber

There is algae or moss growth on the surface resulting in slippery conditions - Clean and treat appropriately

The paintwork on this item has been damaged or worn exposing the metal underneath which is rusting - Treat any rusting components and repaint

Parts of the steel on this item have corroded excessively and the metal has perforated in places - Ensure all affected areas are treated and repaired

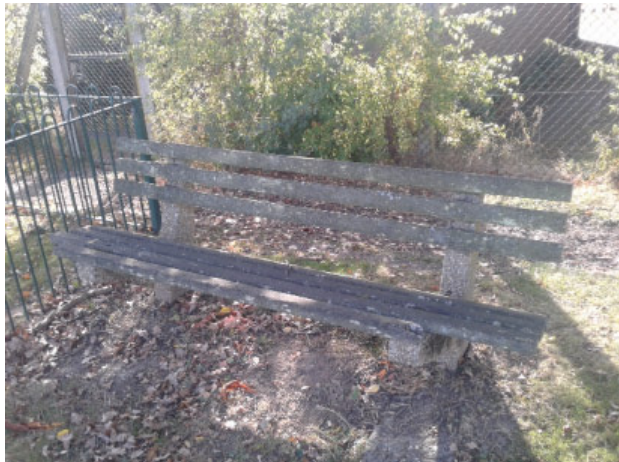
Item: Ancillary Items - Bench
Manufacturer: Not Identified
Surface Type: Grass
Equipment Compliance: N/A
Surface Area Compliance: N/A
Ref/Part Number:
Total Findings: 3

The bench is damaged - Repair or replace as required

The surface has eroded and the foundations are exposed - Reinststate surrounding surfaces to cover the foundations

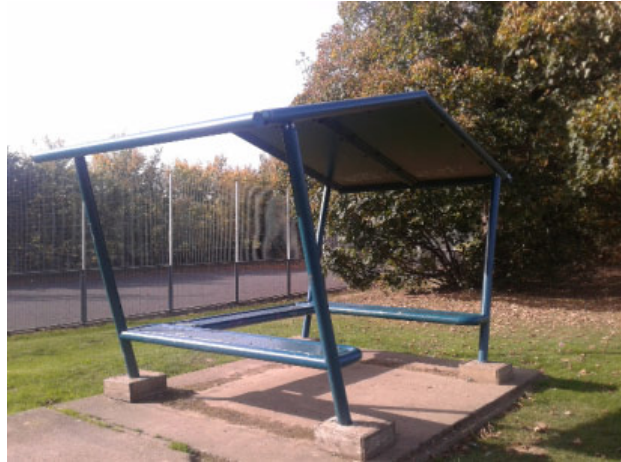
Item: Ancillary Items - Shelter
Manufacturer: Monster Play Systems
Surface Type: Concrete
Equipment Compliance: N/A
Surface Area Compliance: N/A
Ref/Part Number:
Total Findings: 3

There is some graffiti present - Remove the graffiti

There is or are fixings missing on the item - Replace all missing fixings

There is/are bolt cap covers missing or damaged on the item - Replace missing or damaged bolt cap covers

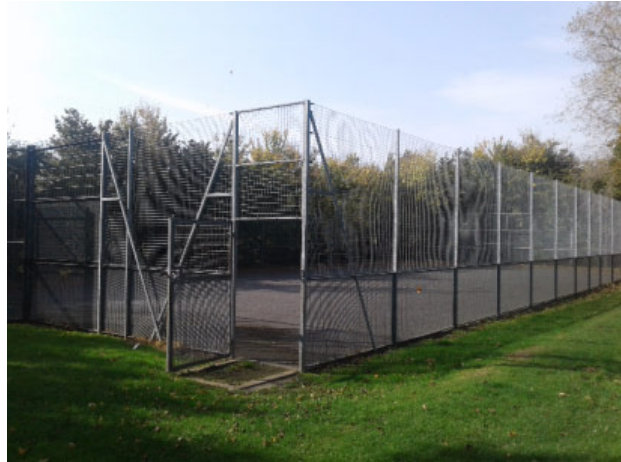
Item: Multi Use Games Area - Multi Use Games Area (MUGA)
Manufacturer: Not Identified
Surface Type: Bitmac
Equipment Compliance: No
Surface Area Compliance: N/A
Ref/Part Number:
Total Findings: 8

A clearly visible sign should be provided in a prominent position with the wording as detailed BS EN 15312- the equipment is not intended for children less than 3 years old- the warning Do not climb on the framework or nets- the warning Do not hang on the ring (if provided)- the warning Do not wear rings or other jewellery- name and telephone number of the administrator- number to call in case of accident - Provide signage to BS EN 15312

There are trip hazards present at the gate entrance - Reinstate surrounding surfaces to level to remove the trip points

There is/are finger entrapments in the panels and the item fails to meet the requirements of BS EN 15312 Clause 4.4.2.2 Entrapment of fingers - Monitor use

There is algae or moss growth on the surface resulting in slippery conditions - Clean and treat appropriately

There are a number of missing panels - Replace

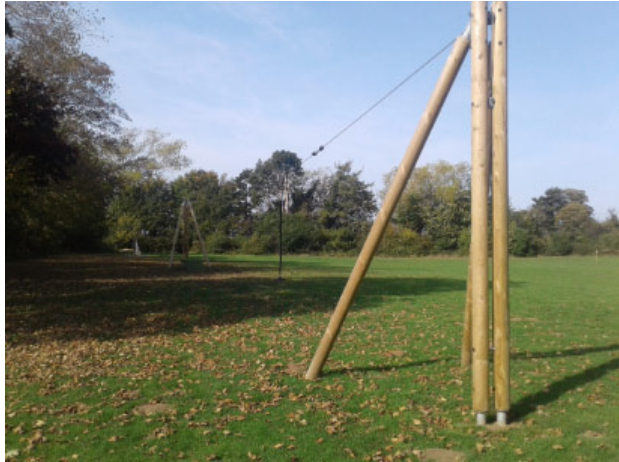
Item: Other - Cable Runway
Manufacturer: Playdale Playgrounds Ltd
Surface Type: Grass Matrix Tiles
Equipment Compliance: No
Surface Area Compliance: Yes
Ref/Part Number:
Total Findings: 3

The height of the seat is less than 400mm when partially loaded - Ensure the seat is a minimum of 400mm above ground level when loaded with 130kg

We recommend that the main cable is thoroughly inspected at least once every 2 years this; will involve either removing the cable or gaining access by ladders and/or steps to inspect for damage or internal rusting, this will help to ensure the continued safe use of the equipment - Inspect cable every 24 months

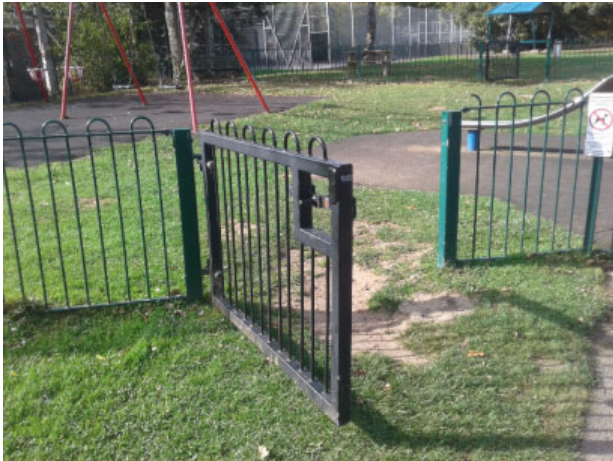
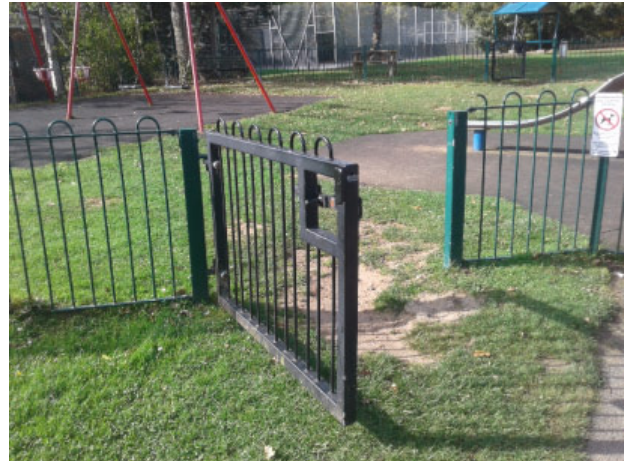
Finding: The gate is not operating correctly

Action: Take effective action to ensure the gate closes between 4 and 8 seconds

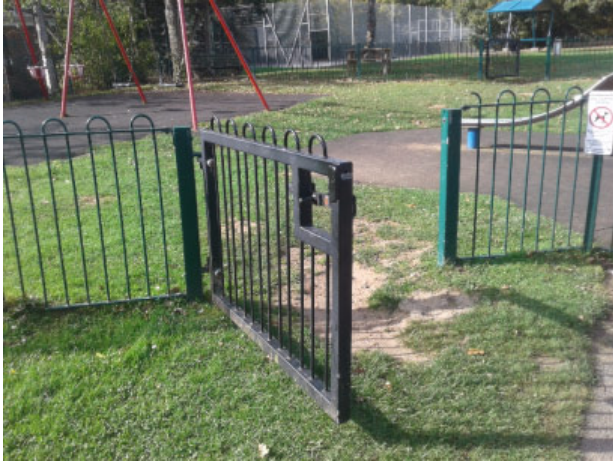
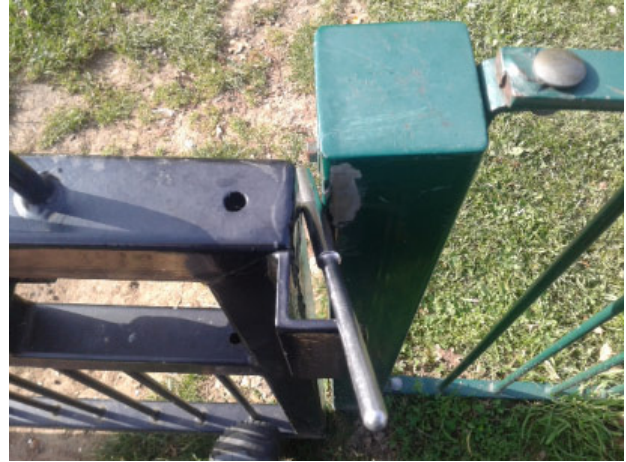
Finding: The opening between the gate and the post is less than 12mm and could trap users fingers
Action: Adjust gate to ensure a 12mm opening all around

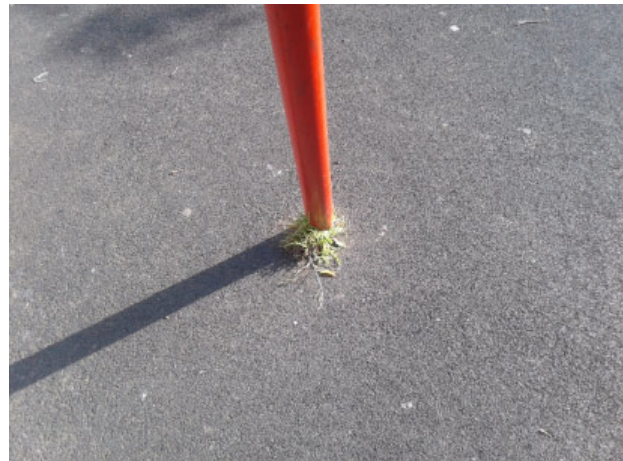
Finding: There are weeds/vegetation growth between or around the edges of the surfacing
Action: Remove weeds/vegetation growth

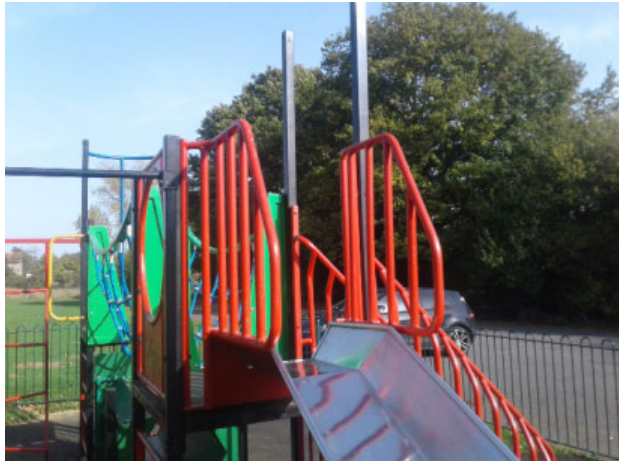
Finding: This item has no slide bar fitted as required by BS EN 1176 Part 3 **Action:** Monitor use

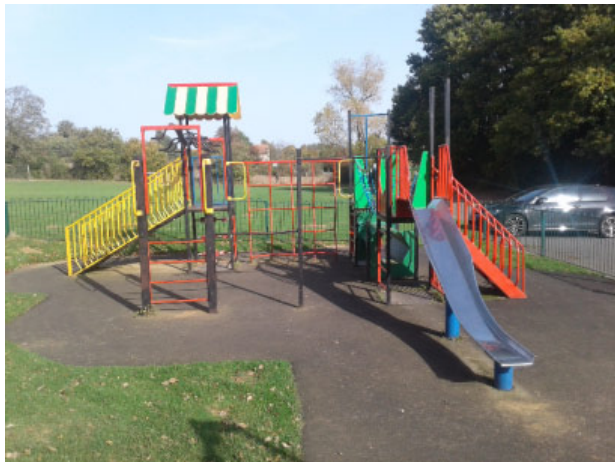
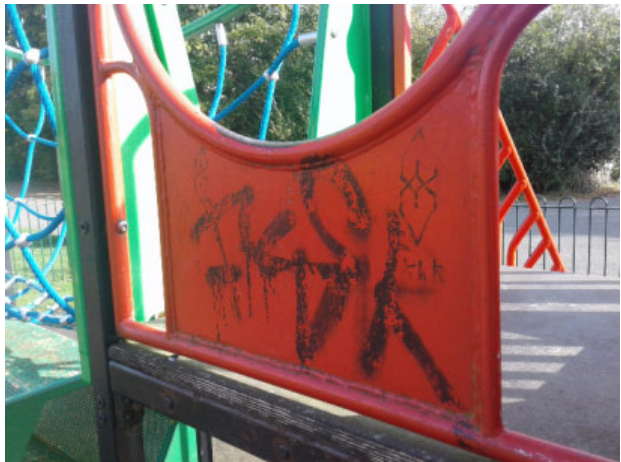
Finding: There is some graffiti present

Action: Remove the graffiti

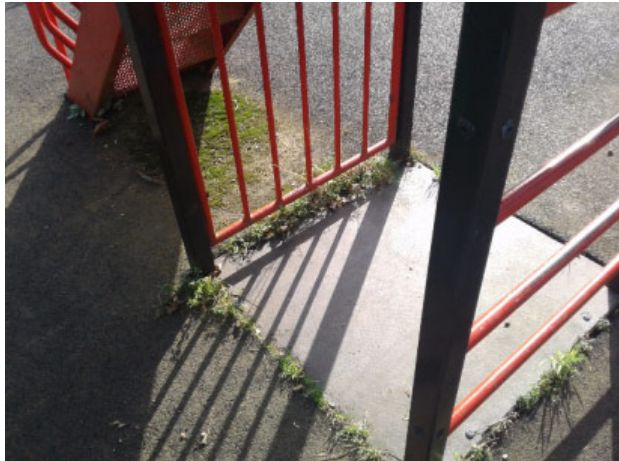
Finding: There are weeds/vegetation growth between or around the edges of the surfacing **Action:** Remove weeds/vegetation growth

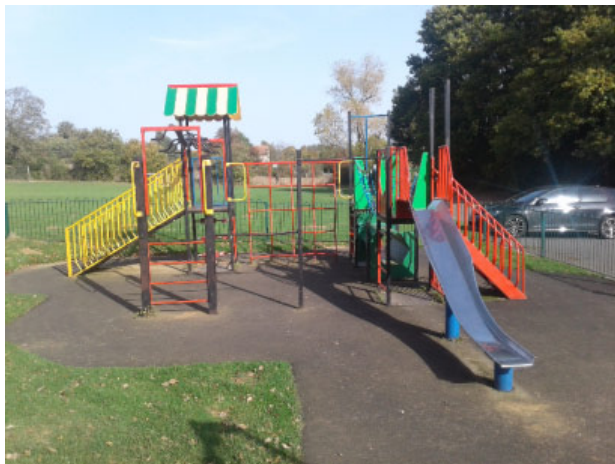
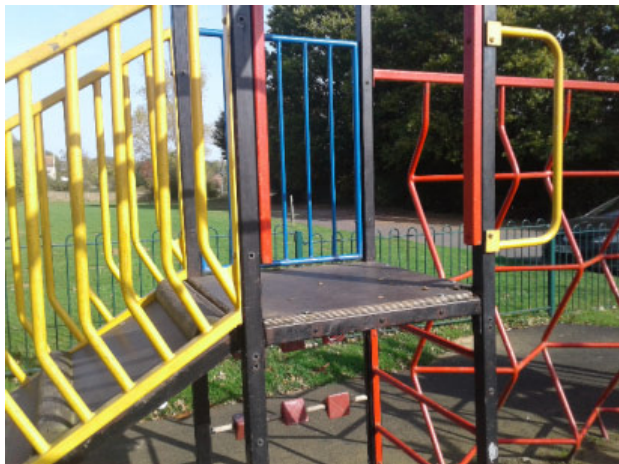
Finding: The unit is easily accessible and has an opening in the barrier to steep play elements in excess of 500mm
Action: Monitor use

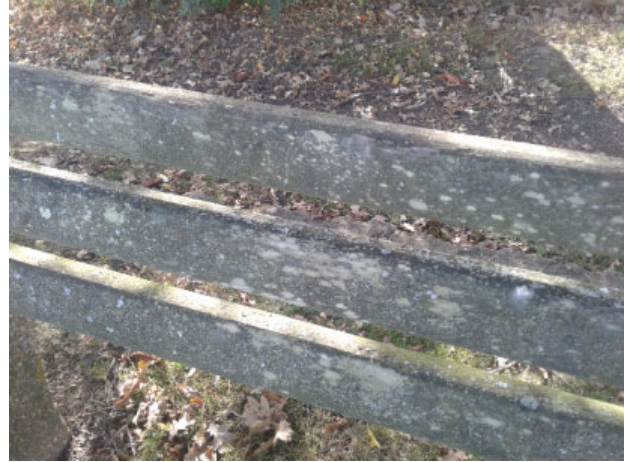
Finding: There is algae or moss on the surface of the equipment

Action: Clean and treat appropriately

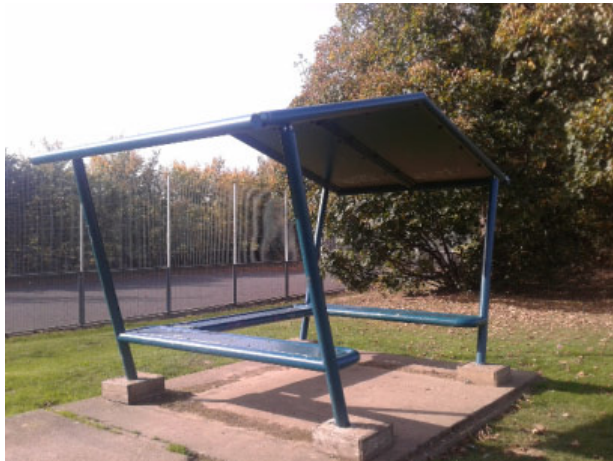
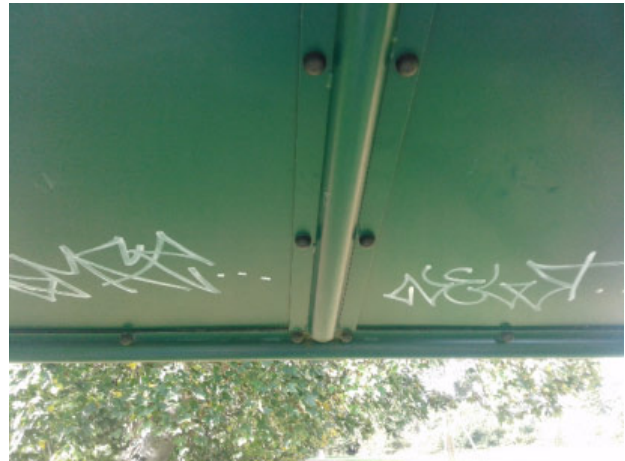
Finding: There is some graffiti present

Action: Remove the graffiti

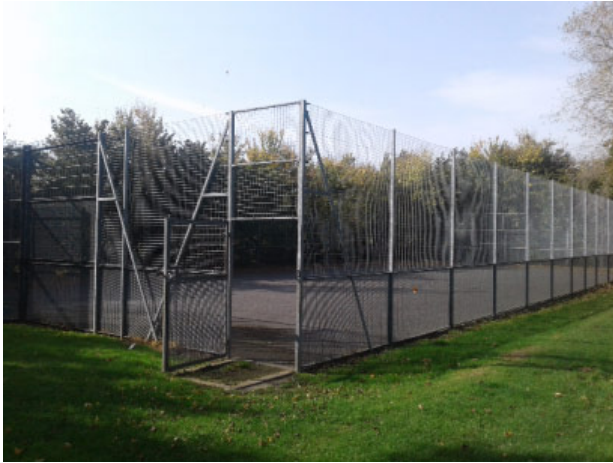
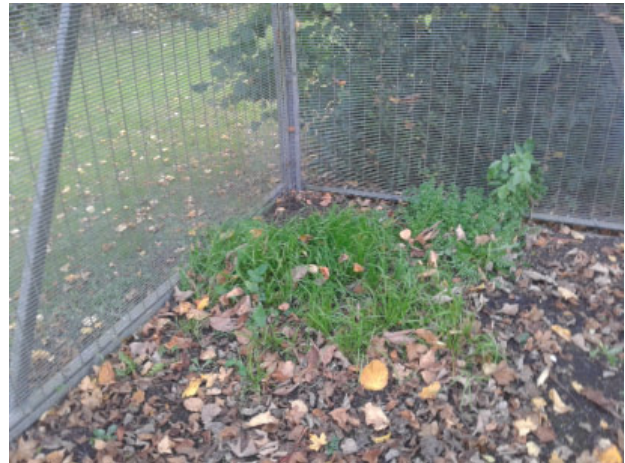
Finding: There are weeds/vegetation growth between or around the edges of the surfacing

Action: Remove weeds/vegetation growth

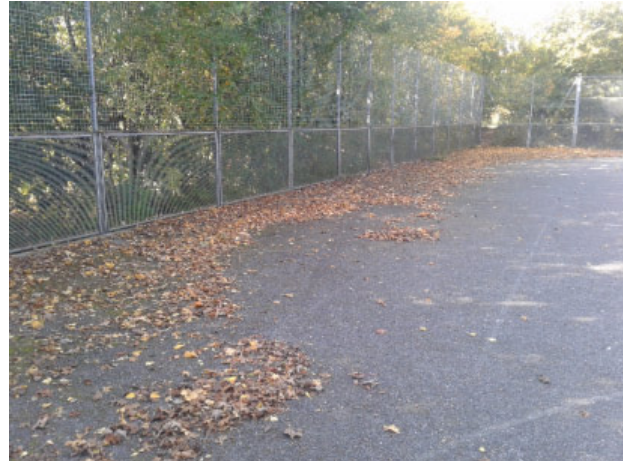
Finding: There is some tree debris on the surfacing

Action: Remove and maintain

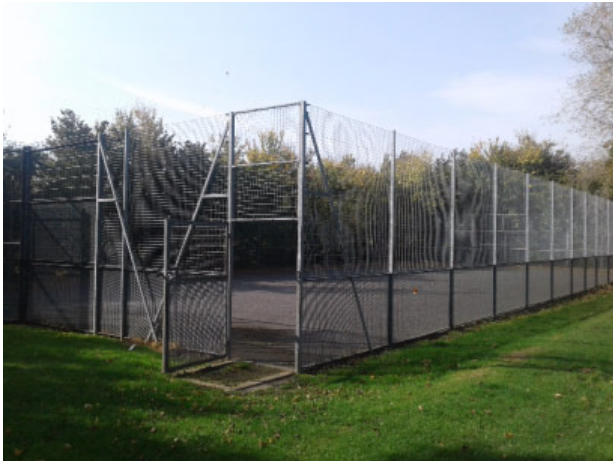
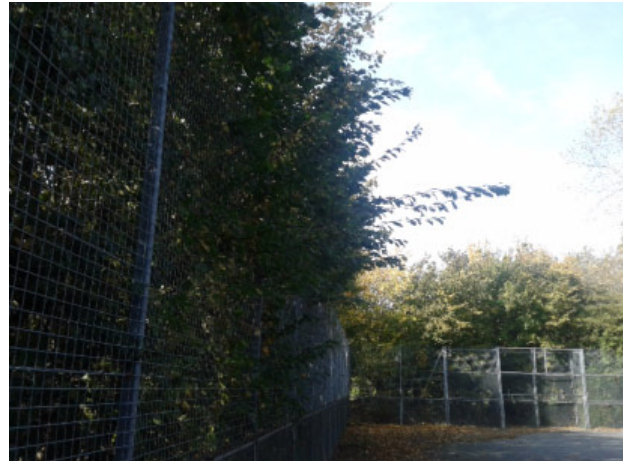
Finding: The tree canopy overhangs the equipment and is less than 2.0m away

Action: Lift tree canopy to ensure a minimum clearance of 2.0m from the equipment

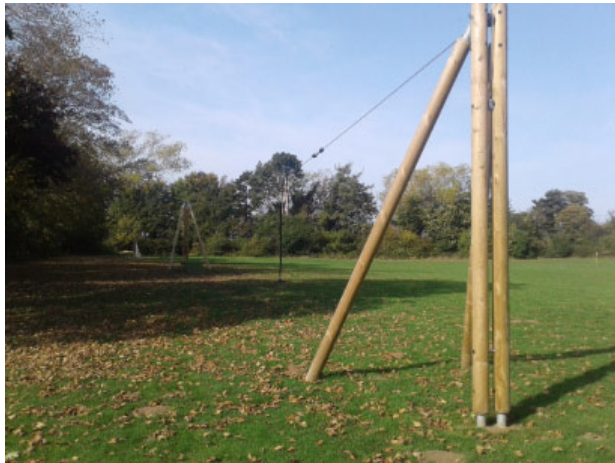
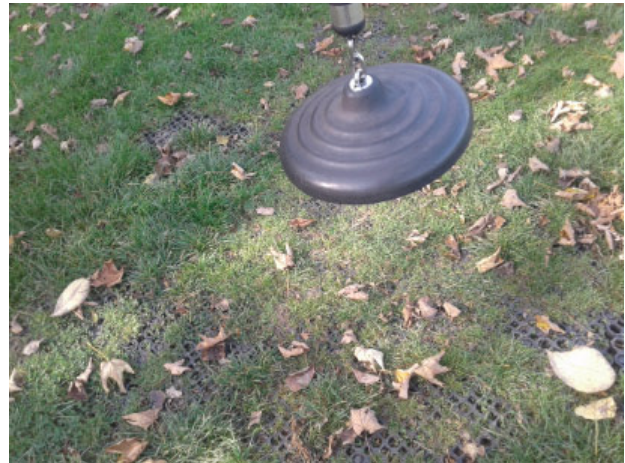
Finding: The height of the seat is less than 400mm when partially loaded

Action: Ensure the seat is a minimum of 400mm above ground level when loaded with 130kg

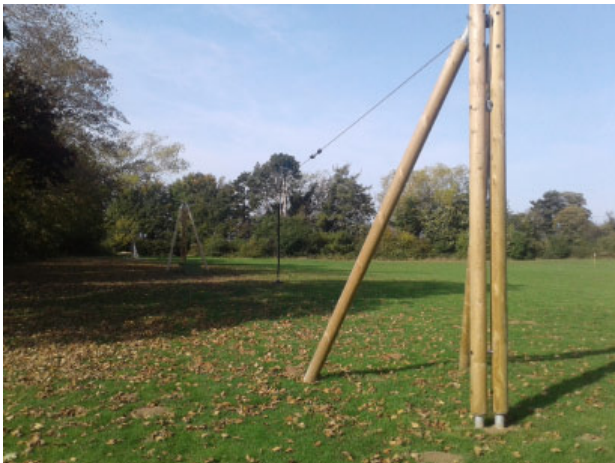
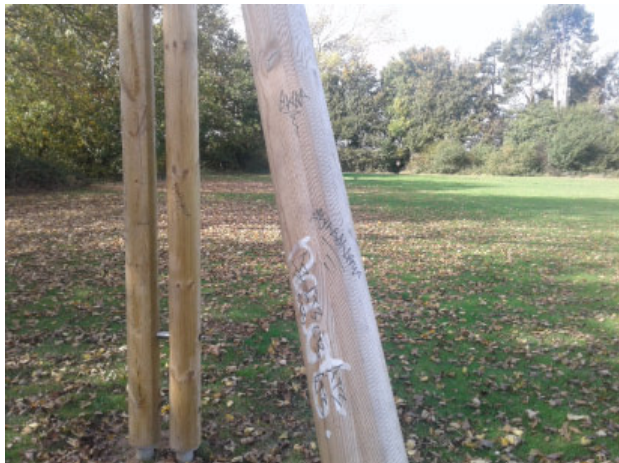
Finding: There is some graffiti present

Action: Remove the graffiti
